**Informal Group on gtr No 9 – Phase 2 (IG GTR9-PH2)  
1<sup>st</sup> meeting, Geneva/Switzerland, 1 – 2 December 2011**

# **FlexPLI Version GTR Prototype SN-02 - Durability Assessment**

Presented by the pedestrian safety experts of the  
International Automobile Manufacturers' Organization (OICA)

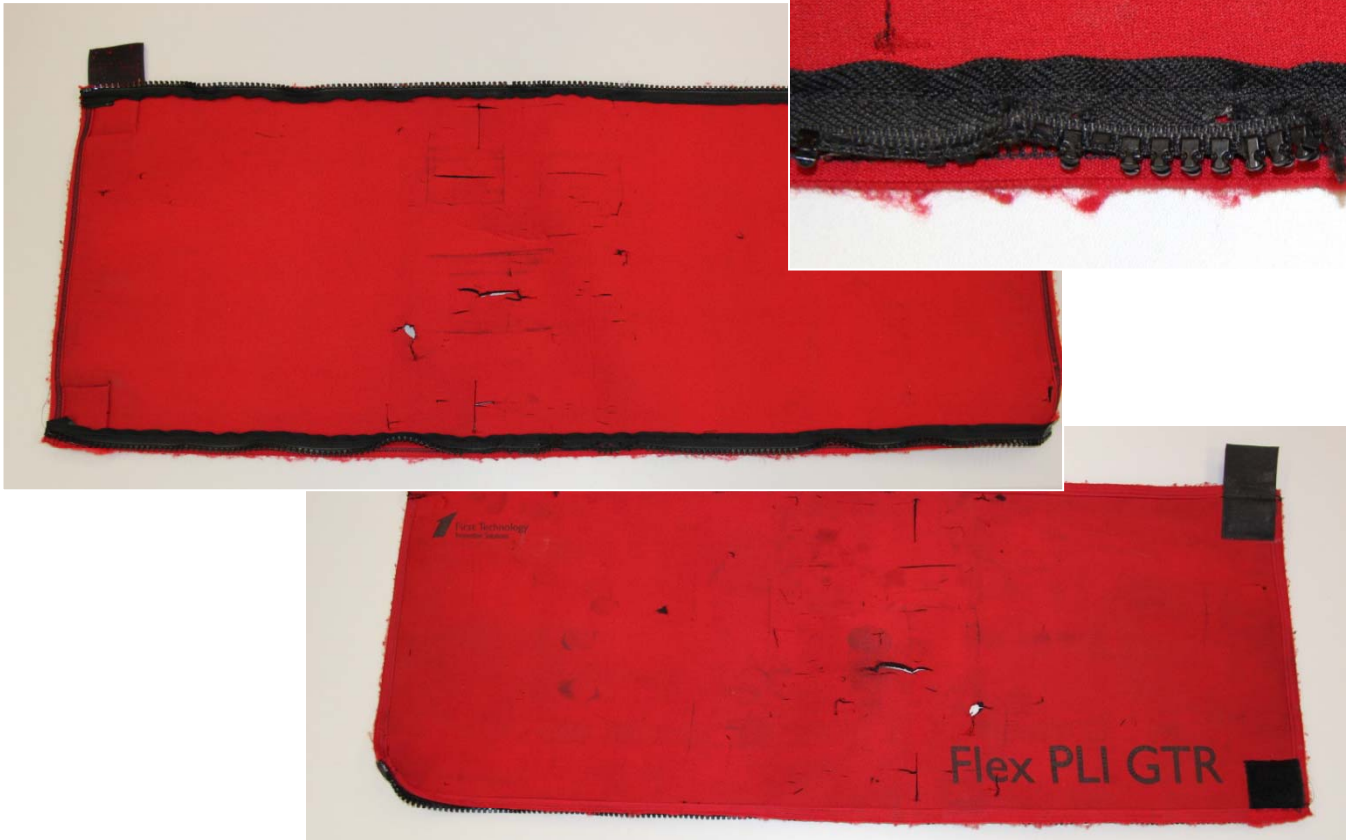
- Skin well used after 50 – 100 tests, depending on structures/objects struck
- Zippers and zipper handle frequently break / wear out

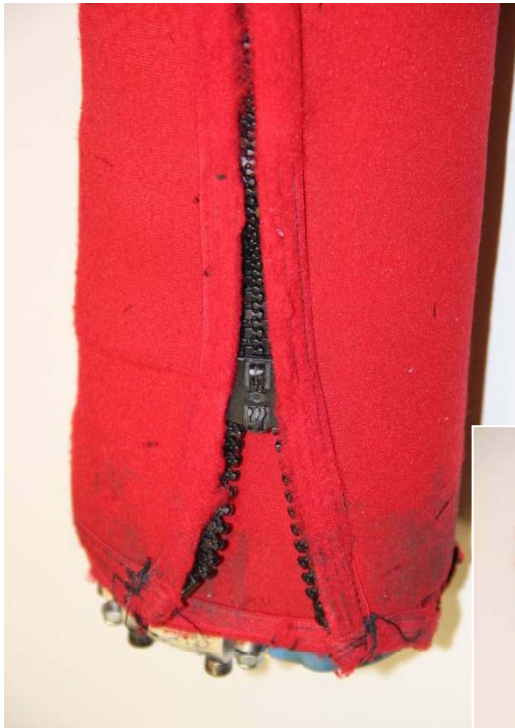
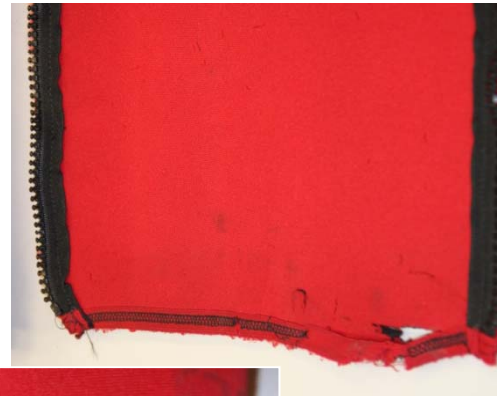
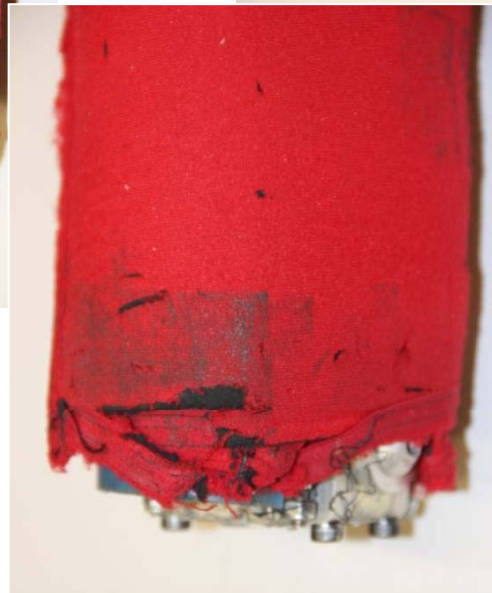
- Innermost skin parts with clear marks of tibia/femur segments

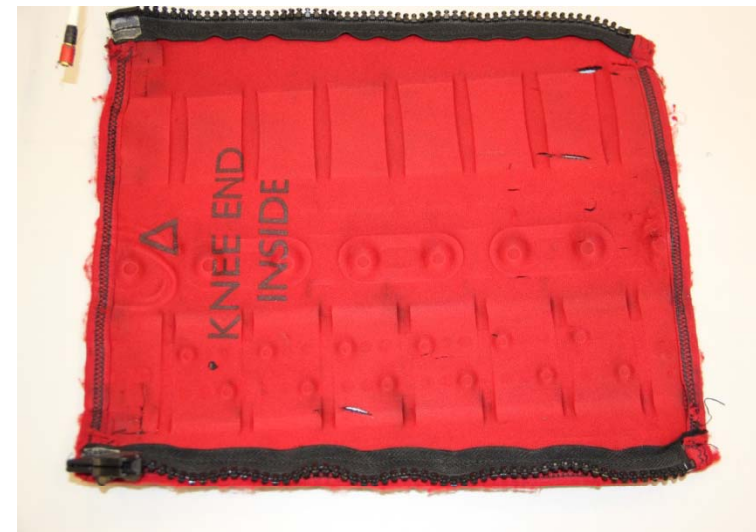
- Skins well used
- Zipper handles broken / worn out

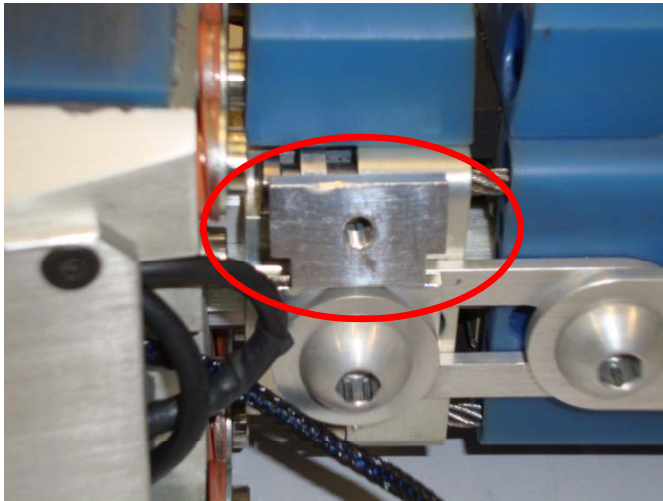
- Stress relief for trigger cable at knee element missing

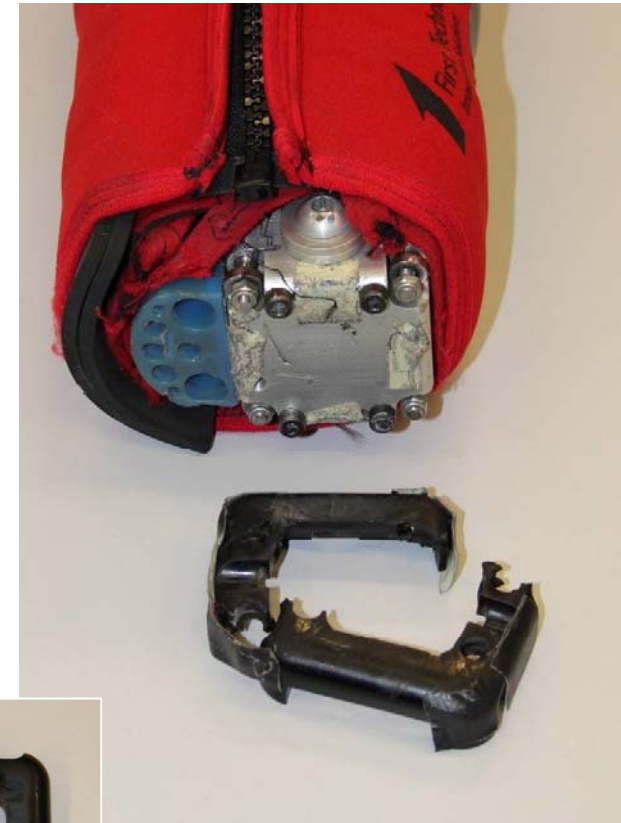
- Lower protective cap broken (plastic part)

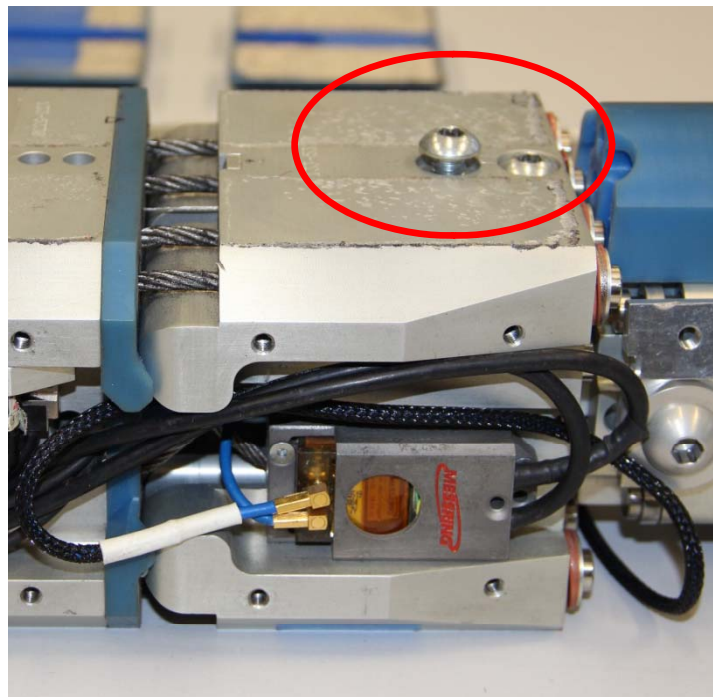
- Loose screw at knee element, only visible after removal of plastic parts
- Further loose screws were found at inner parts, which are not regularly checked

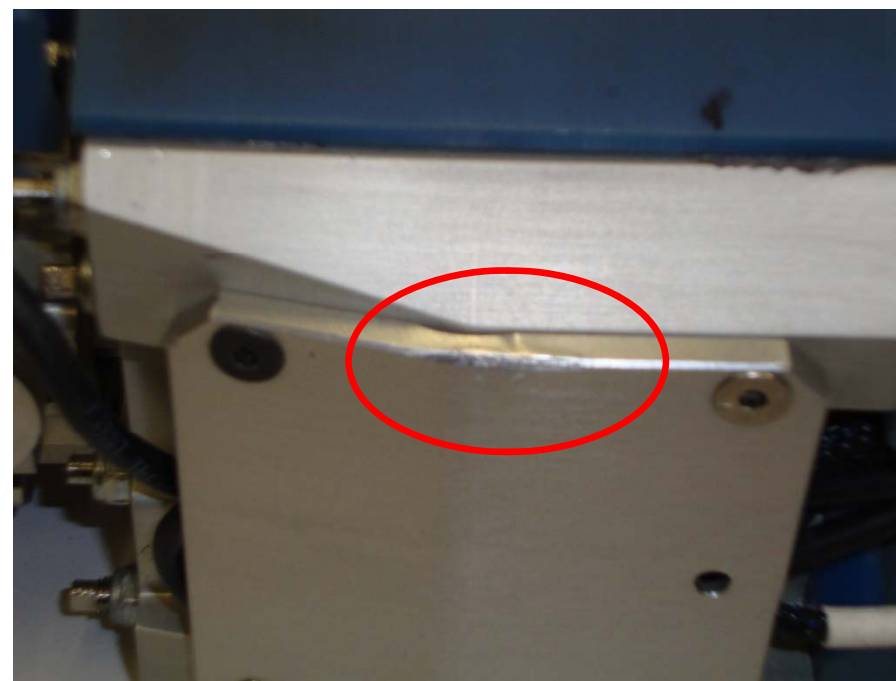
- Mechanical damages to metal parts (hard impacts, misuse?)

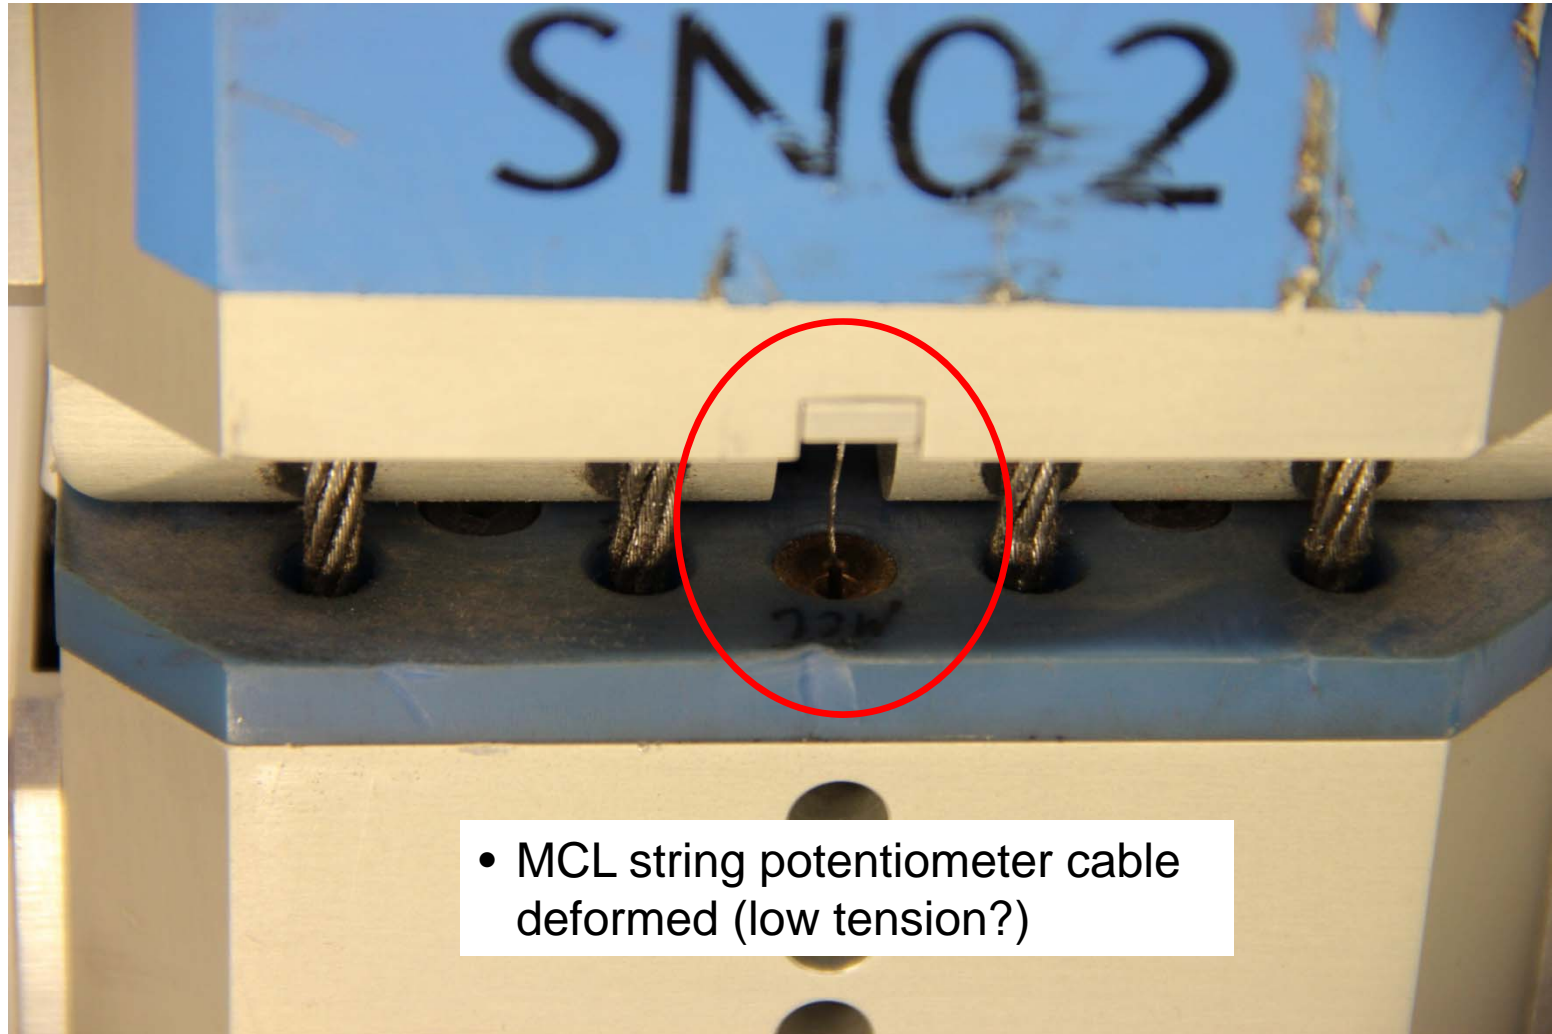
- MCL string potentiometer cable deformed (low tension?)

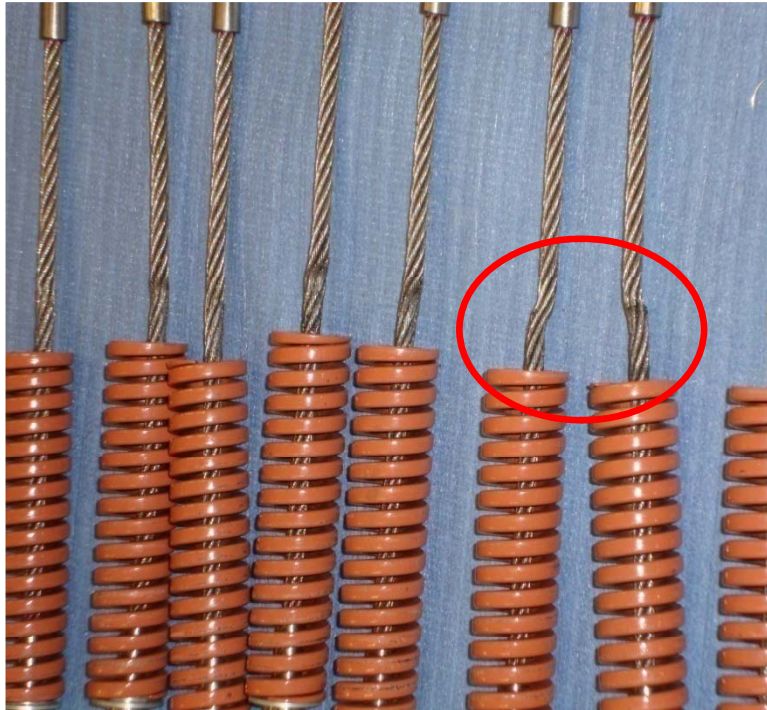
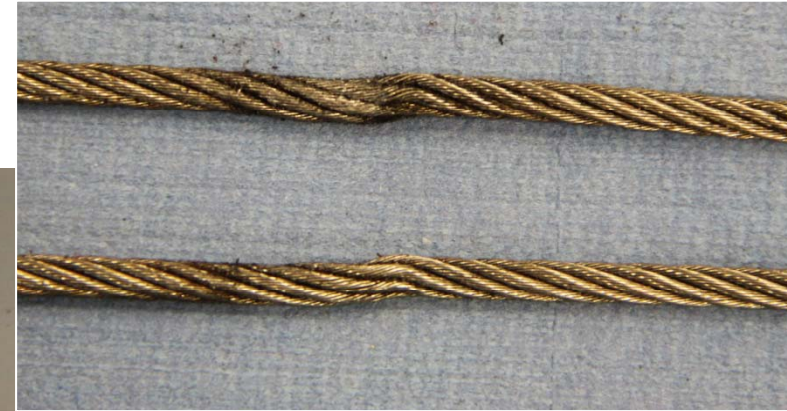
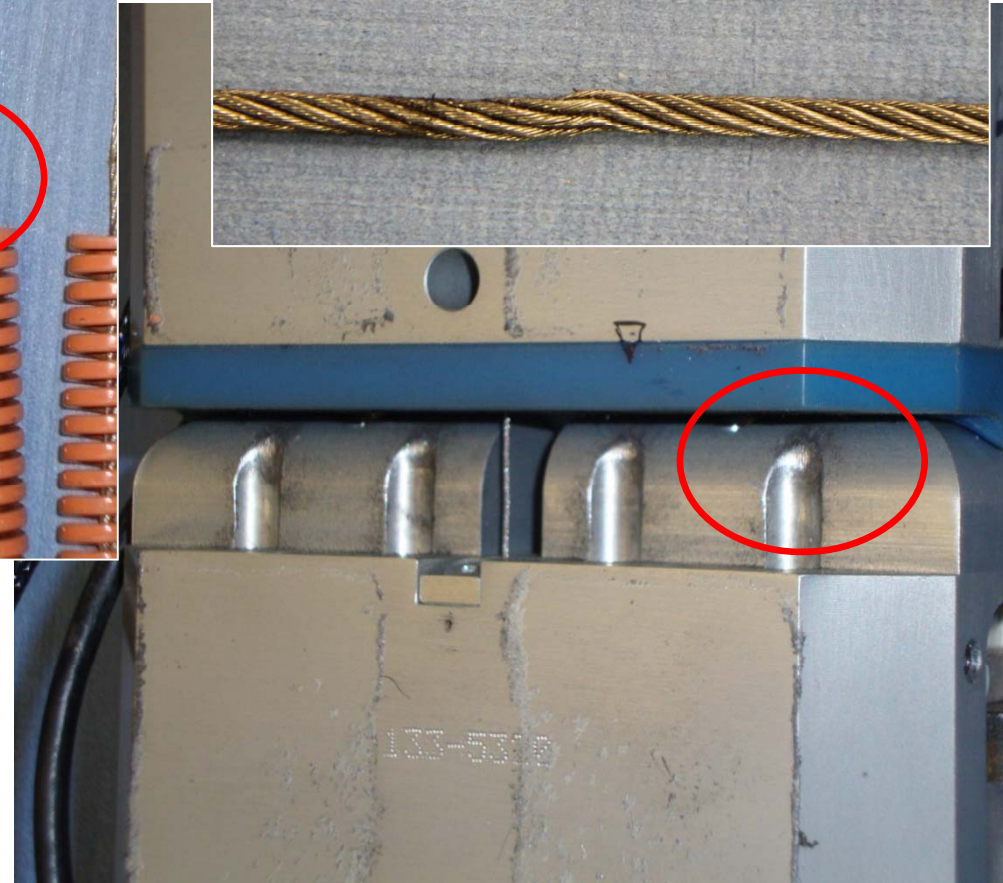
- Wearing at steel cables representing collateral ligaments as well as at their housing

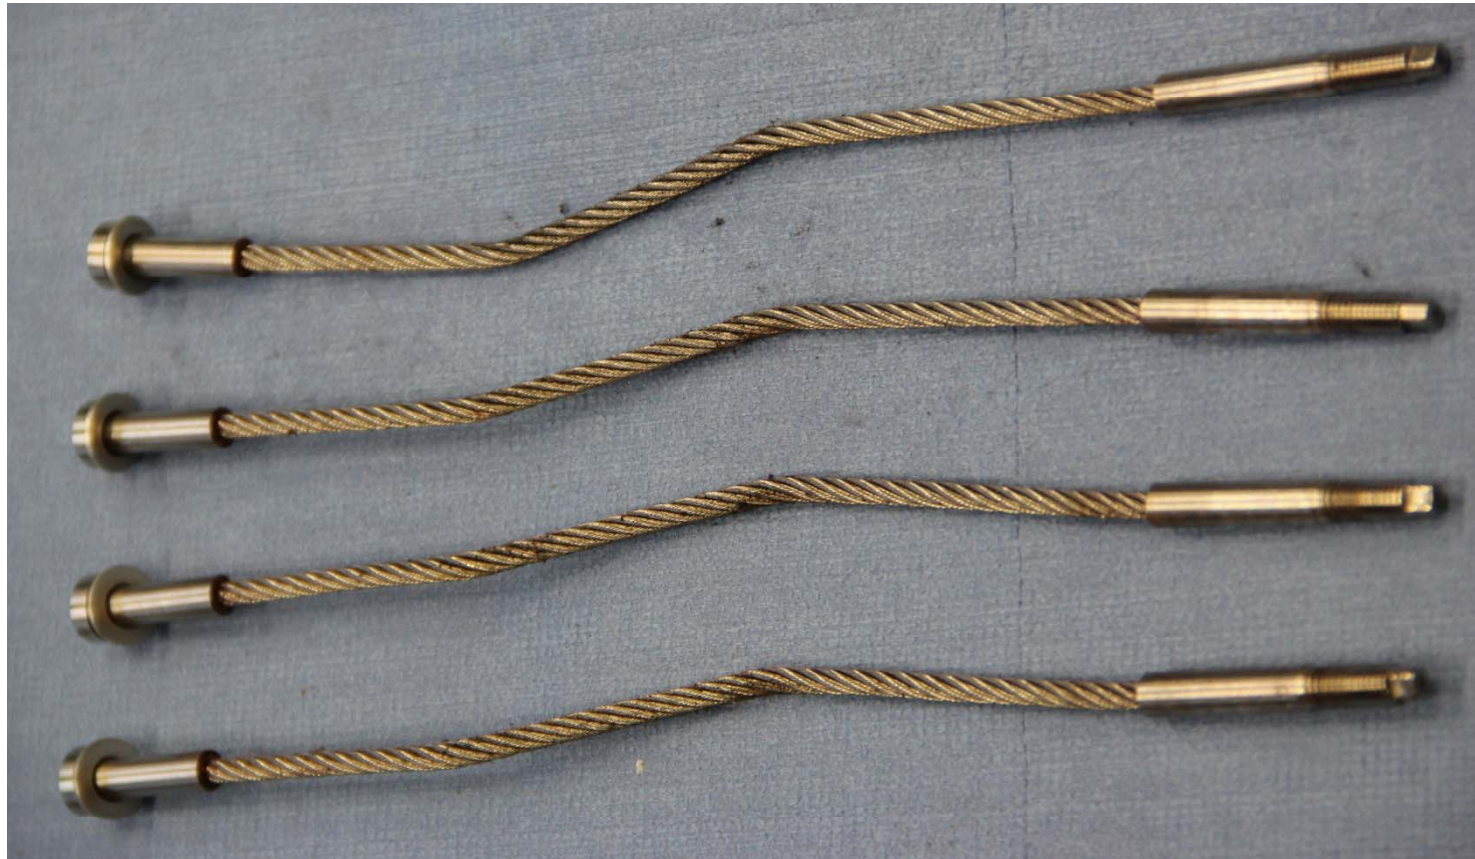
- Wearing/deformation at steel cables representing cruciate ligaments

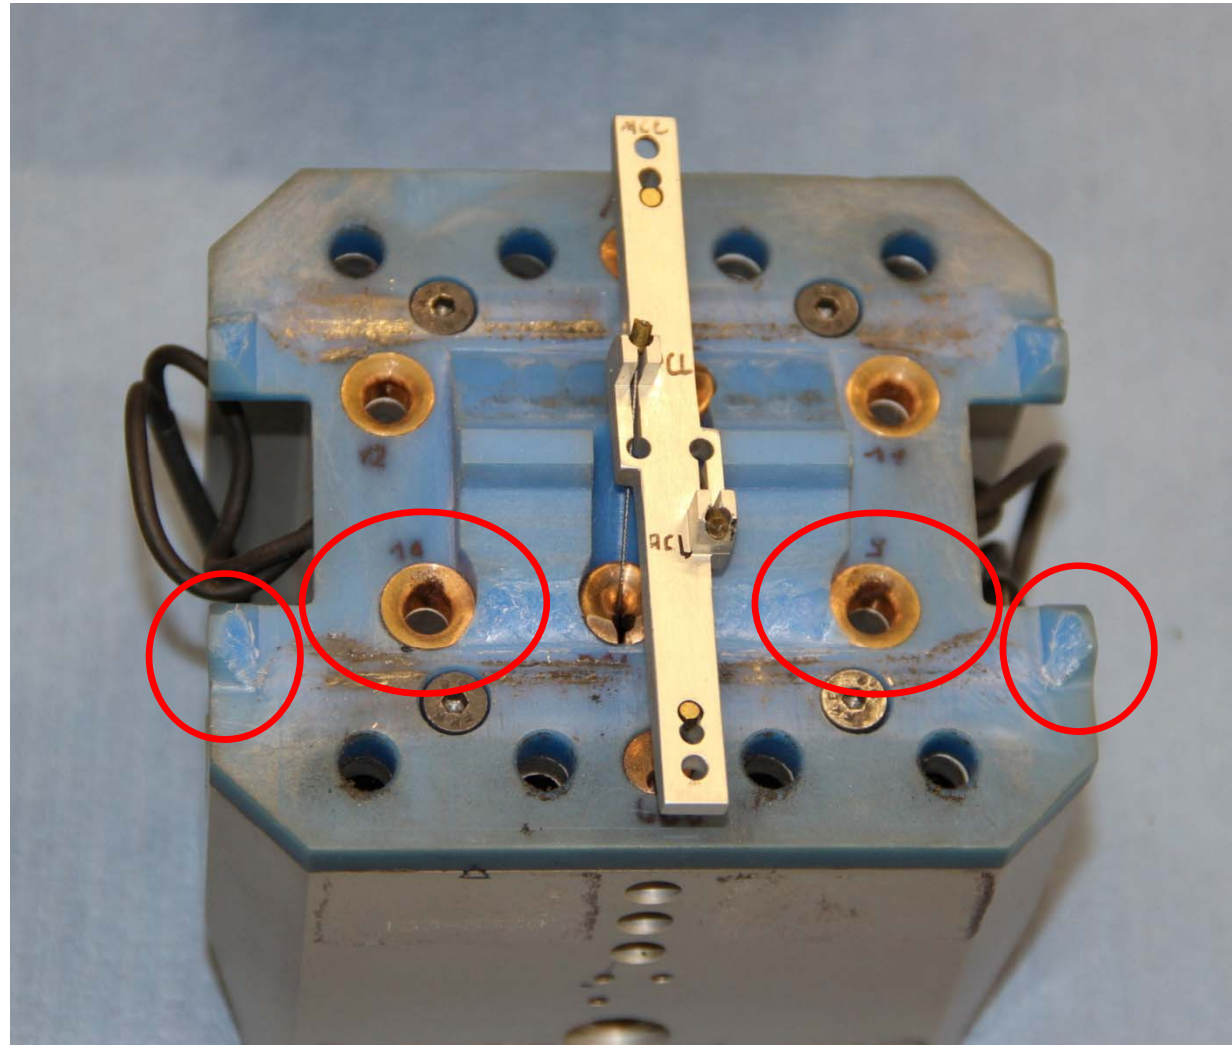
Top view of lower knee segment:

- Wearing at cruciate ligament cable bushes (bronze)
- Wearing at plastic material

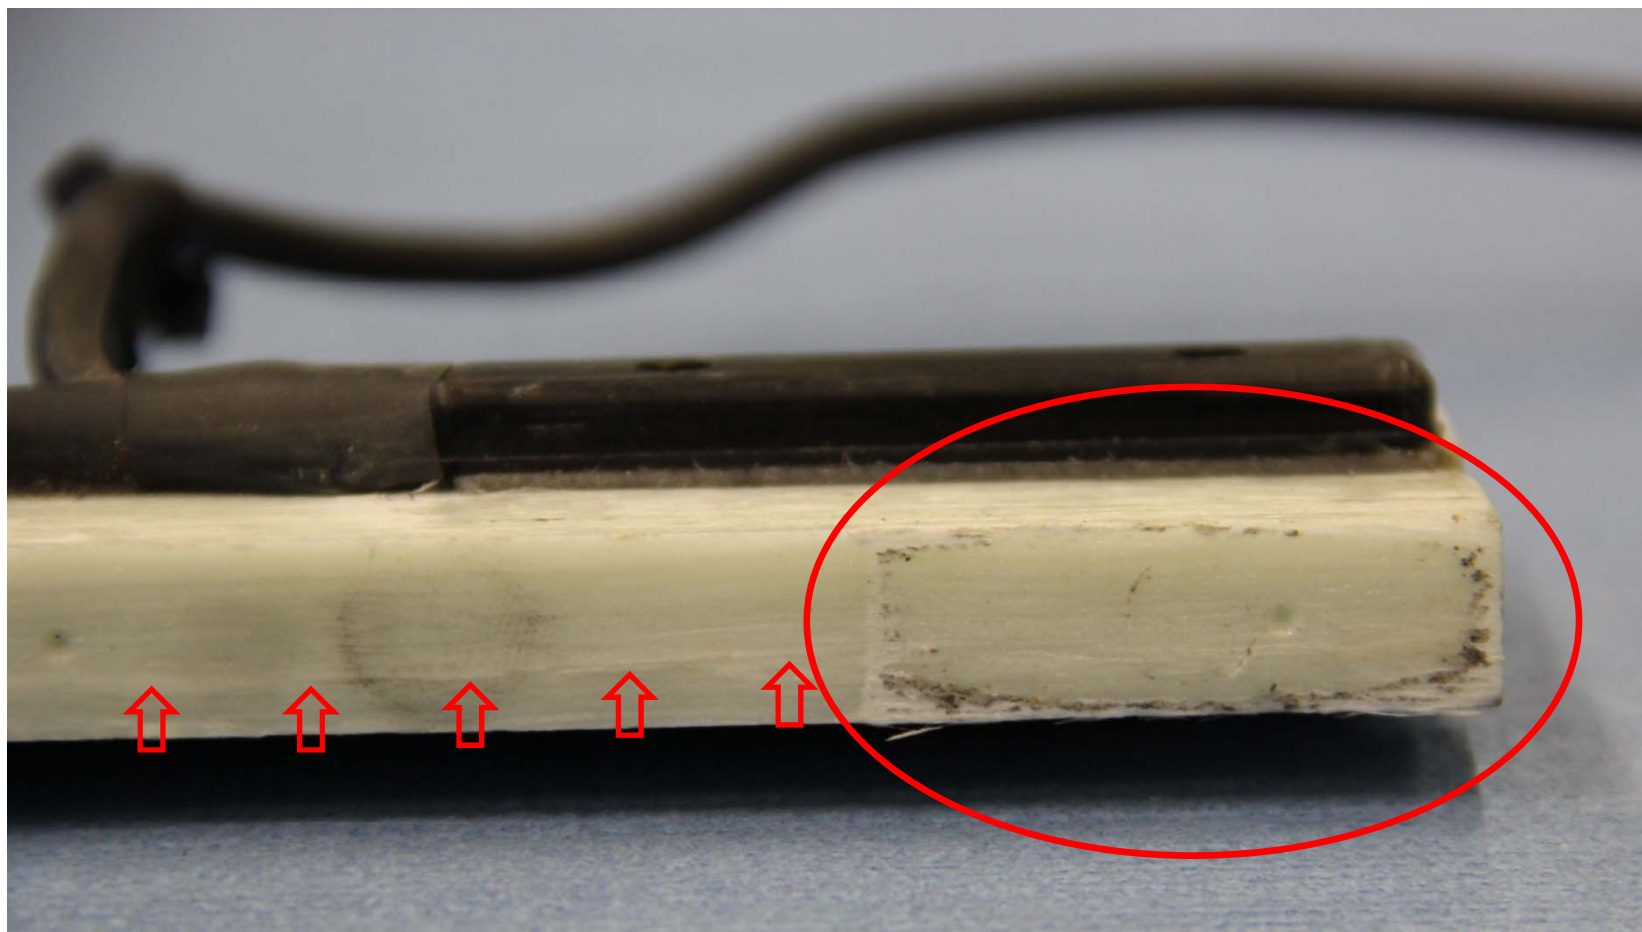
- Wearing and white cracks near/at knee clamping area

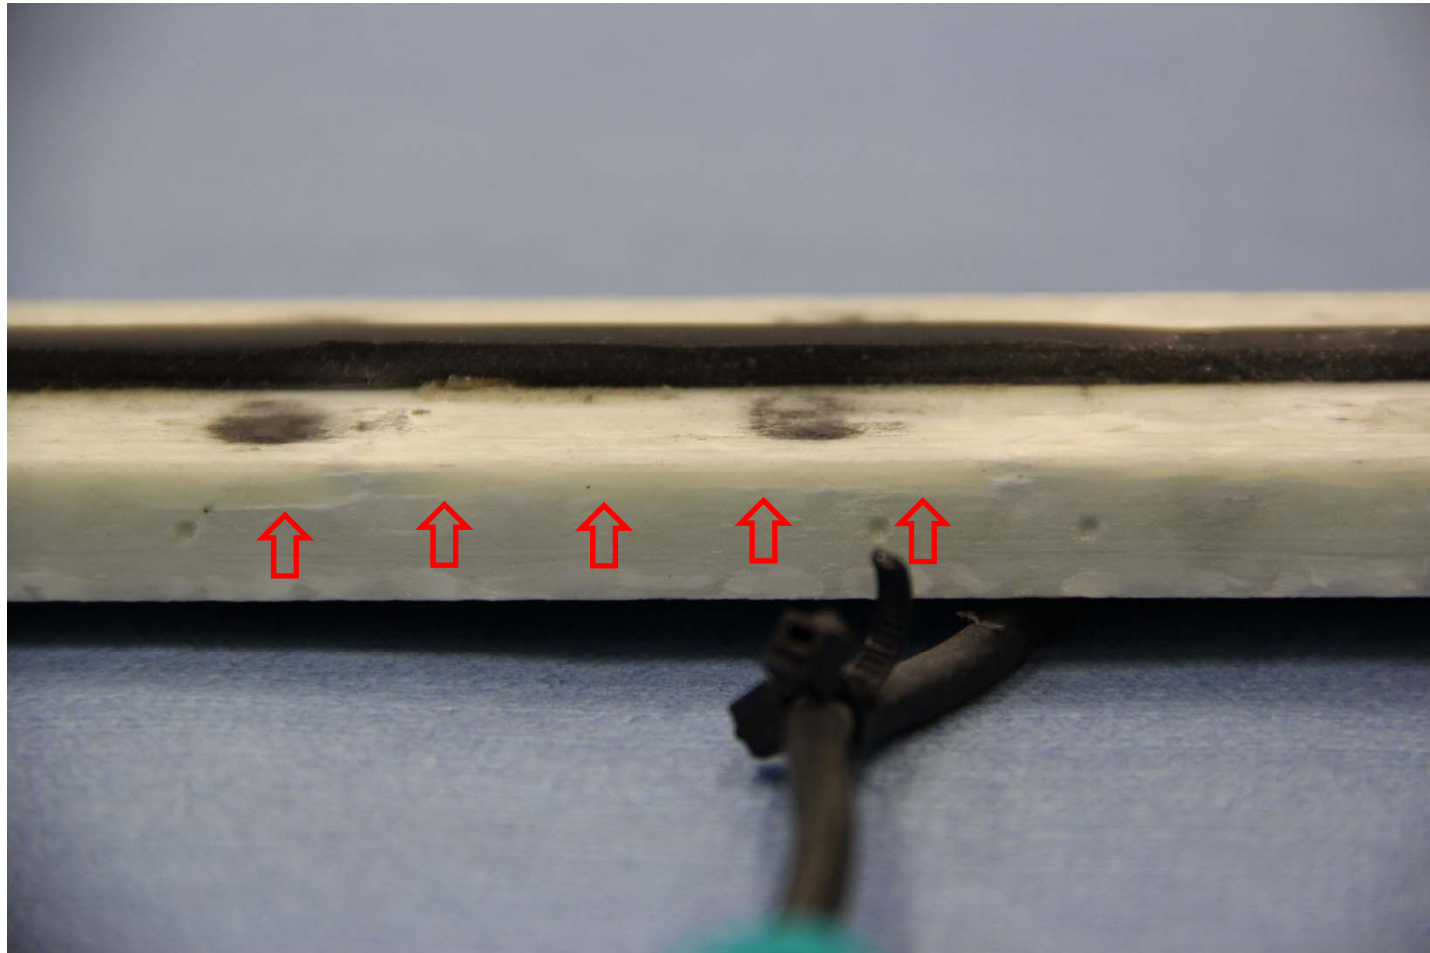
- White cracks (femur section)
