LESSONS LEARNT FROM THE TAILINGS DAM FAILURES AT BAIA MARE AND BAIA BORSA, ROMANIA, IN 2000

ZOLTÁN TÖRÖK, ASSOC. PROF. PHD;

*RESEARCH INSTITUTE FOR SUSTAINABILITY AND DISASTER MANAGEMENT,
BABES-BOLYAI UNIVERSITY, ROMANIA;*

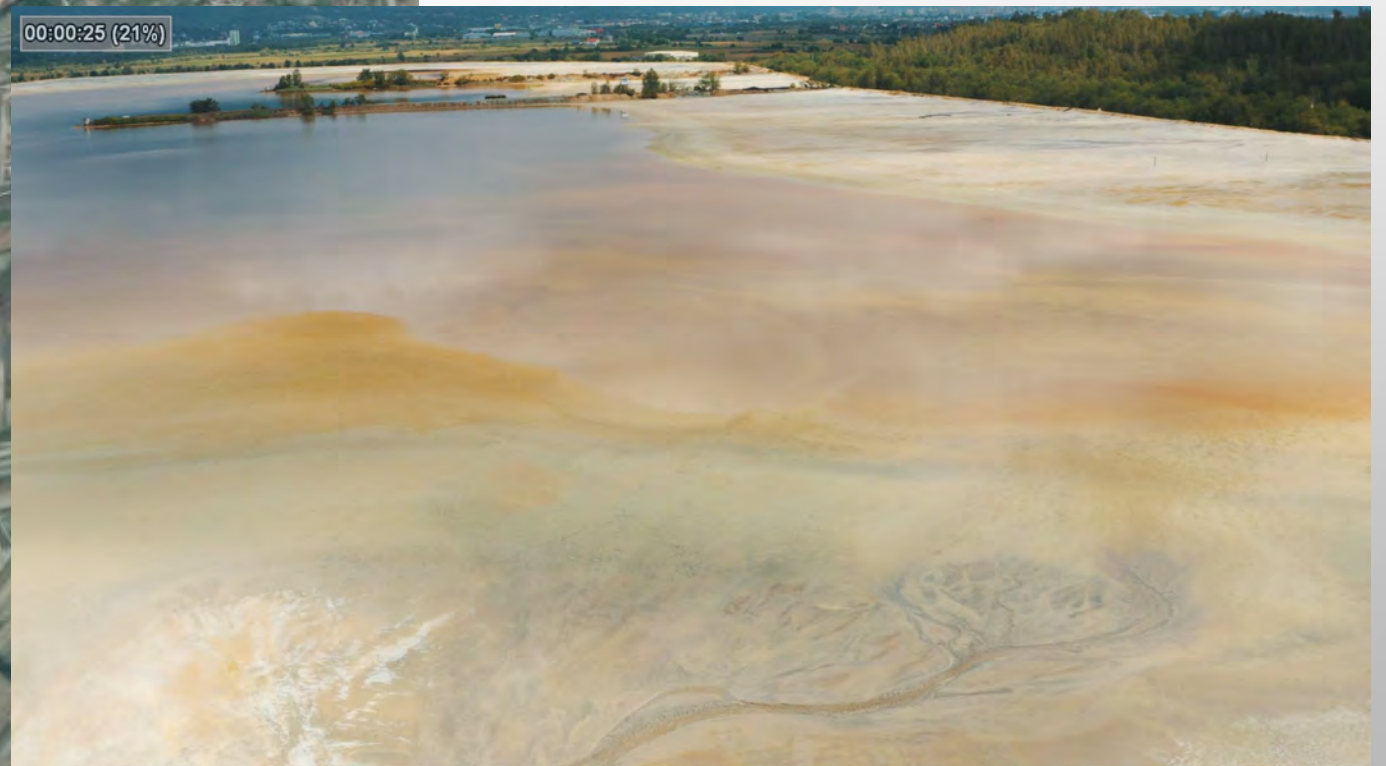
Figure 4. AURUL TMF in 2019

- **NATURAL:**
- HEAVY RAINFALL: APROX. 36 L/M² FOR 24 HOURS
- MELTING OF SNOW: APROX. 43 CM ON THE TMF SURFACE
- **MAN MADE:**
- BAD DESIGN - CLOSED WATER CIRCUIT;
- AUTHORITIES WERE NOT CONTACTED BEFORE THE ACCIDENT ABOUT THE SITUATION OF THE DAM.

- DAM FAILURE OF AURUL TMF ON THE S-E SIDE
- 22,3 M LENGTH AND 2,5 M DEPTH BREACH AND THE SPILL OF 100.000 M³ TOXIC WATER AND SLUDGE CONTAINING CYANIDE AND HEAVY METALS (COPPER, LEAD, ZINC, IRON, MAGNESIUM)
- ATTEMPTS TO BLOCK THE BREACH USING POLYETHYLENE BAGS FILLED WITH STERILE MATERIAL FROM MEDA TMF

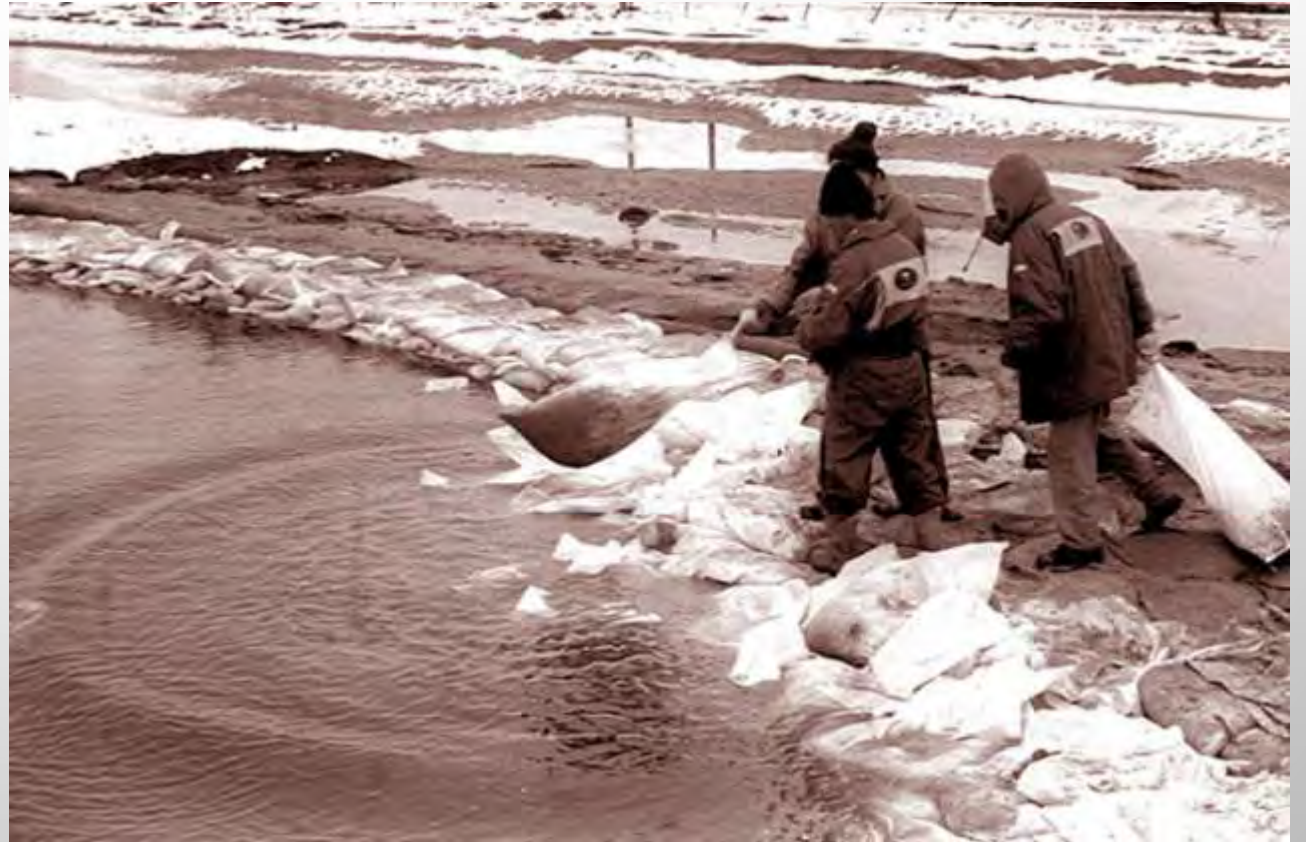
Figure 5. Workers trying to block the breach with sandbags (source: Ecomagazin.ro)

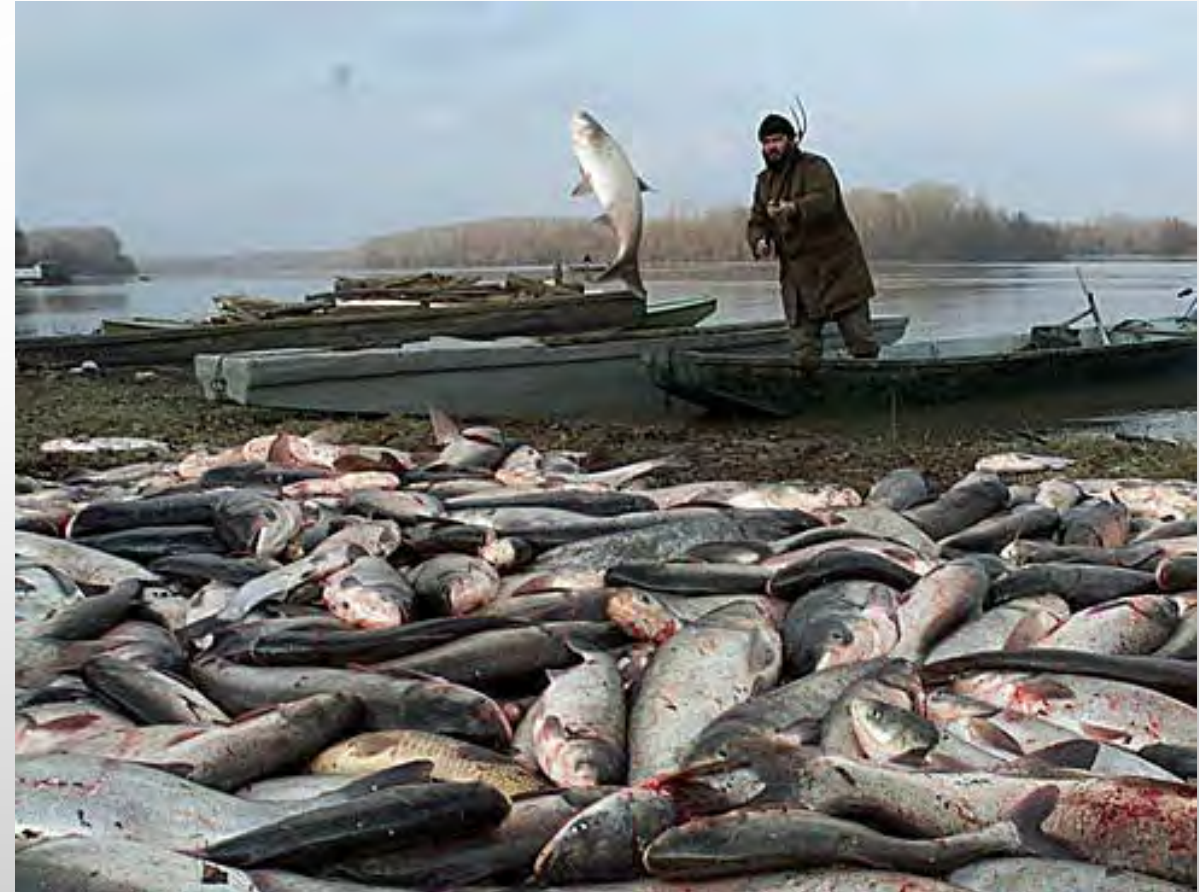
- TRANS-BOUNDARY EFFECTS: EXTENSIVE CONTAMINATION OF A MAJOR RIVER SYSTEM, FROM THE SZAMOS STREAMS AND THE TISZA RIVER, TO THE DANUBE RIVER
- CONTAMINATION AND INTERRUPTION OF THE DRINKING WATER IN 24 TOWNS AND OF 2.5 MILLION PEOPLE;
- MASSIVE FISH-KILL AND DESTRUCTION OF AQUATIC SPECIES IN THE RIVER SYSTEMS.

Figure 6. Dead fish in the Tisza river after Baia Mare disaster

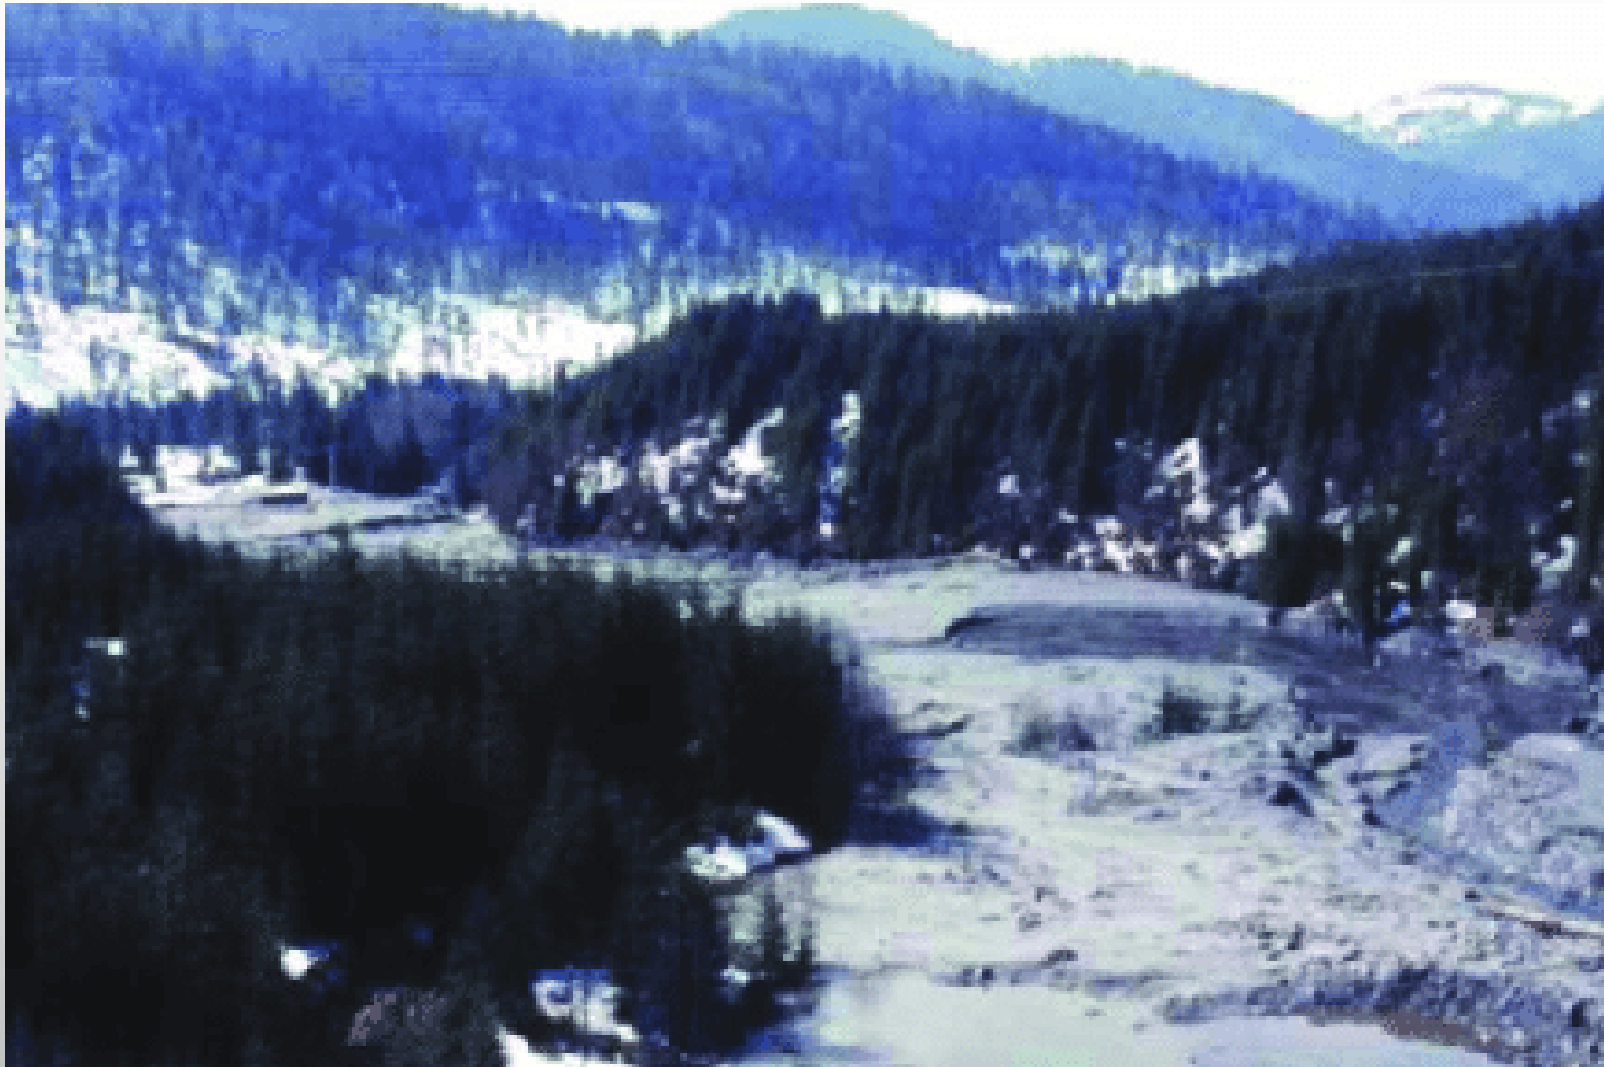
Figure 10. The Baia Borsa spill

- **NATURAL:**
- TORRENTIAL RAINS OF 37 L/M² AND MELTING SNOW (70 CM) FROM THE SLOPES SURROUNDING THE NOVAT TMF (VALLEY TYPE POND WITH 3 INDIVIDUAL DAMS)
- UNMANAGEABLE RISE IN THE RESERVOIR'S WATER LEVEL AND OVERTOPPING
- **MAN MADE:**
- DEFICIENCIES IN THE DESIGN OF THE SYSTEM
- DEFICIENCIES IN THE OPERATION OF THE PLANT RELATING TO PRECAUTIONS AGAINST OVERFLOWS AND SPILLS, AND IN TERMS OF EMERGENCY RESPONSE PLANS;
- WEAK AND INAPPROPRIATE PERMITTING OF THE FACILITY, AND INADEQUATE MONITORING AND INSPECTION.

- BREACH: 25 LONG, 15 DEEP
- APPROXIMATELY 40,000 TONS OF SOLID MINERAL WASTE AND 100.000 M³ OF WATER WERE DISCHARGED.
- 20.000 T SOLID FRACTION RETAINED AND APROX. 20.000 T FLUSHED INTO THE VISEU RIVER, VASER RIVER, TRIBUTARIES OF UPPER TISZA RIVER.
- POLLUTED WATERS REACHED UKRAINIAN TERRITORY DURING THE NIGHT OF 10TH MARCH.
