National Highway Traffic Safety Administration Motorcoach Tests

**GRSG - 94th Session
Nha Nguyen**

Full Frontal Crash Test

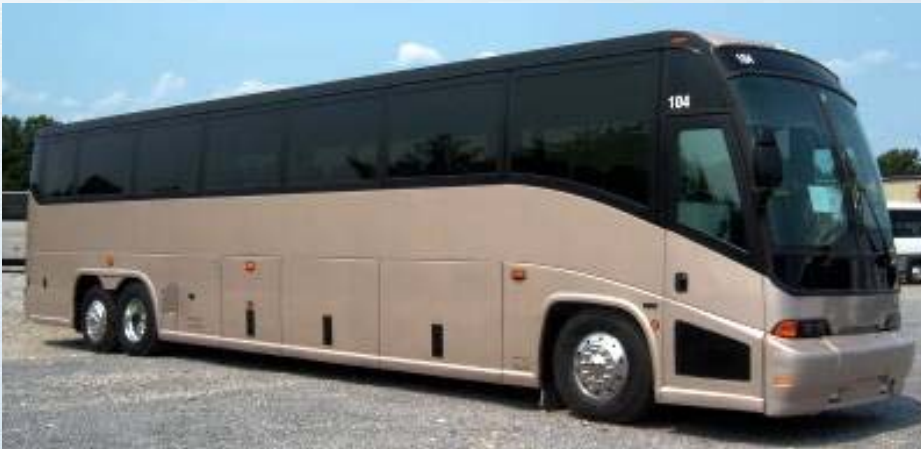
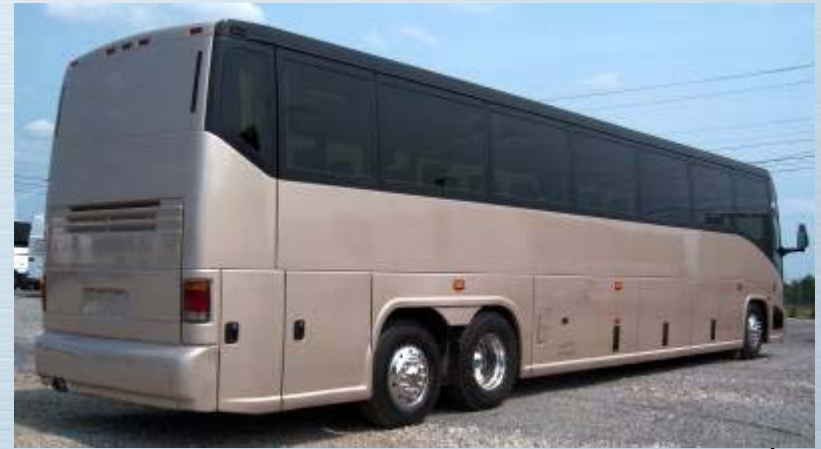
Motorcoach Details

- 2000 MCI 102EL3 Renaissance
- Series 60 diesel engine
- B500 Allison Automatic transmission
- 54 seats
- 45 ft long, 12 ft 6 inches tall

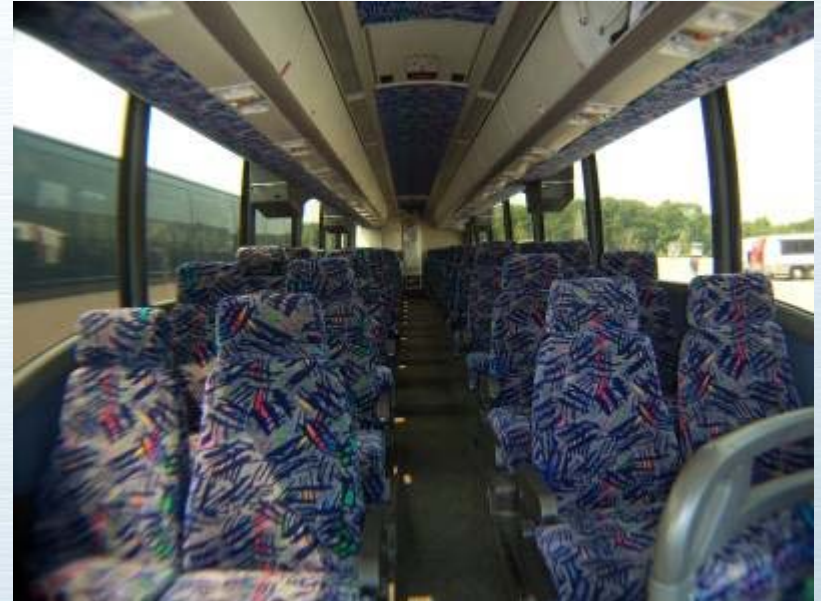
Seats on the Motorcoach

- Baseline seats
 - No belts
 - American Seating
- Seats with Belts
 - MCI/Amaya
 - 3 point belts – 4 rows (dual seats)
 - 2 point belts – 1 row (dual seats)
 - Freedman Seating
 - 3 point belts – 1 row (dual seats)

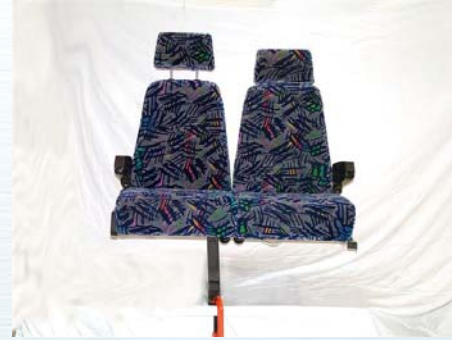
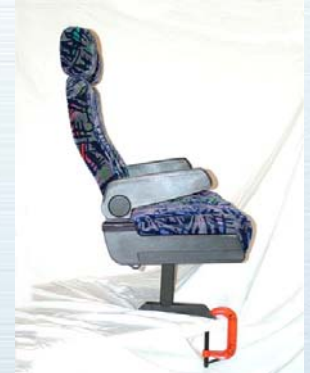
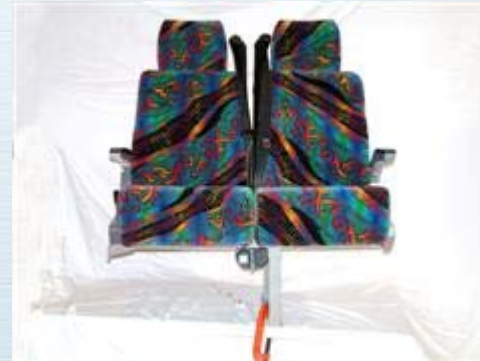
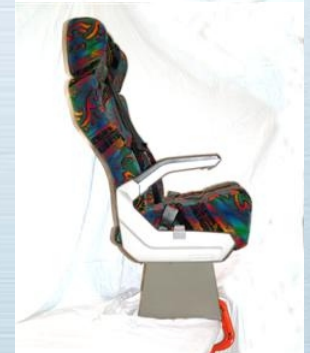
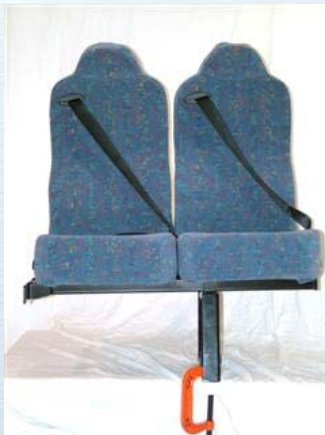
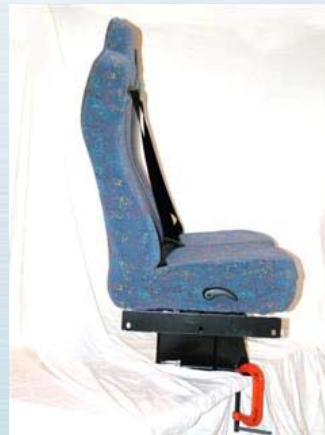
Seats (Continued)

- Baseline (No belts)
- MCI/Amaya/FAINSA
 - 3 – point
 - 2 – point
- Freedman 3 – point

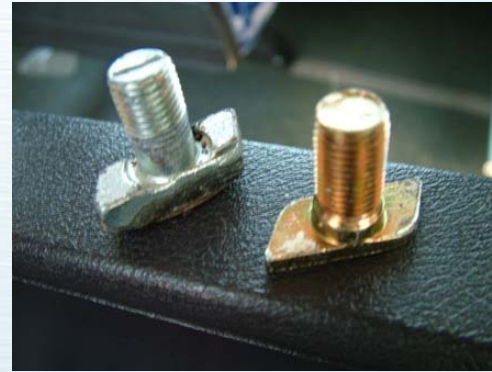
- 9 occupied, 13 unoccupied rows using OEM equipment

- All seat attachments including baseline stayed intact
- Baseline seats and Freeman seatback broke/bent when impacted by unbelted dummies from behind

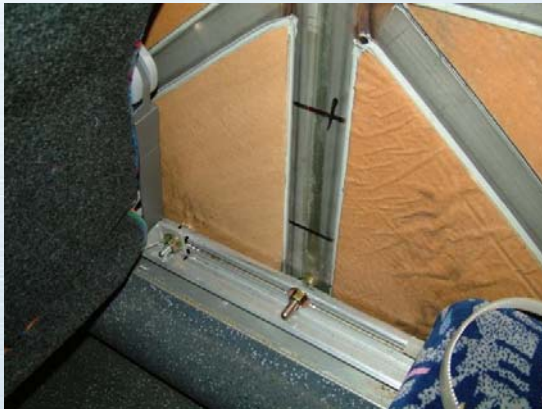
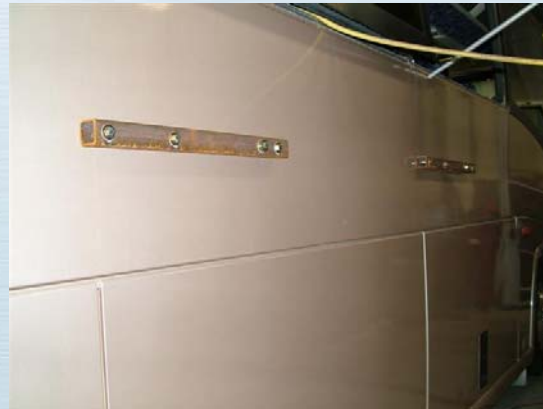
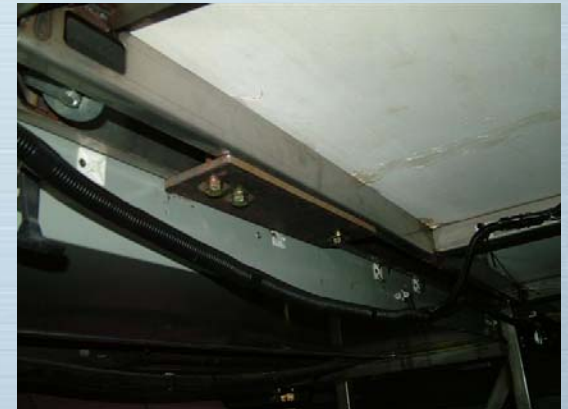
- 2 occupied rows reinforced

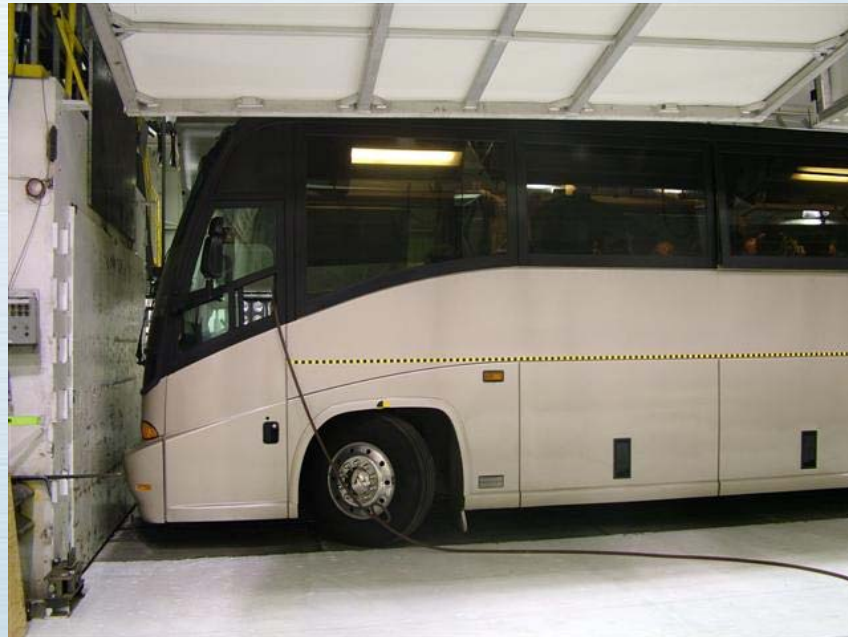
Test Conditions

- Speed: 30 mph (48.3 kph)
- Frontal impact: 0 degrees; full overlap
- Fixed Rigid Barrier
- Data channels: 355 dummy; 26 vehicle channels @ 12500 samples/sec

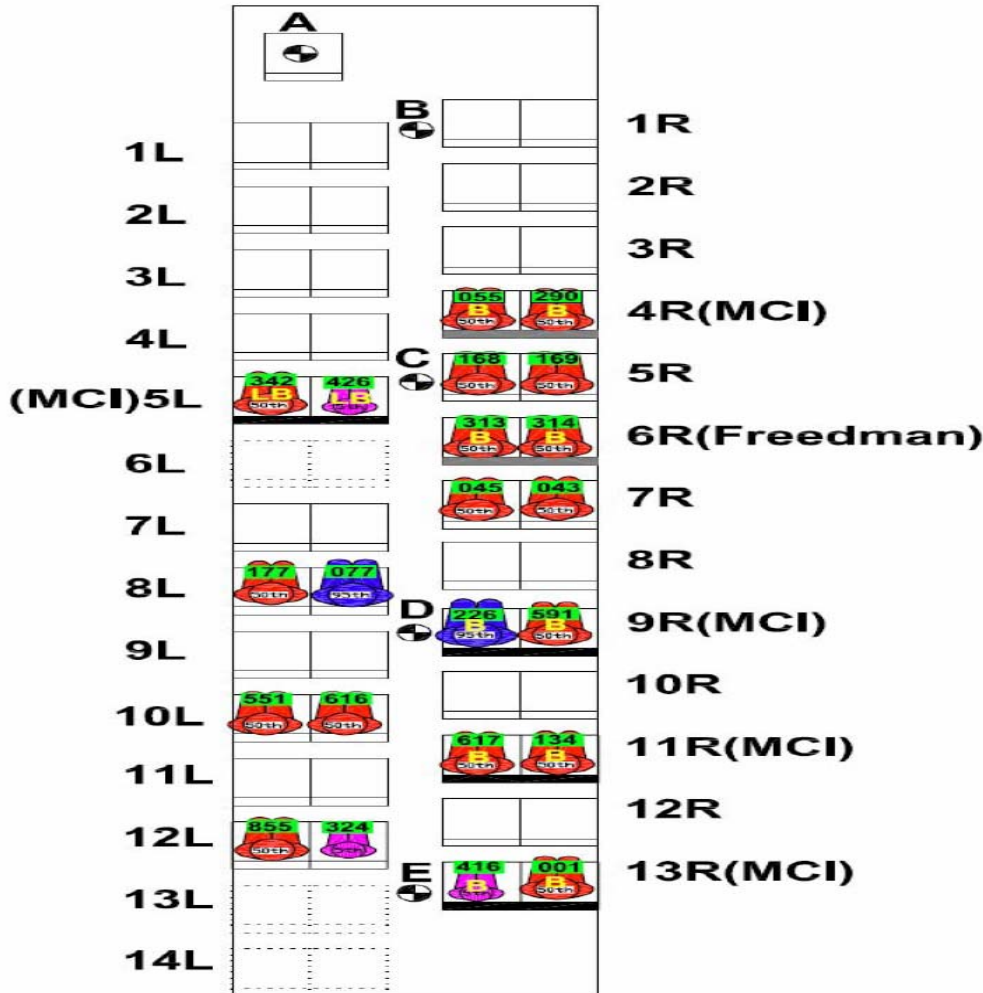
Dummy Seating Locations

Accel Locations
 	95th Unbelted
 	50th Unbelted
 	5th Unbelted
 	50th Lap Belt Only
 	5th Lap Belt Only
 	95th 3-Point Belted
 	50th 3-Point Belted
 	5th 3-Point Belted
 	Reinforced Attachment
 	OEM Attachment

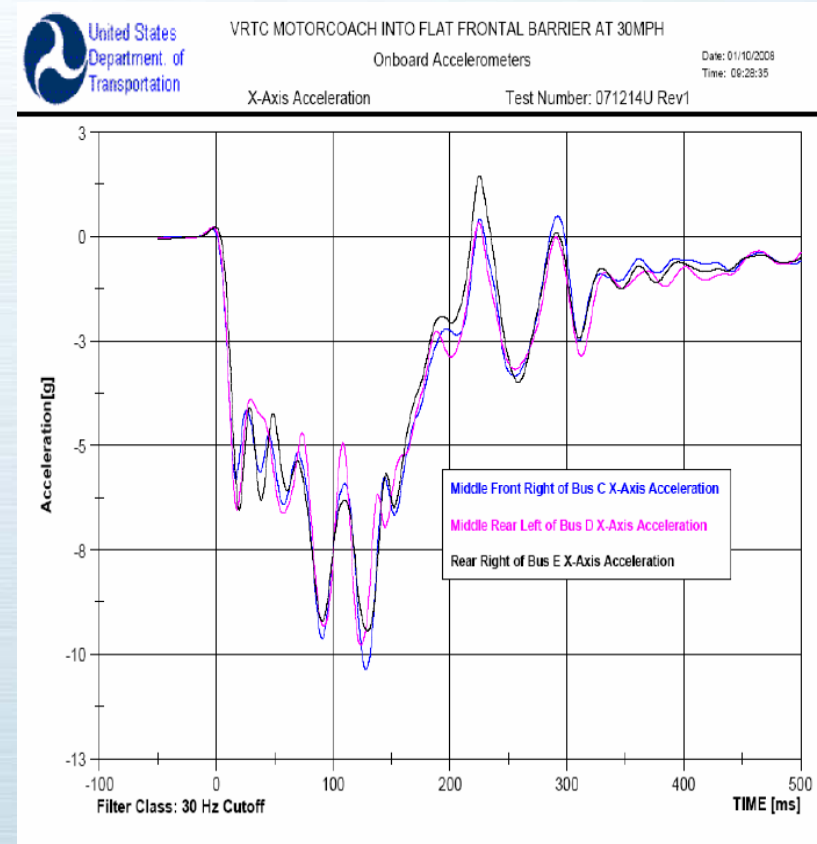
Crash Data

- Speed: 30.36 mph
- Dynamic Crush: 6.5 ft
- Peak deceleration: 10g at 125msec

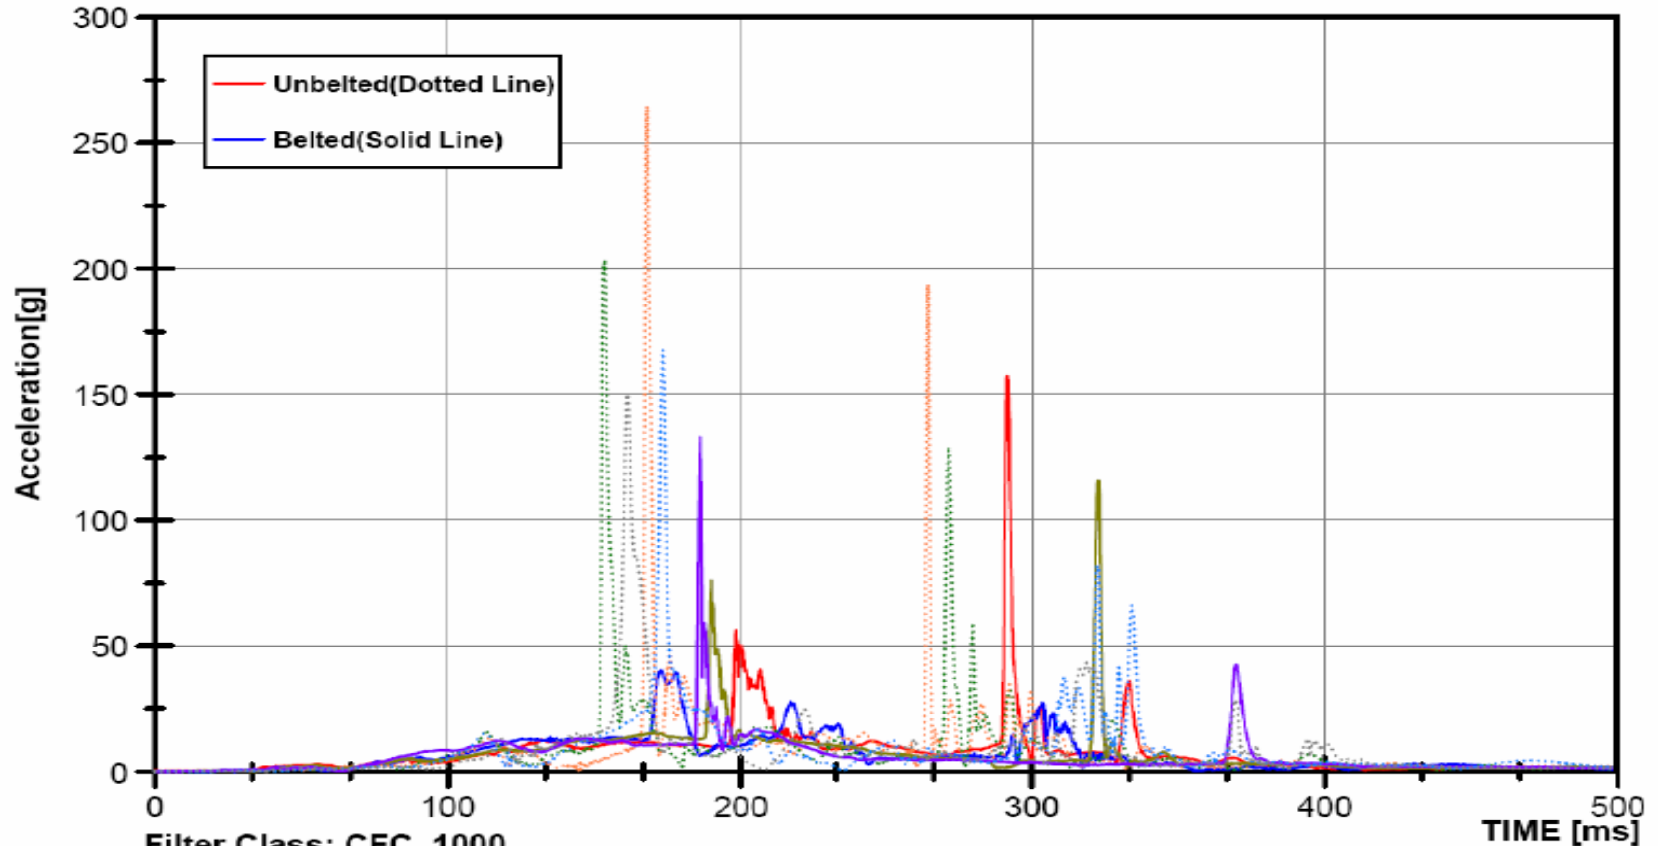
HIC's for HIII Mid-Sized Adult Male Dummies in Rows 4R,5R,6R and 7R

50th Male – Front Seats

Dummy #	Seat	Belt Status	T1(Begin)	T2(End)	Avg. g T1 to T2	HIC[15]
Dummy #055	Seat 4R Aisle	3-Point Belt	439.05	290.56	293.04	127.68
Dummy #168	Seat 5R Aisle	Unbelted	1308.49	167.20	169.60	200.60
Dummy #290	Seat 4R Window	3-Point Belt	77.26	169.84	181.44	33.97
Dummy #169	Seat 5R Window	Unbelted	843.77	152.48	155.20	159.67
Dummy #313	Seat 6R Aisle	3-Point Belt	203.77	321.44	323.92	94.09
Dummy #045	Seat 7R Aisle	Unbelted	612.81	171.76	174.88	132.94
Dummy #314	Seat 6R Window	3-Point Belt	157.21	185.04	188.48	73.86
Dummy #043	Seat 7R Window	Unbelted	728.31	159.04	167.36	95.33

- Unbelted dummies:
 - High head and neck accelerations
- Dummies with 2-pt belts:
 - High head and neck accelerations
- Dummies with 3-pt belts:
 - Low head and neck accelerations
- All dummies have low chest accelerations and chest displacements and femur loads

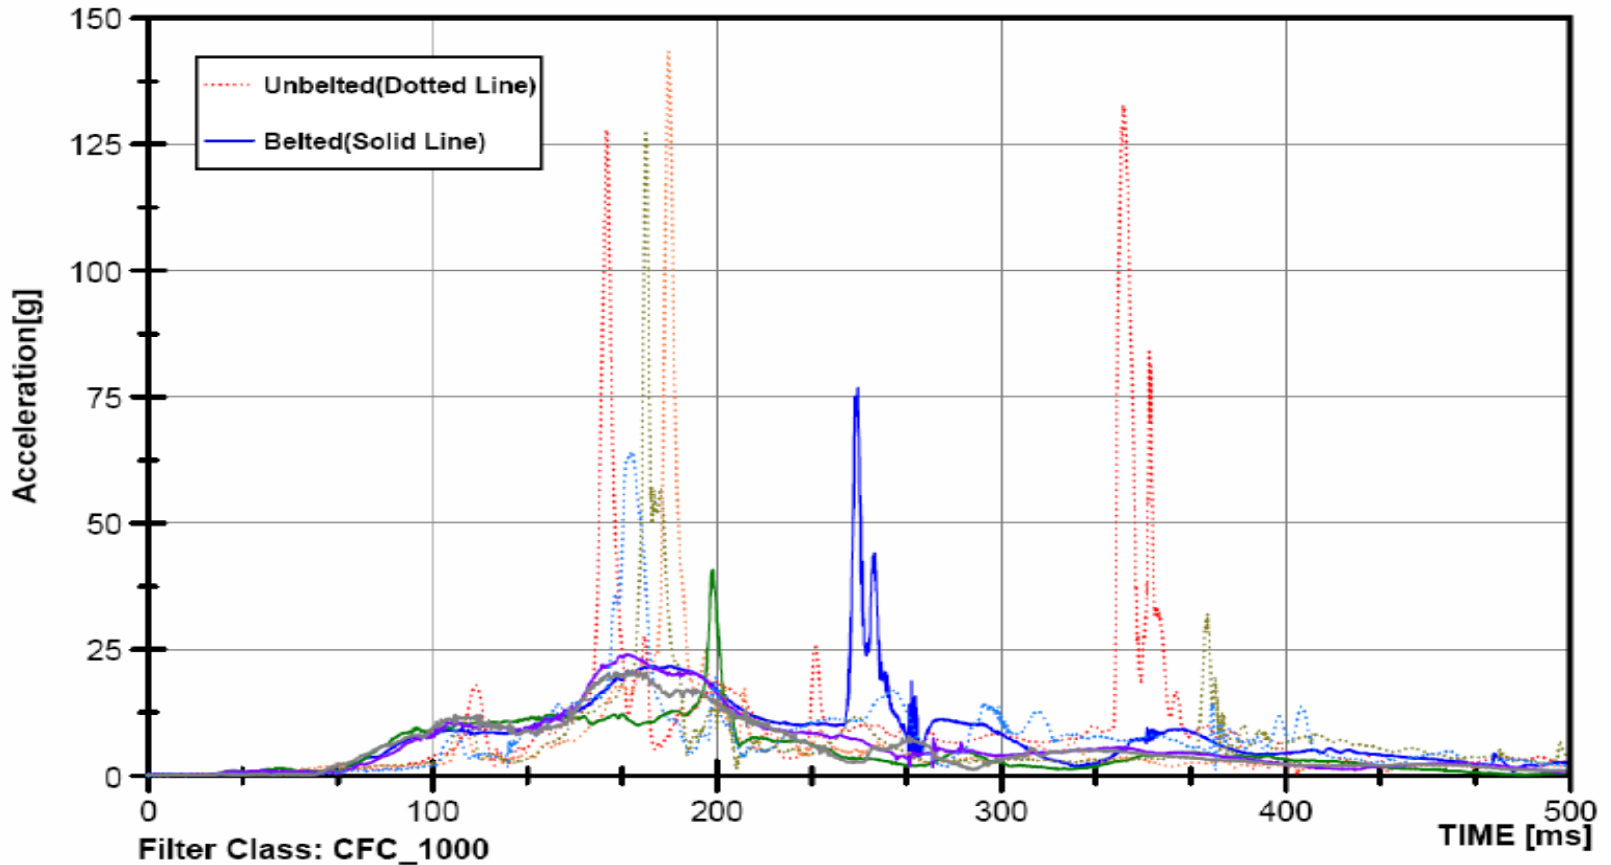
Dummy: HIII Mid-Sized Adult Male

50th Male – Rear Seats

Seat / <th>Condition</th> <th>HIC[15]</th> <th>T1(Begin)</th> <th>T2(End)</th> <th>Avg. g T1 to T2</th>	Condition	HIC[15]	T1(Begin)	T2(End)	Avg. g T1 to T2
Dummy #177 Seat 8L Window	Unbelted	700.05	340.72	346.56	108.37
Dummy #161 Seat 10L Aisle	Unbelted	570.01	181.12	185.52	112.04
Dummy #591 Seat 9R Window	3-Point Belt	117.91	246.80	256.88	42.58
Dummy #617 Seat 11R Aisle	3-Point Belt	29.57	195.04	202.16	28.20
Dummy #551 Seat 10L Window	Unbelted	336.33	172.88	181.92	67.68
Dummy #855 Seat 12L Window	Unbelted	209.65	163.20	175.76	49.05
Dummy #134 Seat 11R Window	3-Point Belt	38.08	161.36	176.40	23.10
Dummy #001 Seat 13R Window	3-Point Belt	26.62	160.72	175.76	20.02

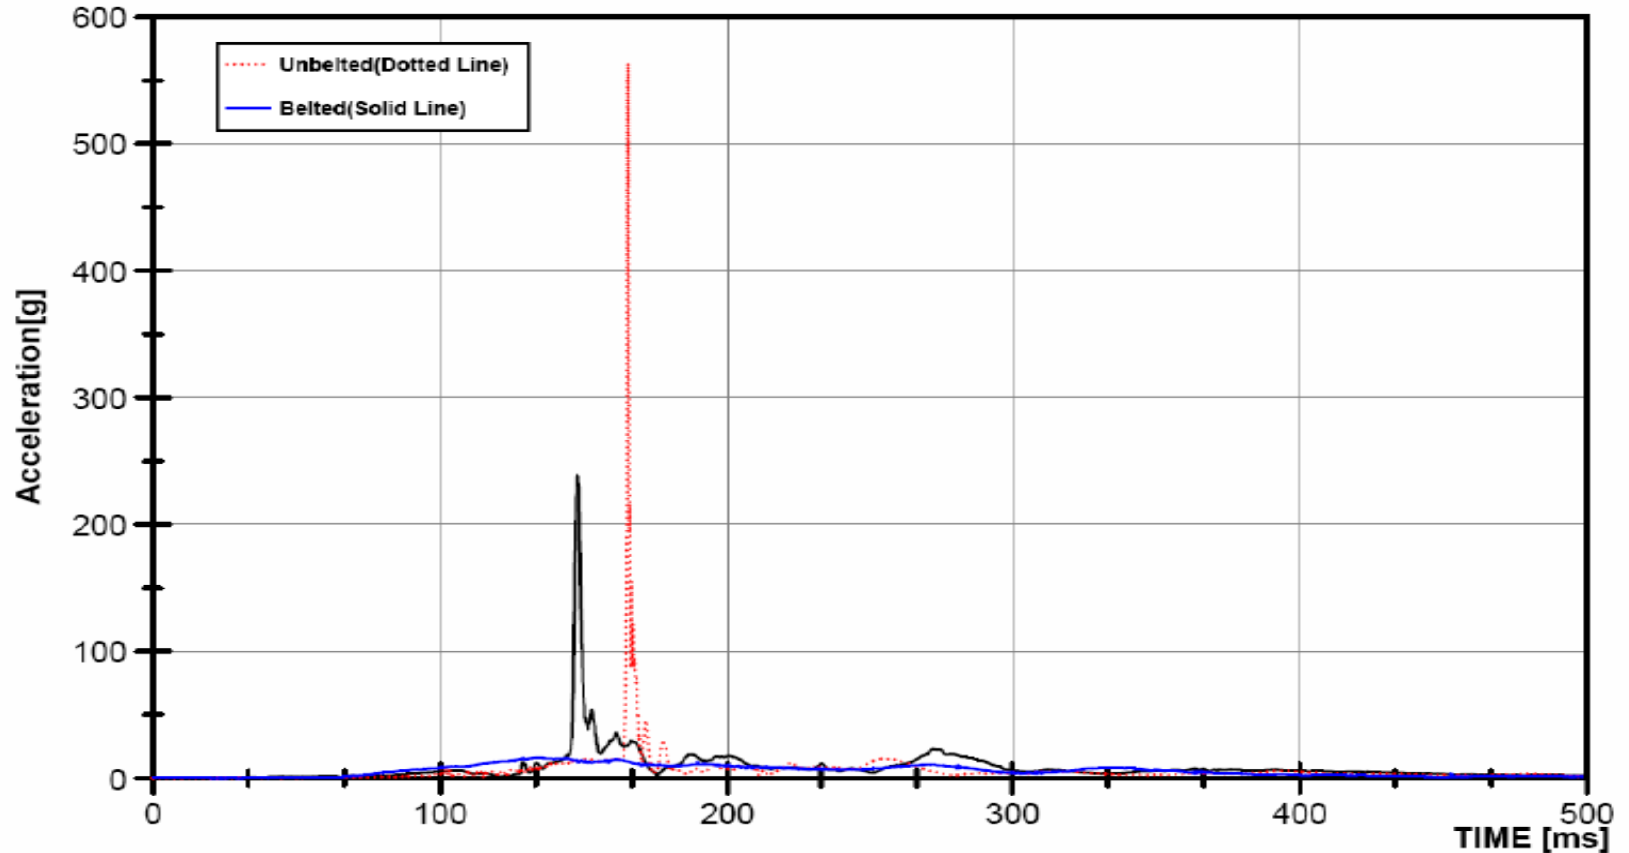
Dummy: HIII Small Adult Female

Head Accelerations – 5th Female

Dummy #426 Seat 5L Aisle Lap Belt Only				Dummy #324 Seat 12L Aisle Unbelted				Dummy #416 Seat 13R Aisle 3-Point Belt			
	T1(Beg)	T2(End)	Avg. a T1 to T2		T1(Beg)	T2(End)	Avg. a T1 to T2		T1(Beg)	T2(End)	Avg. a T1 to T2	
HIC[15]=	1356.42	146.64	149.04	203.45	1958.93	165.20	165.92	393.20	14.37	130.08	145.12	15.64

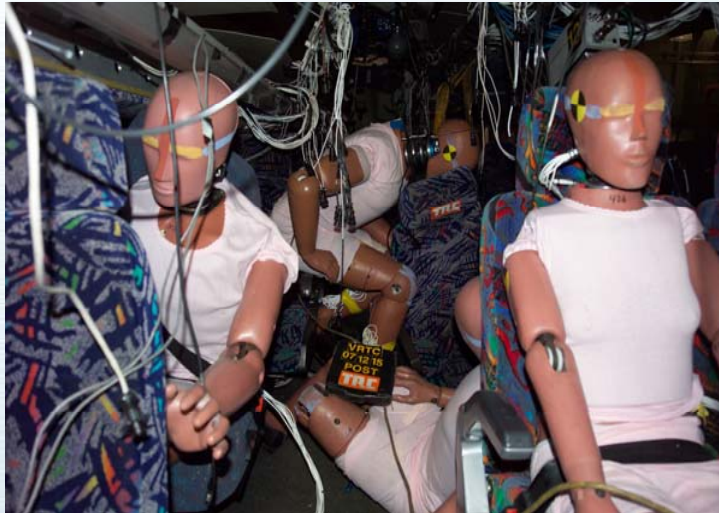
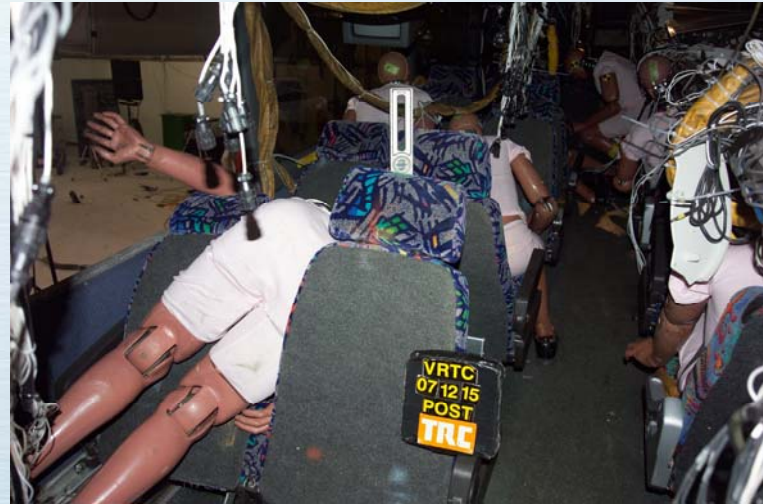
Observation - Unbelted Dummies

- Unbelted dummies typically made head contact with the backseat in front within 150-180 ms
- Dummies on the aisle seats ended up on the floor and dummies on the window seats ended up on the front seats or on the floor

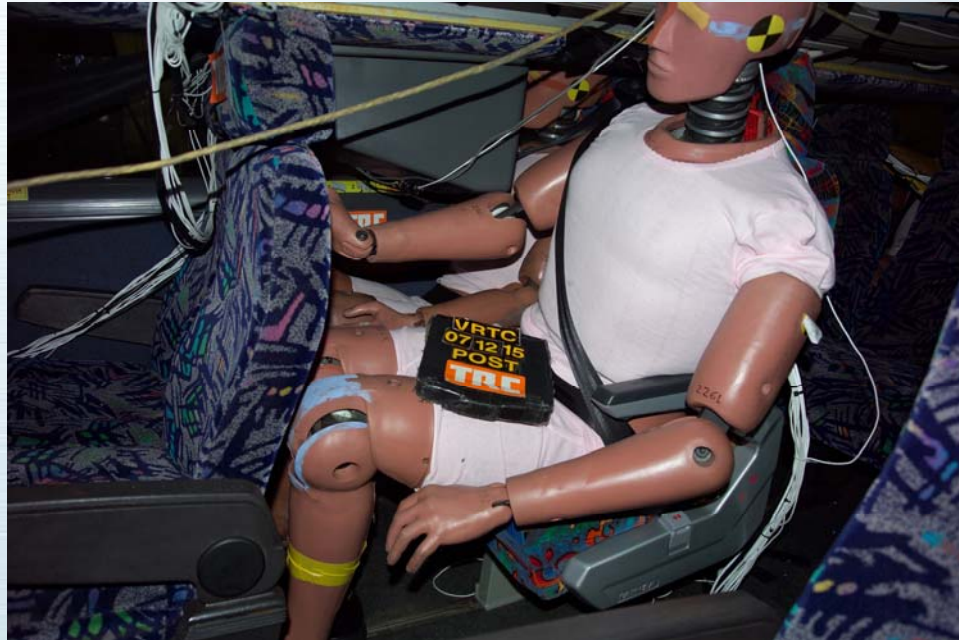
Observation - Belted Dummies

- Dummies stayed in seats
- Head/Knee contact with front backseat for 95th male dummies

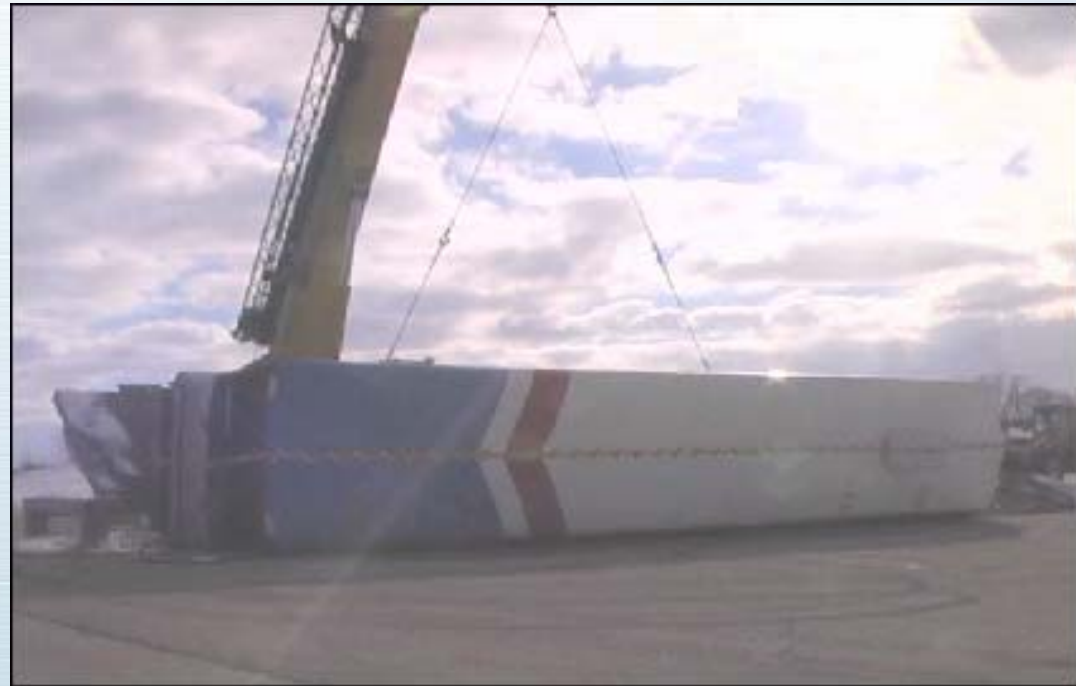
MCI R66 Exterior

- Tests were done on 2 motorcoach models: MCI and Prevost
- ECE-R66 test procedures
- Data is being analyzed

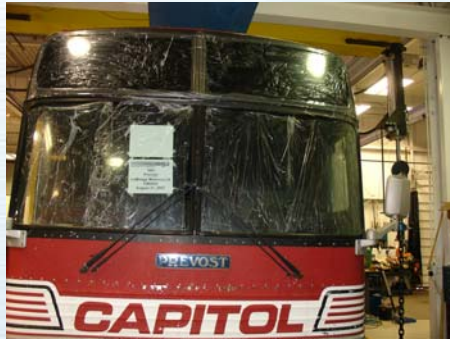
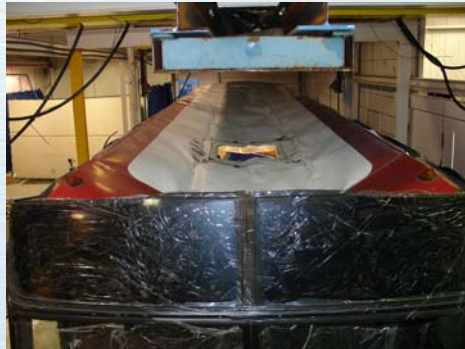
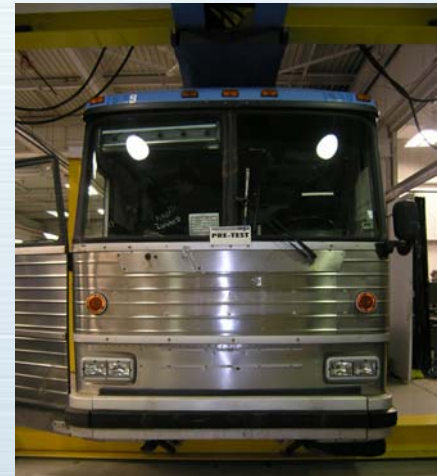
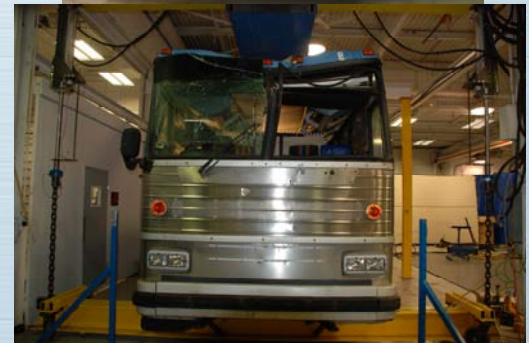
Roof Crush Tests

- Tests were done on 2 motorcoach models: MCI and Prevost
- FMVSS 220 test procedures
- Data is being analyzed
