# Finite Element Analysis of Child Occupant Responses in Side Impact

Masatomo Yamaguchi, Koji Mizuno  
Nagoya University

Yoshinori Tanaka  
National Traffic and Environment  
Laboratory

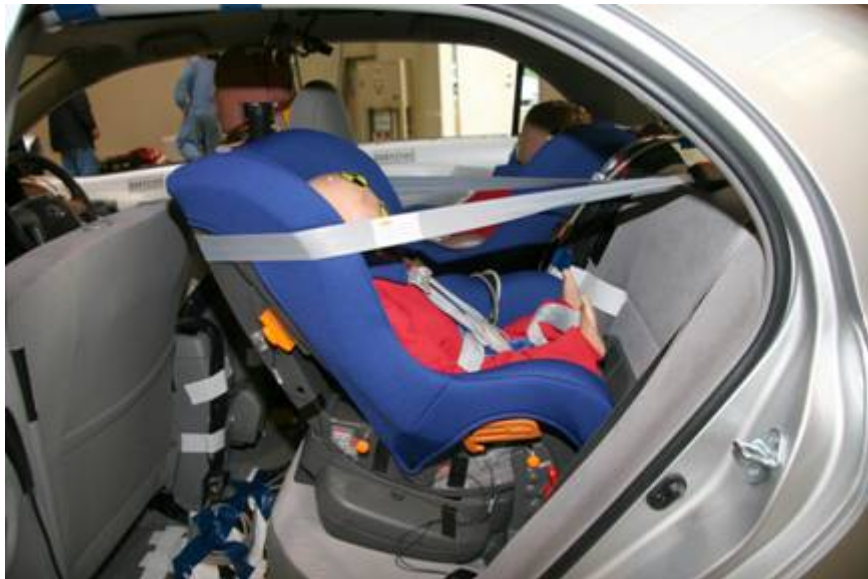
Rear Facing (RF) CRS  
Infant

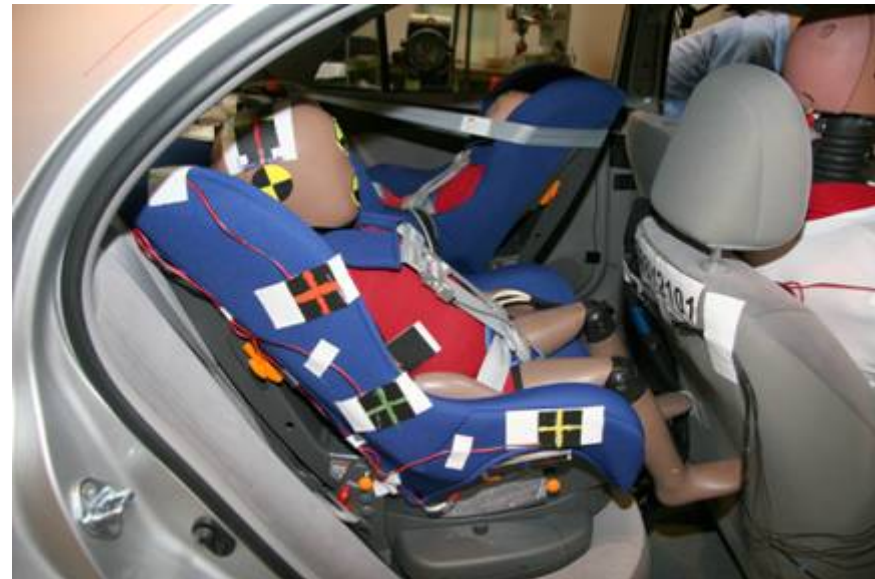
Forward Facing (FF) CRS  
Toddler

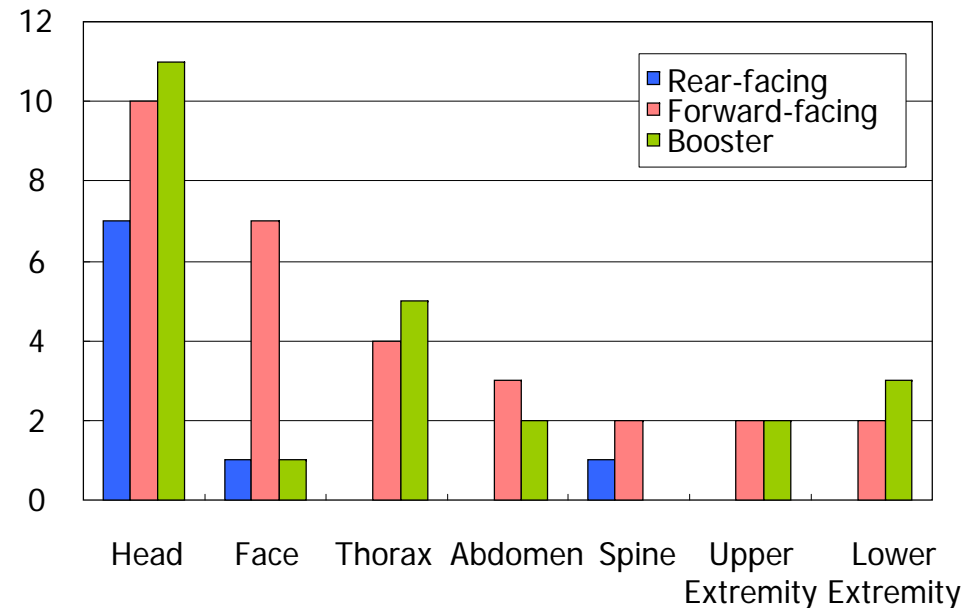
Injury body region

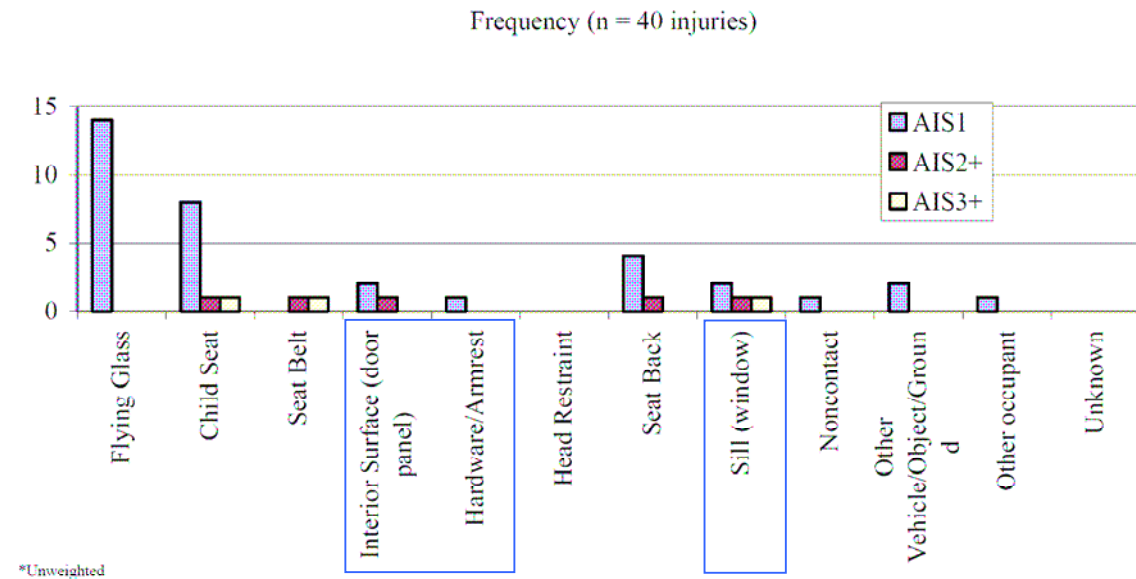
Injury source (Forward facing CRS)

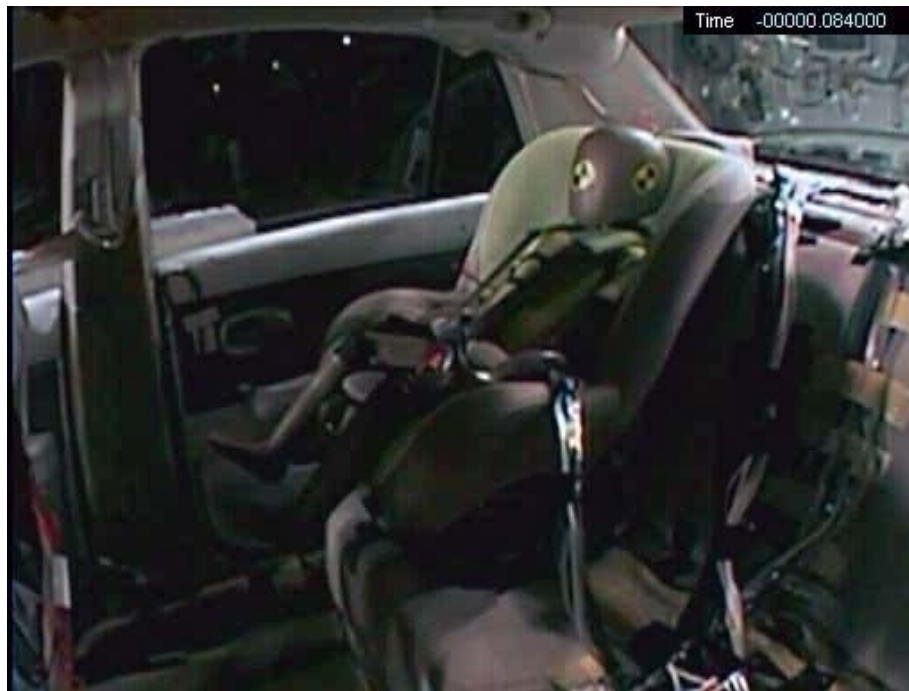
Test 01

**HIC 148**  
**Chest deflection 23.3 mm**

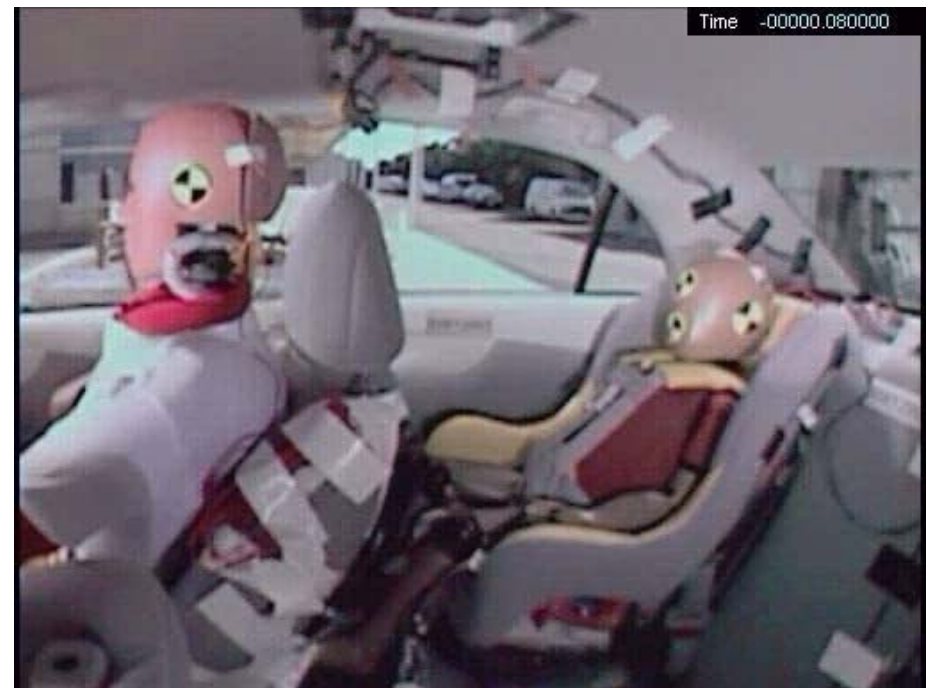
Test 02

**HIC 182**  
**Chest deflection 20.5 mm**

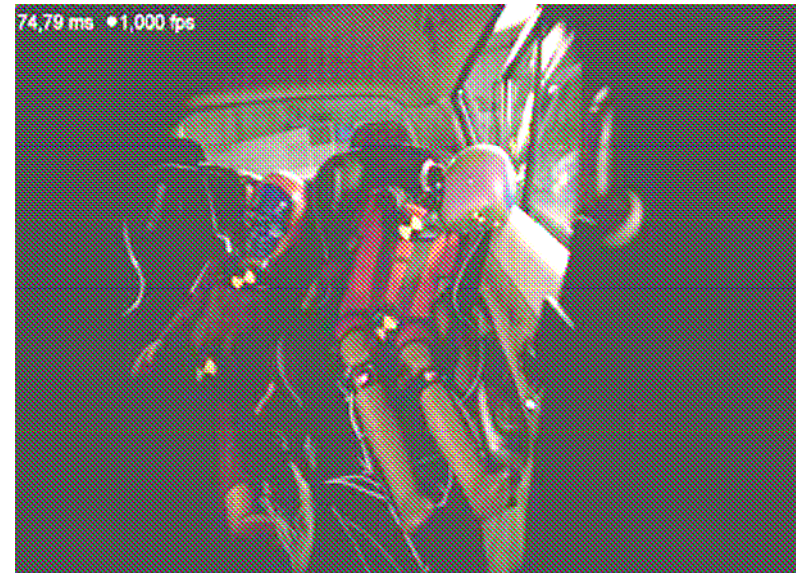
**HIC 200**

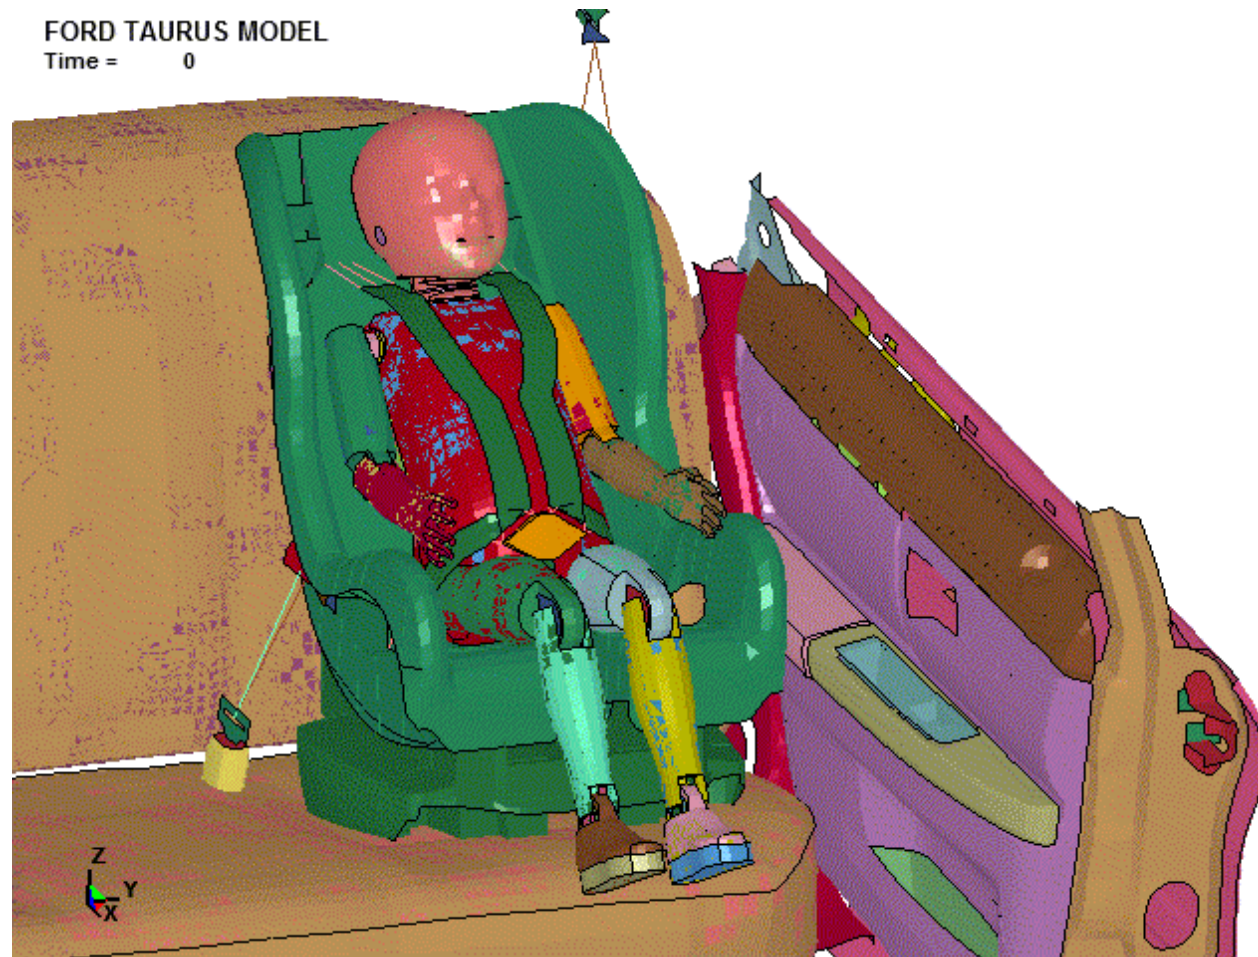
# Kinematic Behavior of Hybrid III 3YO

- In the car-to-car oblique side collision, the head of the Hybrid III 3YO flexed but it did not make contact with the door.
- The head of child FE made contact with the stationary door. The head impact velocity and HIC was small (HIC 185)
- When the slack was added in the shoulder harness of the CRS, the head displacement of the child FE model was substantially large. The head made contact with the door beltline (HIC 481)
- It is probable that the misuse of the CRS could be one of the causes of the head contact with car interior in real world side collisions.

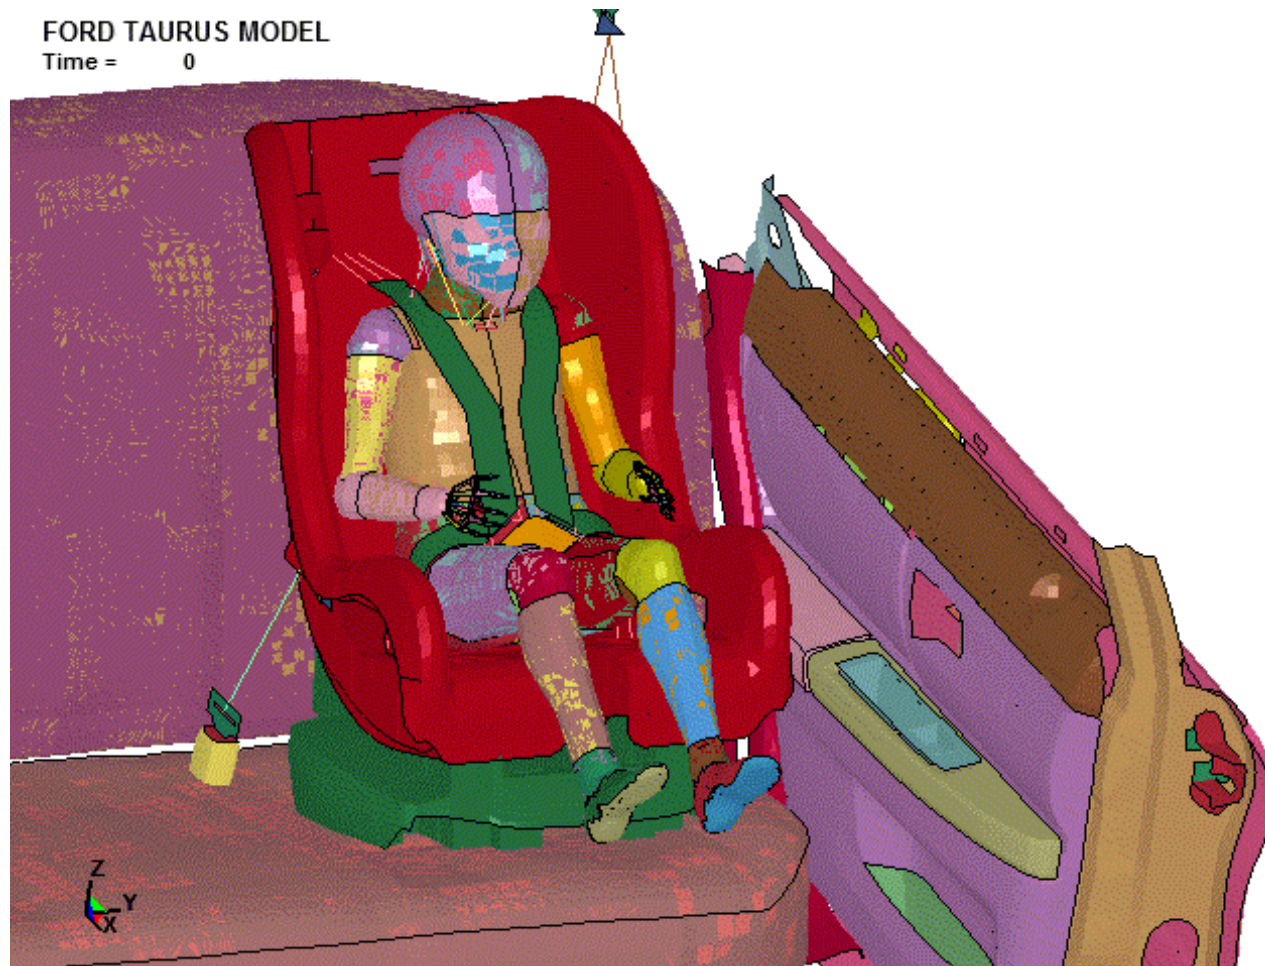
## Child FE (no slack)

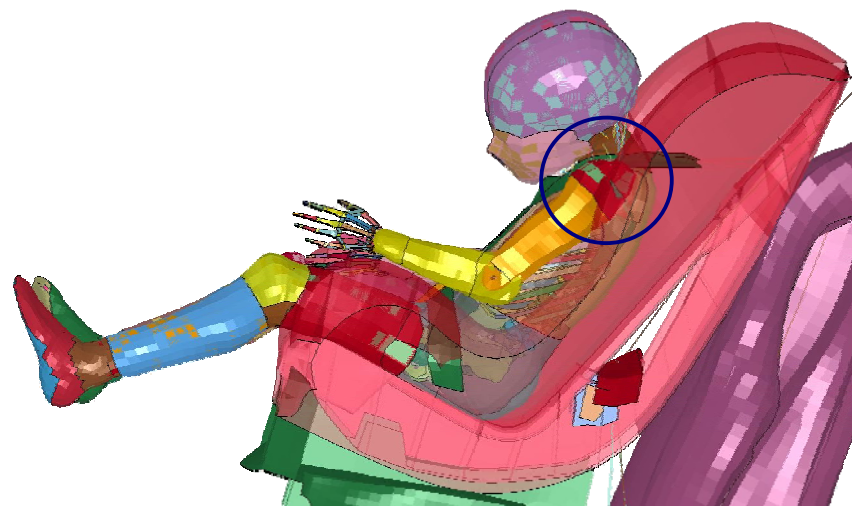
# Child FE (No slack)

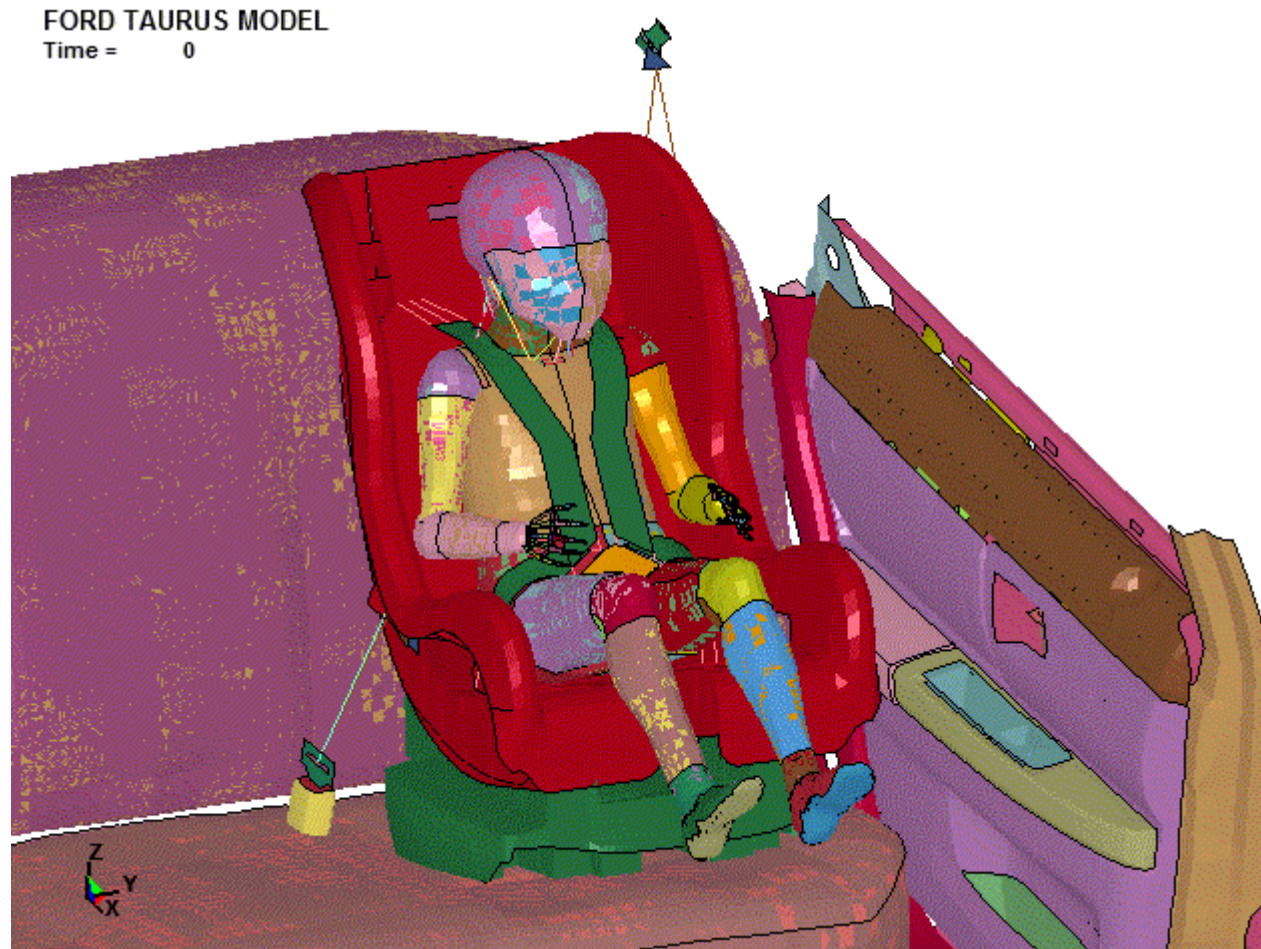
## Child FE (70mm harness slack)

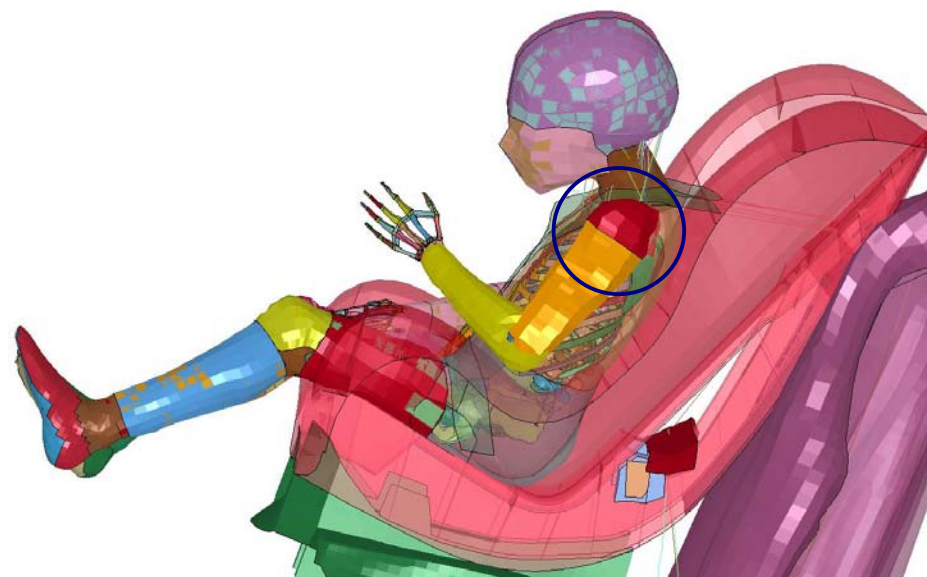
# Child FE (70 mm harness slack)

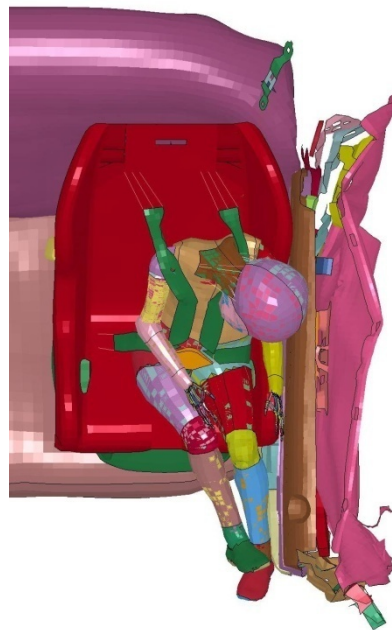
Child FE  
No slack

Head impact velocity  
3.7 m/s

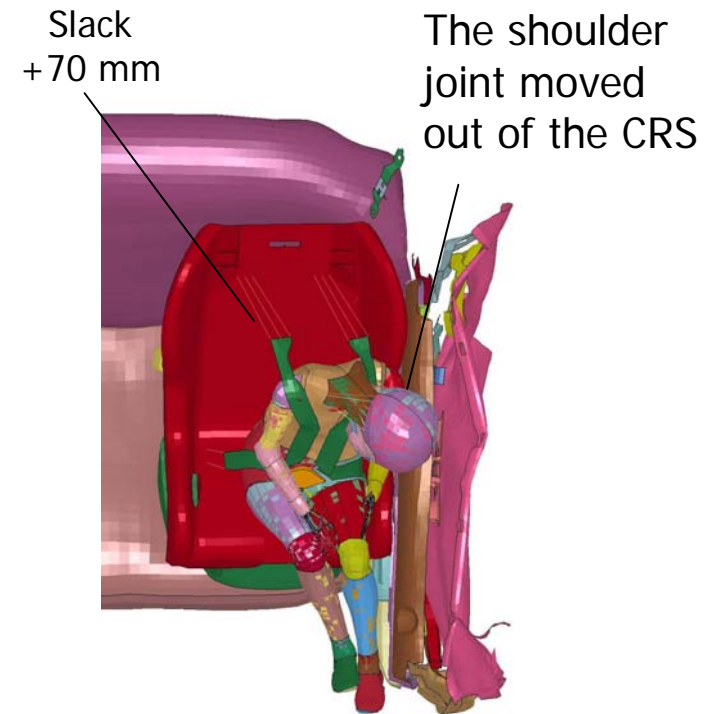
Child FE  
70mm harness slack

Head impact velocity  
6.3 m/s

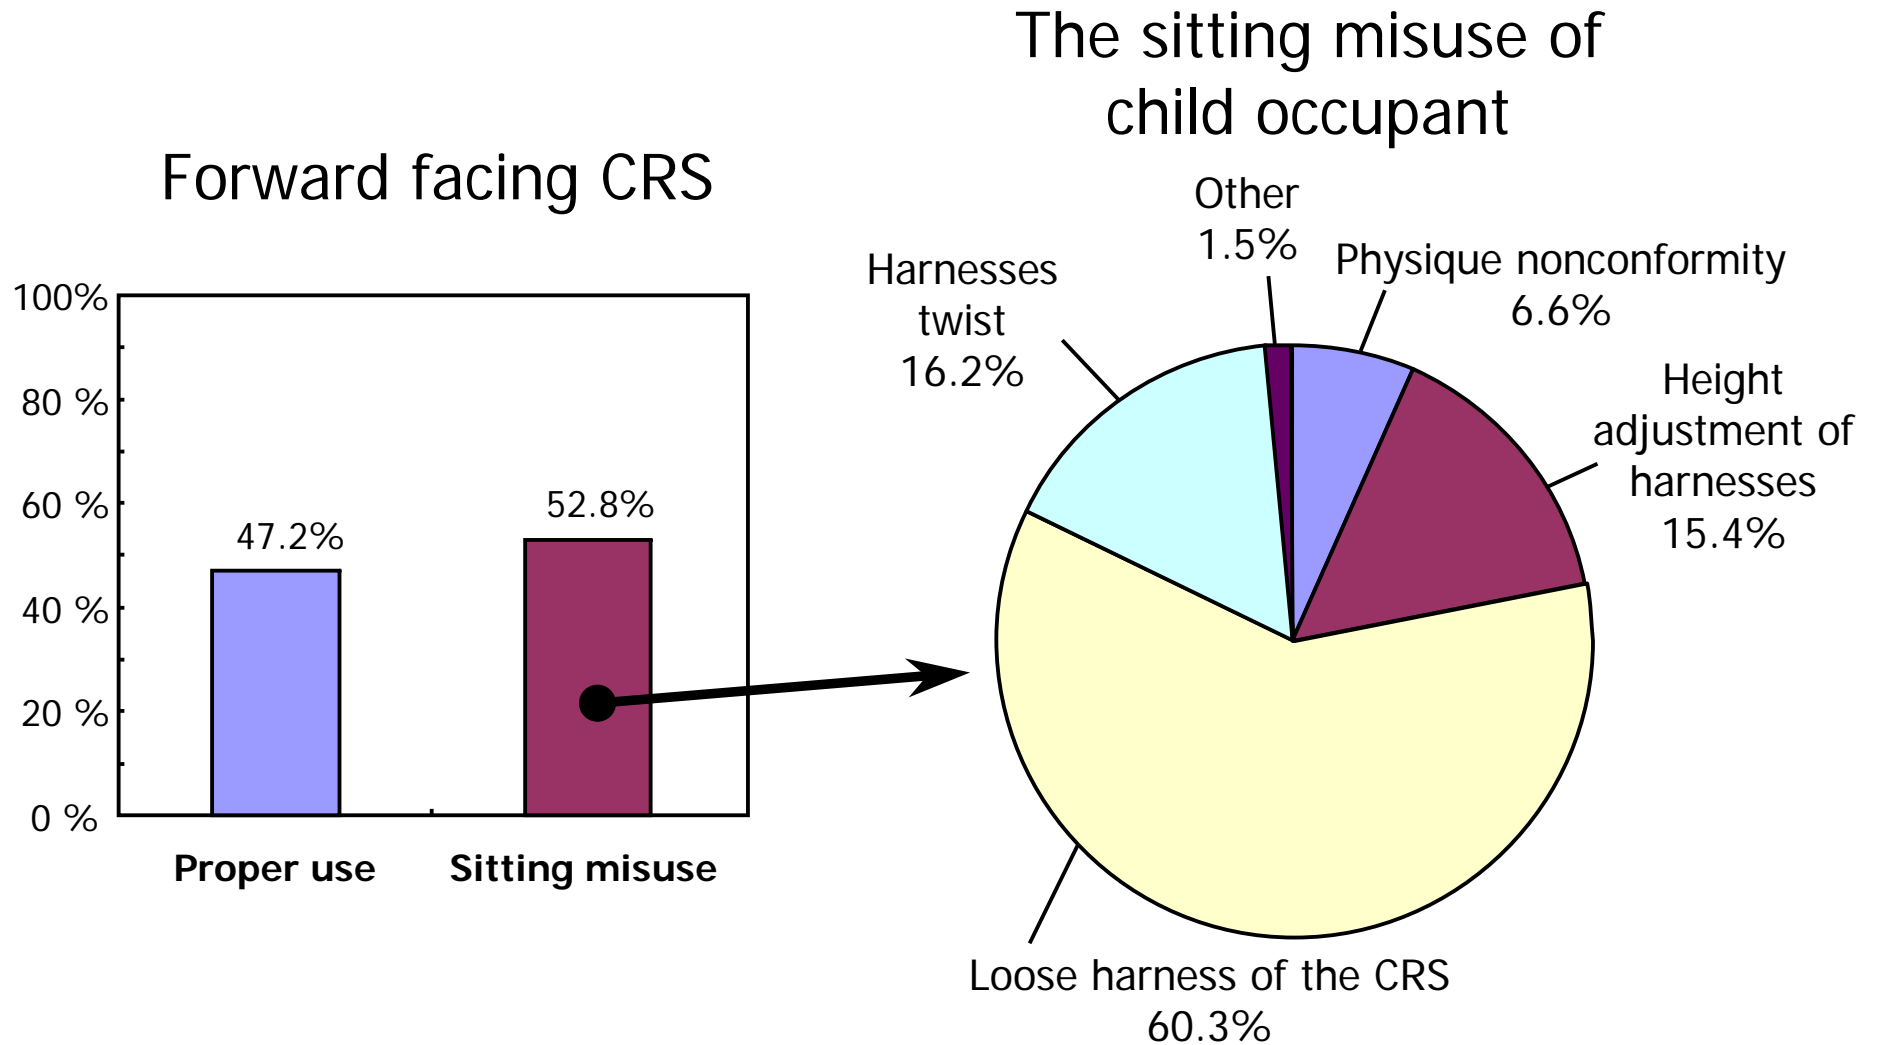
# Forward Facing CRS Misuse
