Informal document GRSP-49-23
(49th GRSP, 16-20 May 2011,
agenda items 4(a))

Update on Pedestrian Leg Testing

**National Highway Traffic Safety
Administration**

Pedestrian Leg Testing

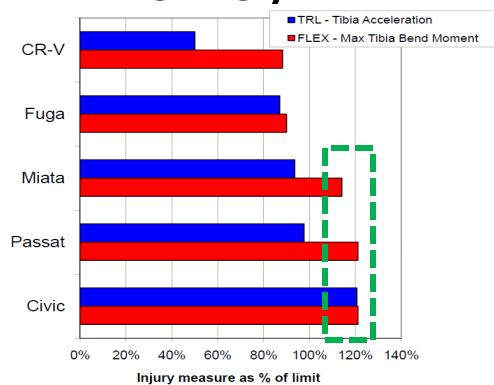
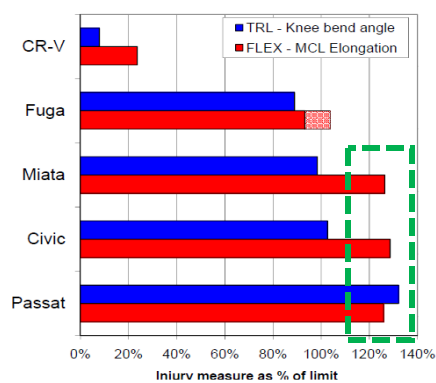
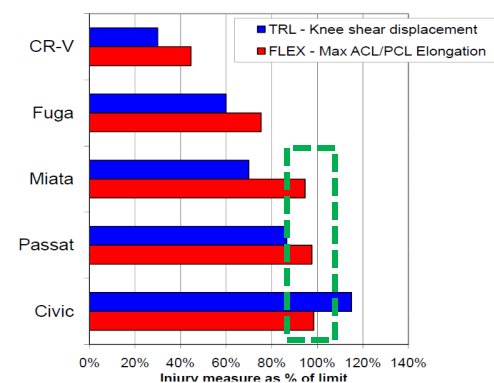
- The Flex-GTR had not been tested against aggressive vehicles in the US fleet and there was concern about its durability
- There was also concern about topping out the Flex-GTR's measurement limits (Mallory, 2010)

Fracture

Bend

Shear

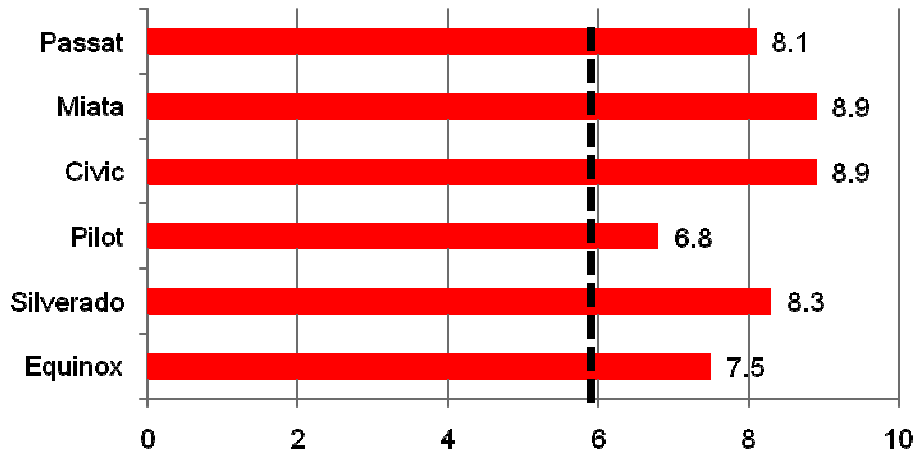
Peak Shear Displacement (mm)

TRL Test Results

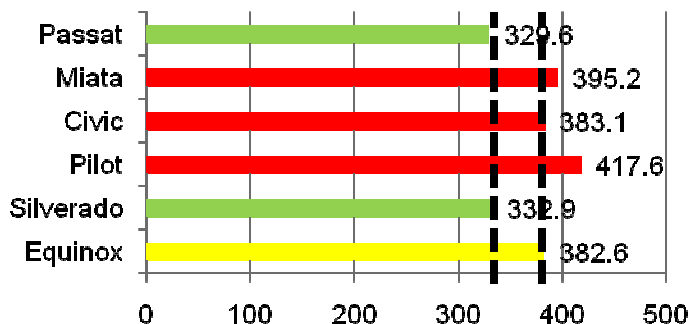
Peak Tibia 1 Moment (Nm)

Flex-GT Test Results

*Performed under GTR conditions with legform 25 mm above ground reference level

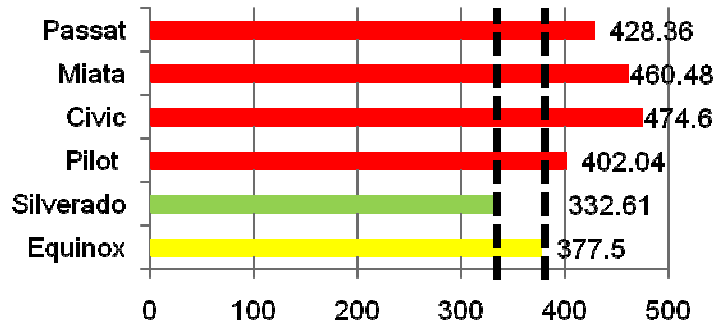
Peak Tibia 1 Moment (Nm)

Flex-GTR Test Results

*Performed under GTR conditions with legform 75 mm above ground reference level

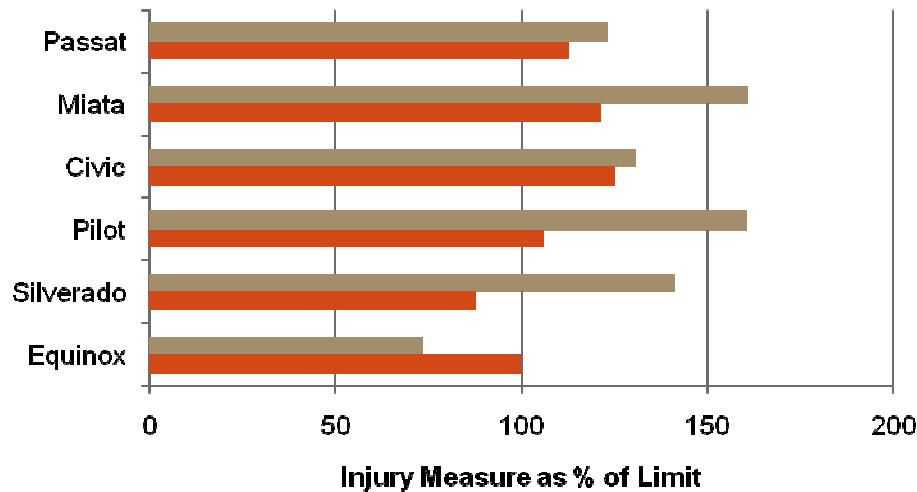
Fracture Measures

■ TRL - Tibia Acceleration ■ Flex-GTR - Max Tibia Bend Moment

- The Flex-GTR measures lower values than the TRL legform
- The current Flex-GTR seems to be able to distinguish differences in relatively aggressive vehicle bumper designs better than the previous version

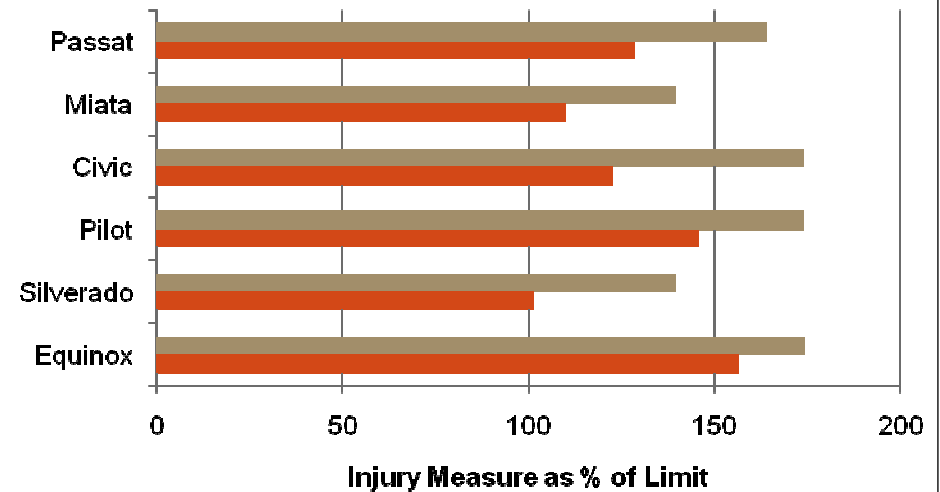
Bending Injury Measures

■ TRL - Knee Bending Angle ■ Flex-GTR - MCL Elongation

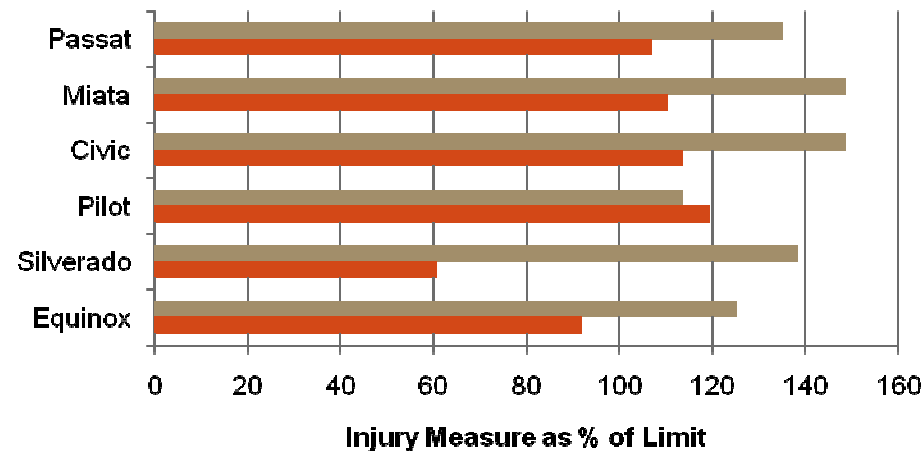
Shear Injury Measures

■ TRL - Knee Shear Displacement
 ■ Flex-GTR - Max ACL/PCL Elongation

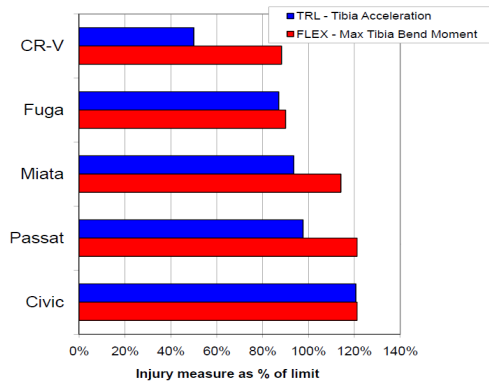
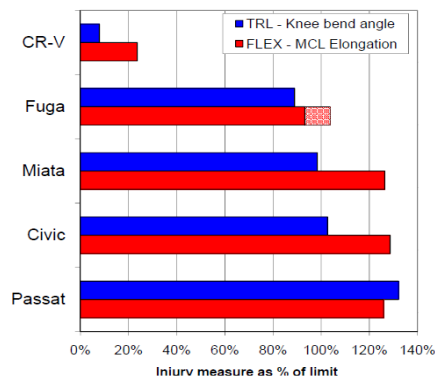
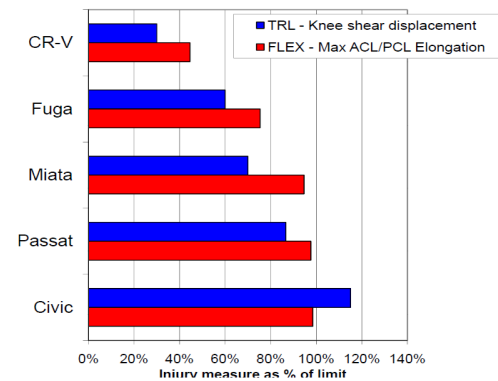
- Testing with a previous version of the Flex-GTR legform showed an inability of the legform to distinguish among vehicles that performed poorly
 - Measurements reached a limit (Mallory, 2010)

Fracture

Bend

Shear

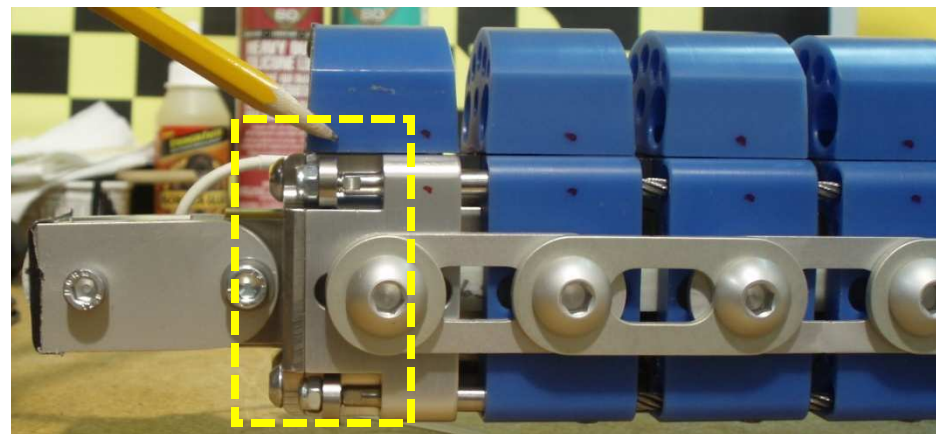
- Improvement in the current series of tests may be due to changes in Flex-GTR legform
 - Cable stop gap increase
 - Femur: 8 mm → 9.1 mm
 - Tibia: 9 mm → 10.3 mm

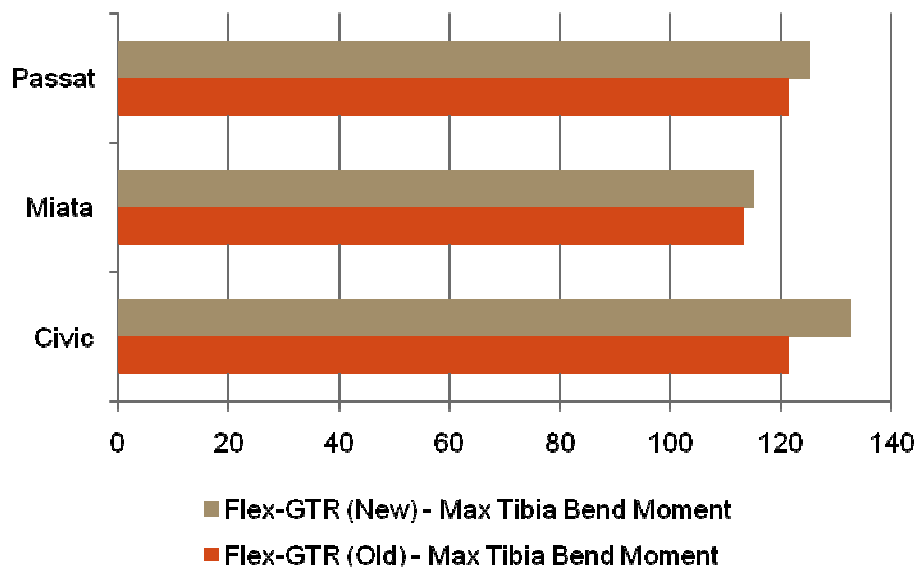
Fracture Measures

Comparison of Old and New Flex-GTR Data – Center Impacts

- The Flex-GTR measures lower values than the TRL legform
- The current Flex-GTR seems to be able to distinguish differences in relatively aggressive vehicle bumper designs better than the previous version
 - Topping out is not a concern with the current Flex-GTR
- Flex-GTR repeatability was not directly evaluated, but
 - Silverado Flex-GTR tests 1001 and 1002 showed similar numbers at the same impact location, which is promising

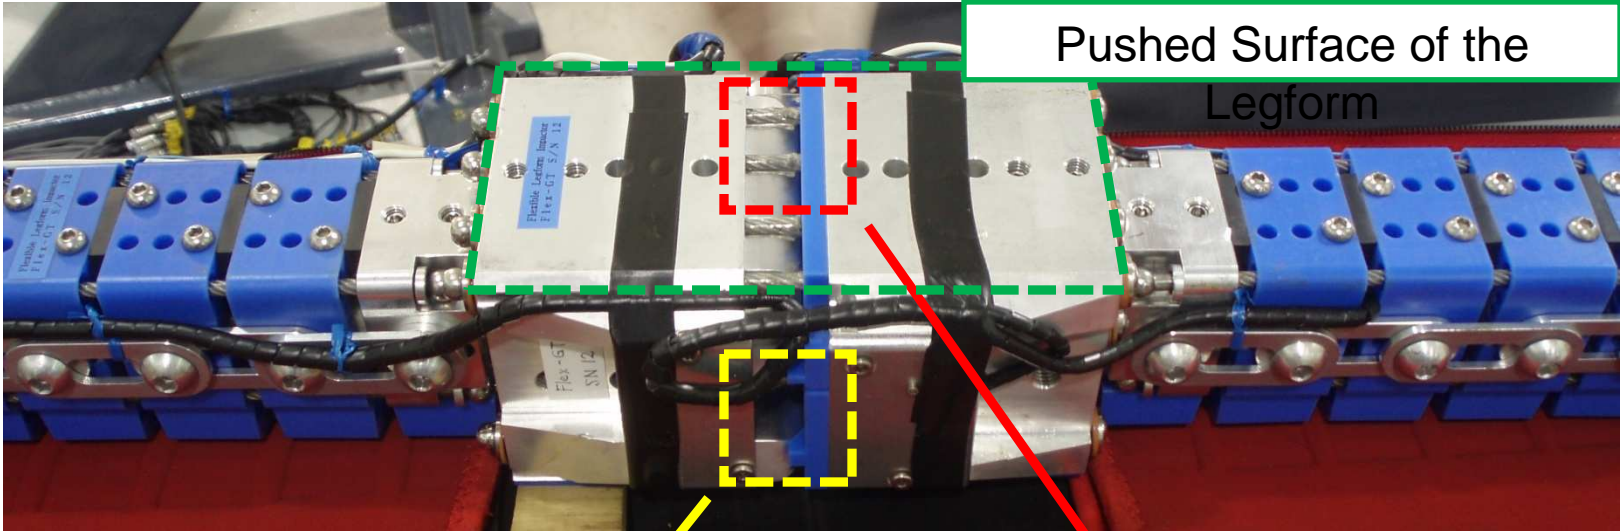
Observations and Durability Assessment (Flex-GT)

Pushed Surface of the Legform

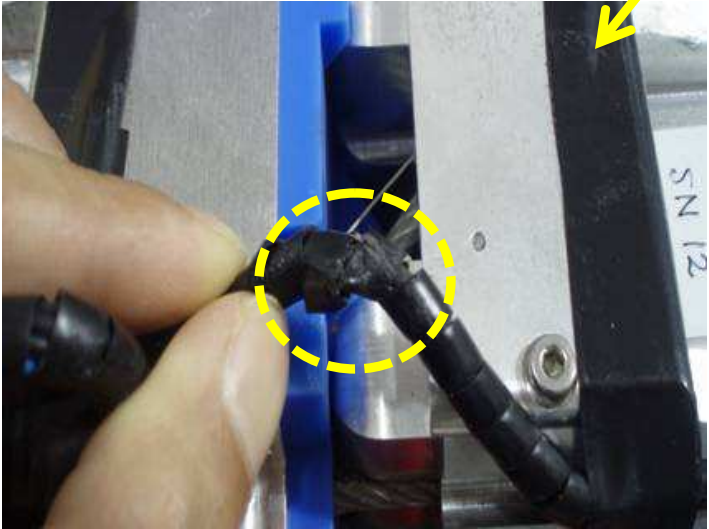
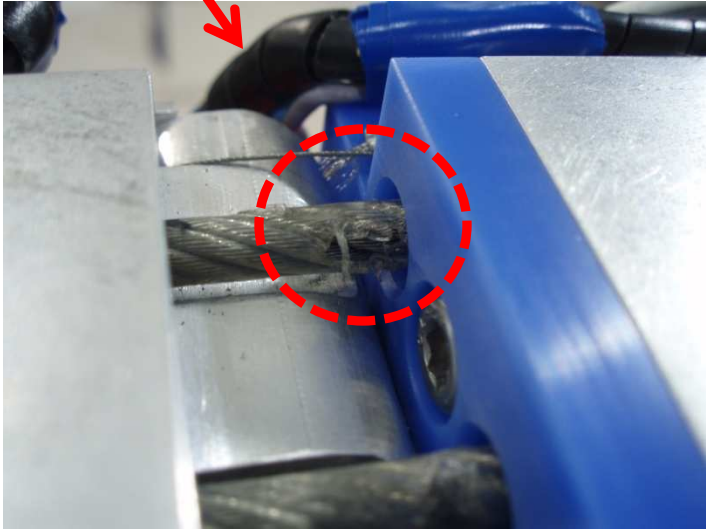
Pinching of wires between blue tab and metal knee condyle

Wear and tear of plastic sheath around knee tension cables

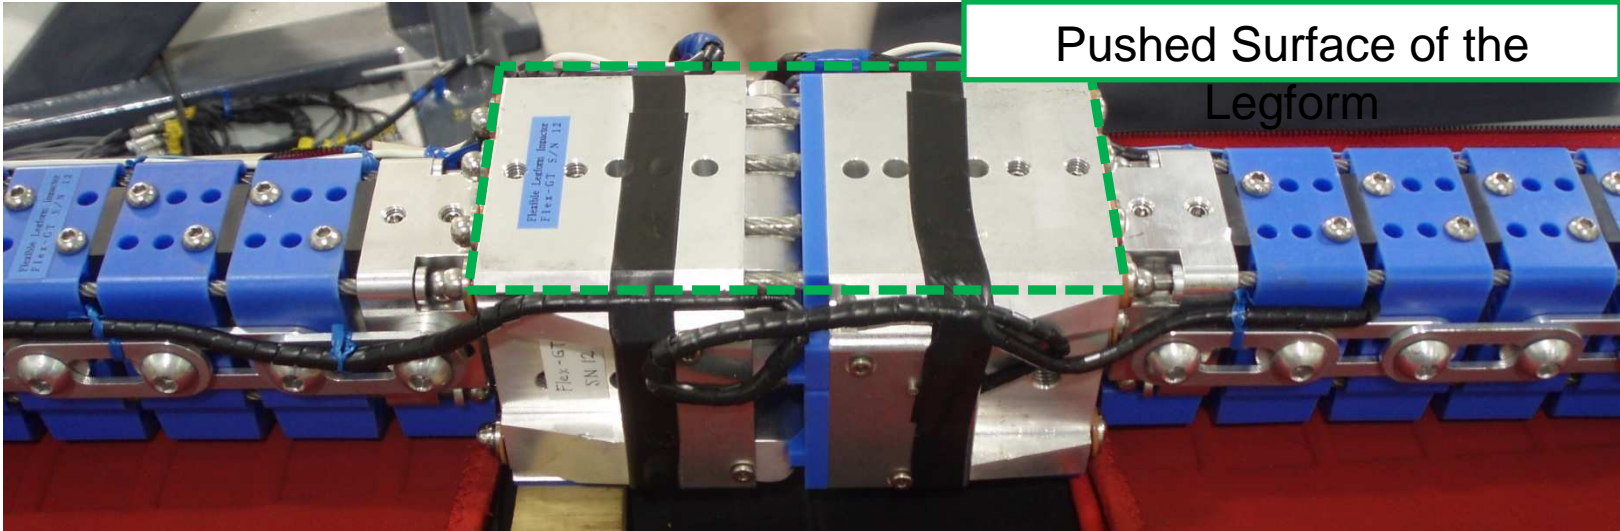
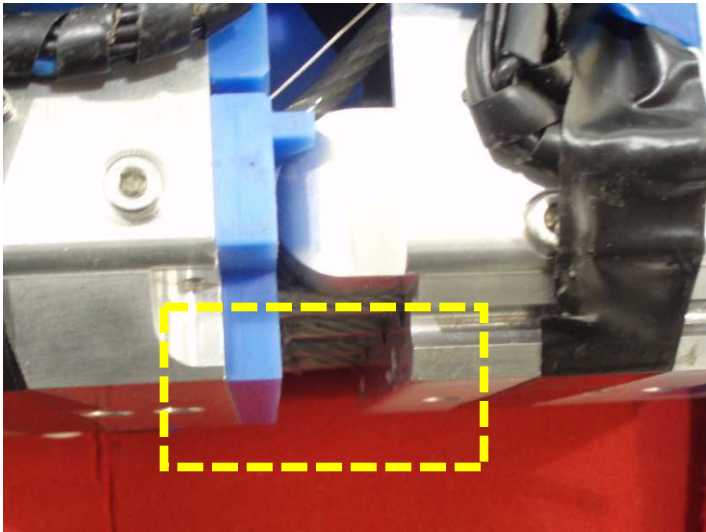
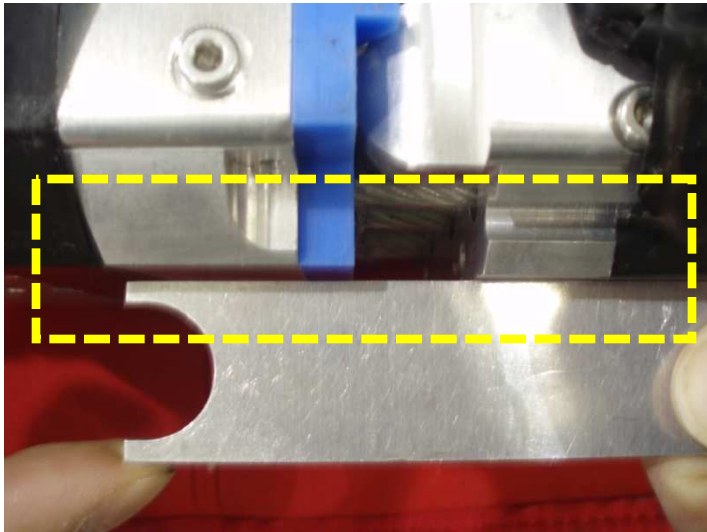
Observations and Durability Assessment (Flex-GT)

Tibia and Femur knee blocks are rotated/not flush with each other

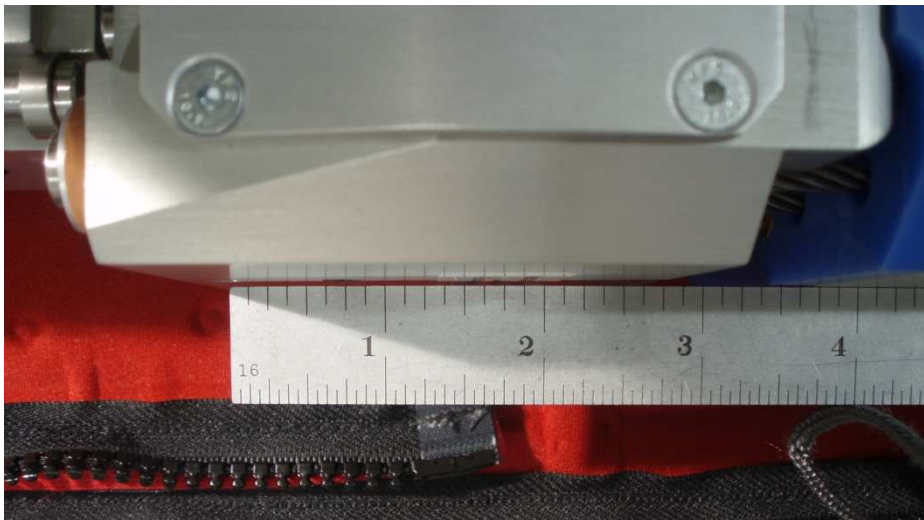
Observations and Durability Assessment (Flex-GTR)

Misalignment of the knee after
Passat and Miata impacts

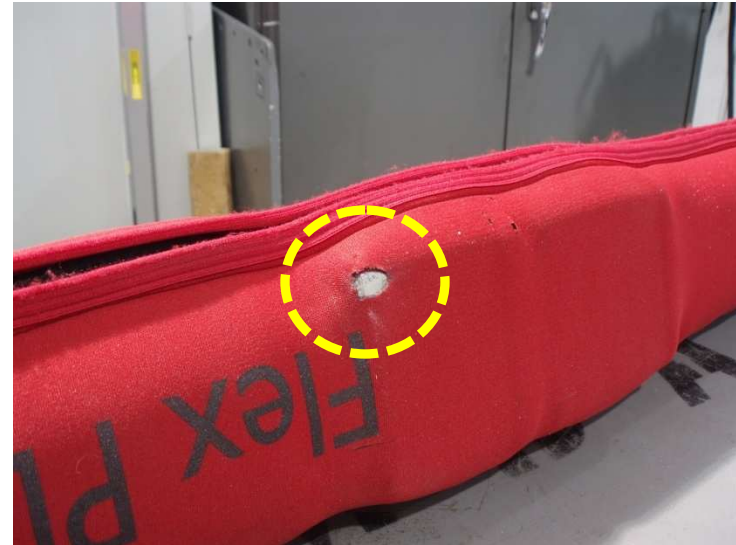
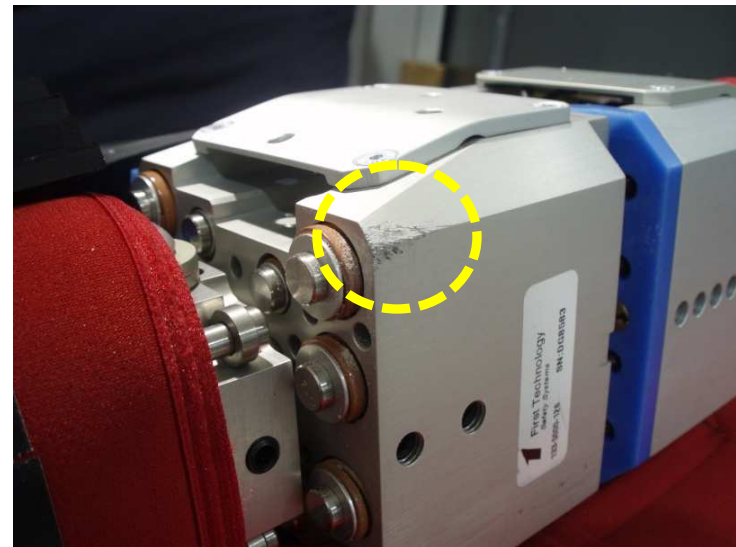
Tear in the neoprene skin and
scratches on the femur knee

block

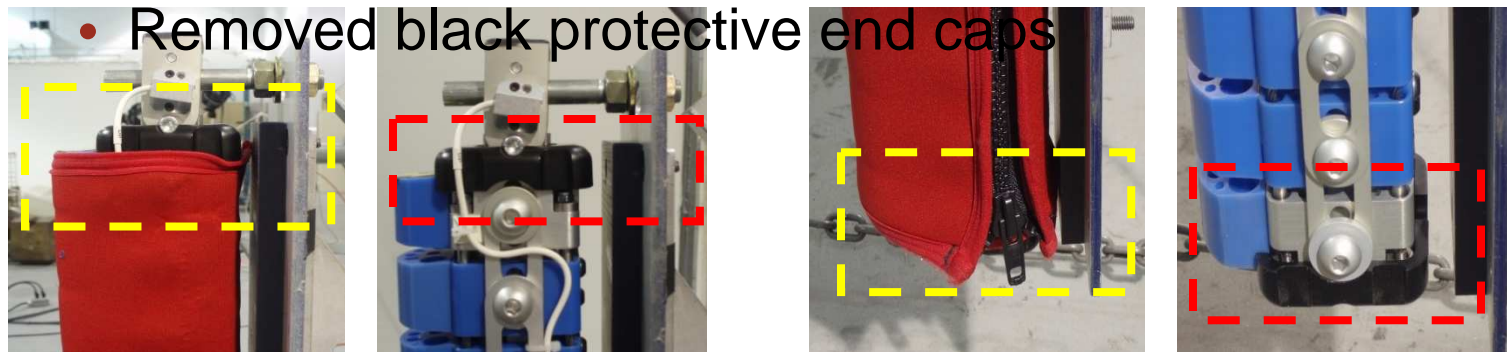
- Needed to modify the legform in order for its flight to be within GTR tolerances for forward pitch (specific to the VRTC launch system)

- Konosu-san (JARI) informed us that they cut out notches at the top and bottom of the launch plate to accommodate for the end caps
- Femur strain gauge #2 (middle gauge)
 - Broken gauge/wire
 - Still being investigated
