Informal document GRSG-103-02  
103<sup>rd</sup> GRSG, 2-5 October 2012  
Agenda item: 2

**Background information to the problems of emergency exits  
and ejection of passengers in buses**

## **PASSENGER'S EJECTION IN BUS ROLLOVER ACCIDENT**

Dr Matolcsy Mátyás  
GTE, Hungary

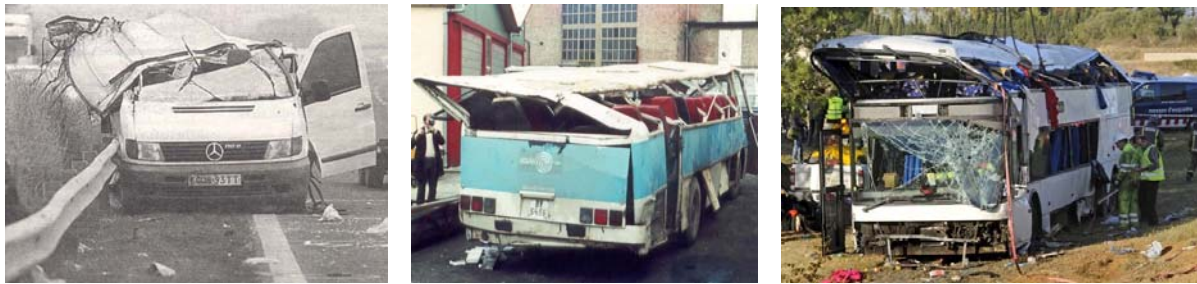
Figure 1. Collapsed superstructures in bus rollover

In the mid '70-s the bus rollover became known as a very dangerous accident. It may be said that this time it was known as the most severe bus accident. Because of the generally weak superstructures endured large scale plastic deformations or in many cases completely collapsed, so the passengers were compressed, or hard structural elements intruded into their bodies. Typical results of rollover accidents are shown on Figure 1. proving that the way of large scale deformation is general and similar – when the superstructure is weak – in small and large buses, double deckers. The fatality rate was very high in these accidents (30-50% of the passengers being on the board in the accident). International legislative – and belonging research – work was initiated in UN-ECE (Geneva) which resulted in 1986 the Regulation 66. which required a certain roof strength for Class II and Class III coaches. This regulation was improved and developed in 2004 and now it may be said that the roof strength problem of buses is solved. The coaches, which are approved on the basis of Reg.66. do not collapse in a

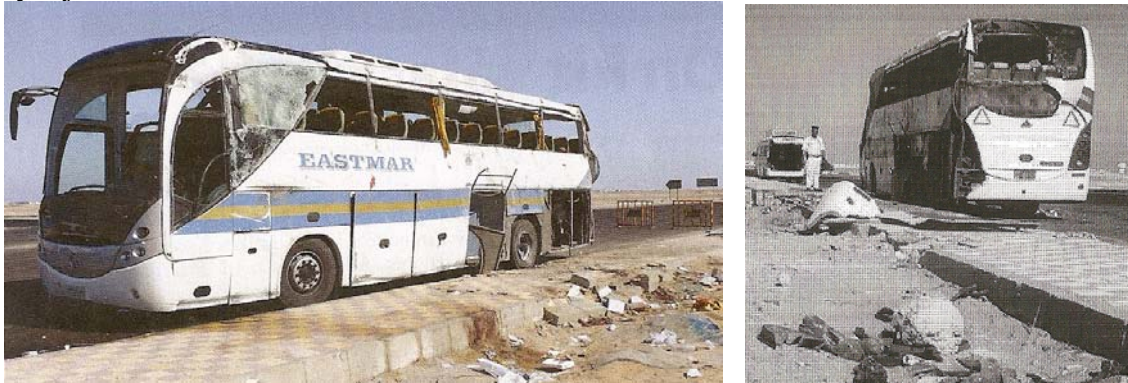
Figure 2. The bus turned on its side and slid away (Egypt)

***Rollover accident in Egypt [1]*** A HD coach (Class III.) – taking a curve with relative high speed – rolled over with 50 Hungarian tourist on board, turned on its left side, slid 30-50 m away and stopped. The superstructure was strong enough, no significant structural deforma-

tion. All the side windows were broken (see Figure 2.), the casualties were caused by the ejection of passengers, mainly partial ejection. The passengers fell onto the left side of the bus, compressing the people sitting next to the windows, through the broken windows to the concrete road surface and they were rasped by the glass fragments and by the road. The result: 11 fatalities, 29 injured and hospitalized persons, among which 4 were in life danger and 15 seriously injured.

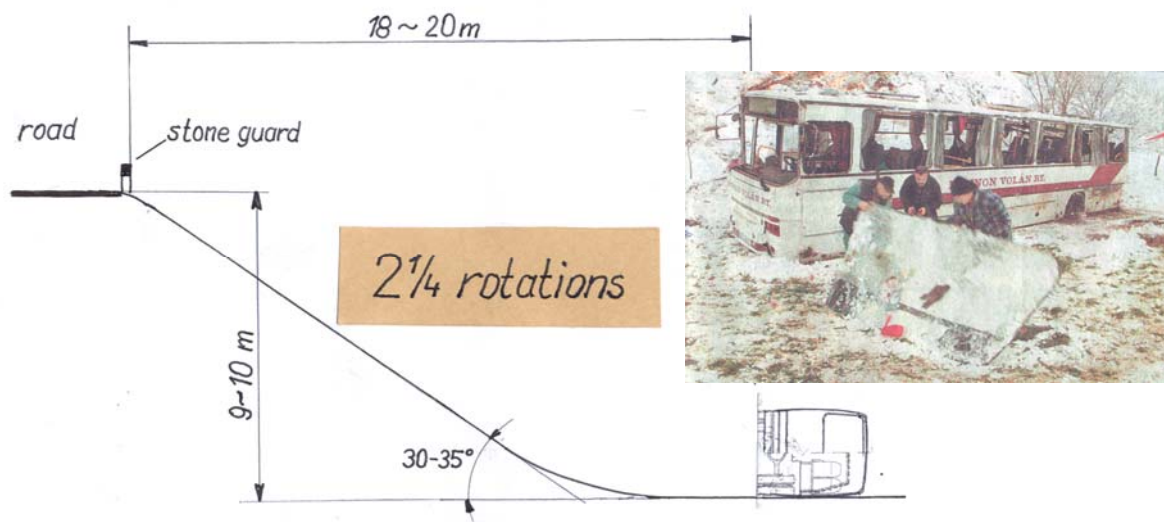
Figure 4. Rollover on a slope with 2 ¼ rotations

**Rollover accident in Hungary** [3] The driver of an intercity coach (Class II.) on an icy, snowy road lost the control, the coach slipped in a sharp curve and rolled down on a snowy slope with 2 ¼ rotations and stopped on its side. 15 passengers on board, plus driver. The superstructure was strong enough, no significant deformations. The windscreen and the majority of the windows were fallen out without breaking (installation with rubber profiles). The slope and the bus – after the accident – is shown on Figure 4. The result: 8 serious injuries, 8 light, but 7 of them were hospitalized. 3 persons (among them the driver) were totally, 3 passengers partially ejected. They were partially under the bus, getting very severe injuries. It took more than one hour for the firemen to escape them. They were ejected in the second round. It is interesting to note that the passengers – even the rollover was a relative slow process – could not describe the process, their motion. They estimated 2- 2,5- 3 and also 4 rotations.

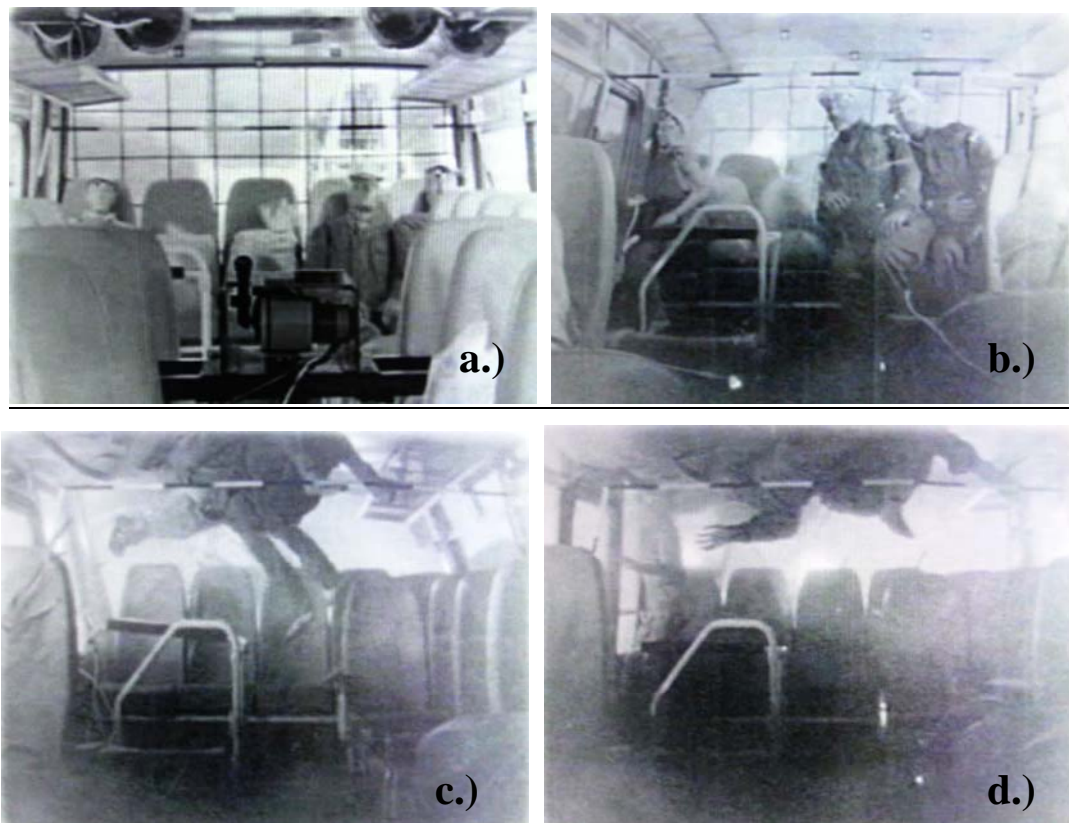
Figure 5. Motion of unbelted dummies in a rollover test

In the mid of the '70-s IKARUS made a lot of different rollover and roof strength tests [7]. Rollover tests on a standard 6/4 slope were carried out to study the energy input and energy absorption by the superstructure. In the test with loaded bus all the seats were loaded by a

sandbags (68 kg), fixed by ropes to the seats. Many sandbags were “ejected” during 1,5 rotation, they were scattered on the slope, and the ejection process could be seen on the high-speed film. But our conclusion was – when evaluating the test – that the mass and the inertia of the rolling bus could be changing during the process and we did not recognize it as a dangerous injury mechanism, because the ejection problem was not recognized at that time, as a dangerous injury mechanism. Later on, another similar rollover test was performed with dummies. Three dummies were used – without seatbelt – and filmed. Figure 5./a shows their original position sitting on the rearmost seat row, 5/b when two of them are leaving their seats but still in “seating” position, while 5/c and 5/d in “flying” position. During this motion they hit the roof structure, the windows on both sides and bump each other. The superstructure was strong enough, the side windows did not break, therefore the dummies were not ejected. The evaluation of this process gave good arguments to the international discussion: how to consider the effect of the unbelted, or belted passengers in the rollover, related to the energy input. [8] Again, at that time we did not consider the „projection” and “ejection” as injury mechanism just an effect on the energy input, energy balance. Twenty years later an interesting rollover test was produced by VOLVO [9]. Eleven dummies, representing children and adult passengers, using 3 pts safety belt, were used in this test. (Two of them were not belted). This test proved that the 3 pts safety belts are effective against projection, because they kept the dummies on them seats after 3 ¼ rotations. The unbelted dummies were flying around the passengers compartment.

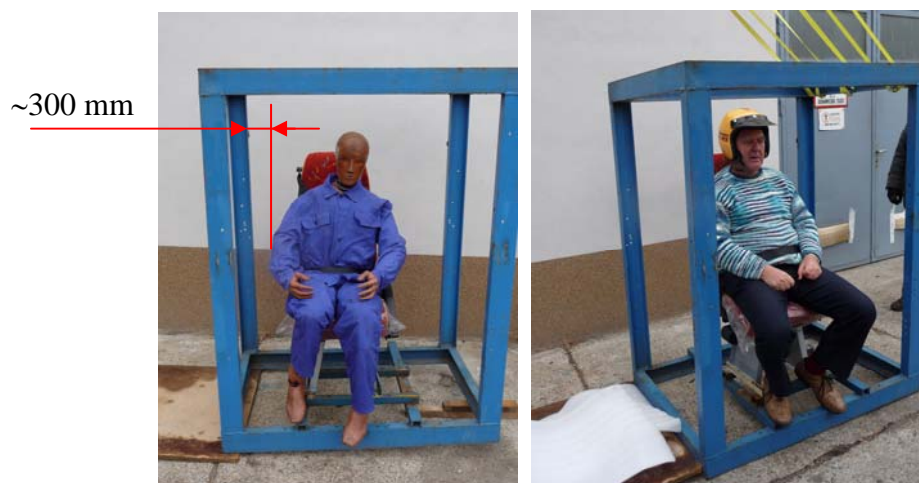
Figure 6. Tilting tests with seatbelt

The safety belts (both the 2 pts and 3 pts belts) are very effective tools to keep the passengers in their seats – in their survival space – in frontal collision. To prepare a future test series, preliminary tests were performed in Jáfi-AUTÓKUT Research Institute (Hungary) comparing the effect of 2 pts and 3 pts belts with Hybrid III 50% male dummy and also with human body. A coach seat was built into a strong frame which was tilted sideways (both quasi-static and dynamic turn over). Figure 6. shows the arrangement.

The coach seat was fixed to a strong, steel frame, far away from the theoretical bus side wall with ~ 300 mm, to avoid any kind of damage of the dummy. Quasi static and dynamic tilting

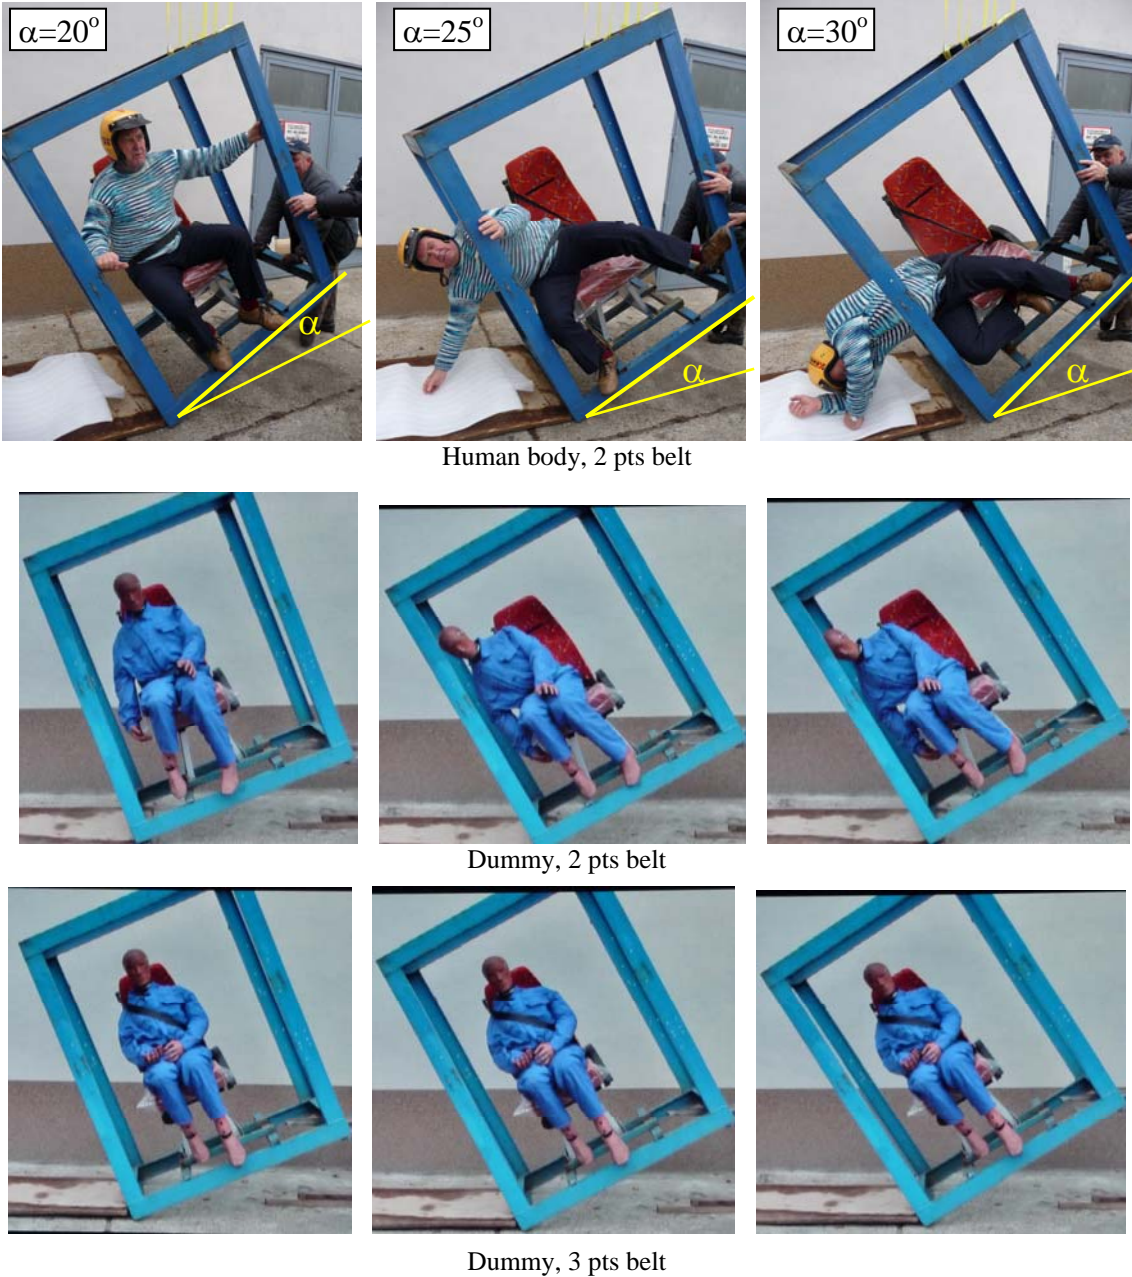
Figure 7. Different behaviour of the dummy and the human body in the tilting test.

tests were performed, having 90° degrees rotation. Figure 7. tries to summarise the main conclusions:

- a) The passenger – using 2 pts belt – can not sit on the seat without massive grasping at tilting of  $\alpha = 20^\circ$ . At  $\alpha = 25^\circ$  it is impossible to remain inside the passenger compartment and at  $\alpha = 30^\circ$  the passenger can not control his position, he is partially ejected.
- b) The dummy with 2 pts belt has certain inclination in the three given tilting position, but much less than the human body. After the dynamic tilting the dummy hit its head to the ground, which was not in the real position, real distance from the seat (see Figure 9.)
- c) The dummy with 3 pts belt had smaller inclinations than the dummy with 2 pts belt and after the dynamic tilting its head did not contact the ground. The dummy was completely hanging on the seat belt.

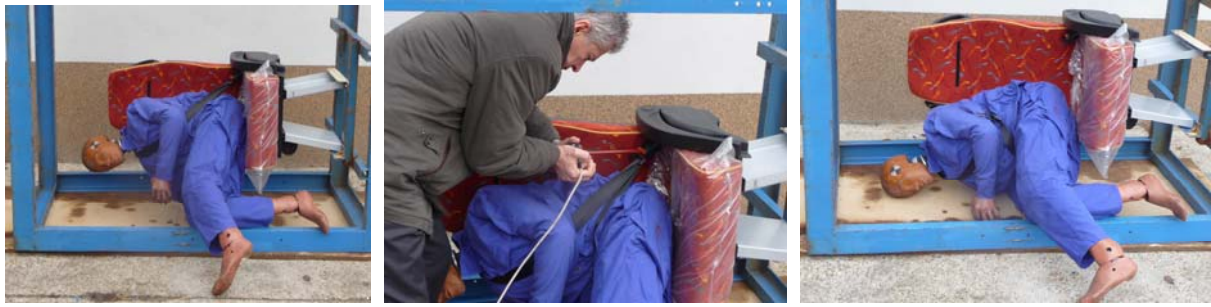
Figure 8. Hanging dummy, 3 pts belt – no way to release the safety belt

The dummy – hanging on the 3 pts belt – created a very dangerous situation: the belt could not be released – as usual – by finger. Figure 8. shows the hanging position of the dummy, the release of the safety belt by a force transducer (380 N) and the dummy final position, lying on the ground. Figure 9. shows the final dummy positions with 3 pts and 2 pts belt. With 2 pts belt the dummy had larger displacement, its upper part – through its head – was supported somehow by the ground, therefore not the total mass was hanging on the seat belt. The belt release force is smaller in this case (310 N), but also unacceptable high for finger operation. For empty seat, when the belt is not loaded, the releasing force was 29 N, one order less than with loaded by hanging dummies.

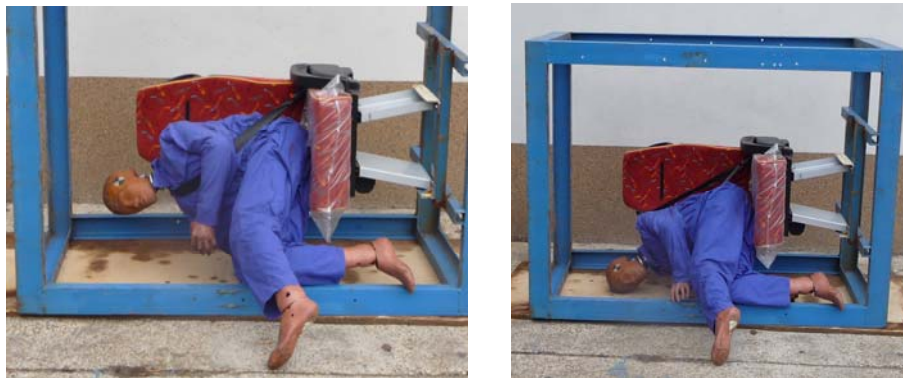
Figure 9. 3 pts and 2 pts belted dummies in final position

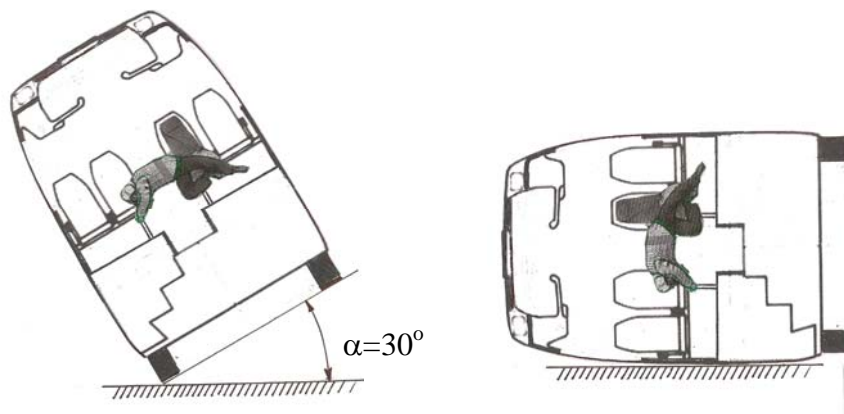
Figure 10. Hanging passengers in a bus which is lying on its side.

This test series highlighted another, new problem to be considered: the passengers hanging on their seat belts cannot release the loaded belt, cannot leave the bus, the bus cannot be evacuated. If they could release the belt – e.g. cutting it – they would fall down onto the passengers having position below them, which also would not make easier the evacuation. Hanging on the safety belt, trying to release it and in the same time to hold their wait by grasping: this is not an easy task. This situation could be fatal if a fire breaks out after the rollover accident. Table I. shows that it could happen and this is one of the most dangerous accident situations in respect to the fatality and casualty rates. But this hanging position is very disadvantageous if there is no fire. The passengers can not help each other, there is no way to help the injured persons to leave the bus through the rear wall window, roof hatches or windscreen. Figure 10. illustrates the situation at tilting angle  $\alpha = 30^\circ$ , and we do not have any idea about the passenger's position at  $\alpha = 90^\circ$  (when the bus is lying on its side)

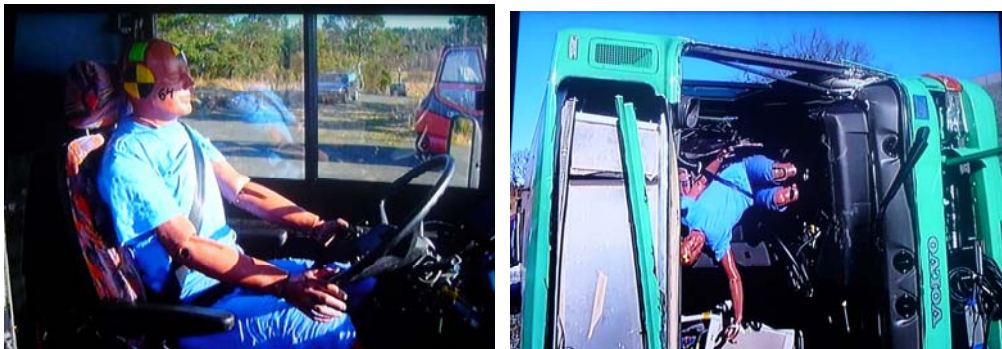
Figure 11. Original and final position of the “driver” in the VOLVO rollover test.

Figure 11. shows the driver dummy in original and in final position after  $3 \frac{1}{4}$  rotations in the VOLVO test, using 3 pts belt [9].

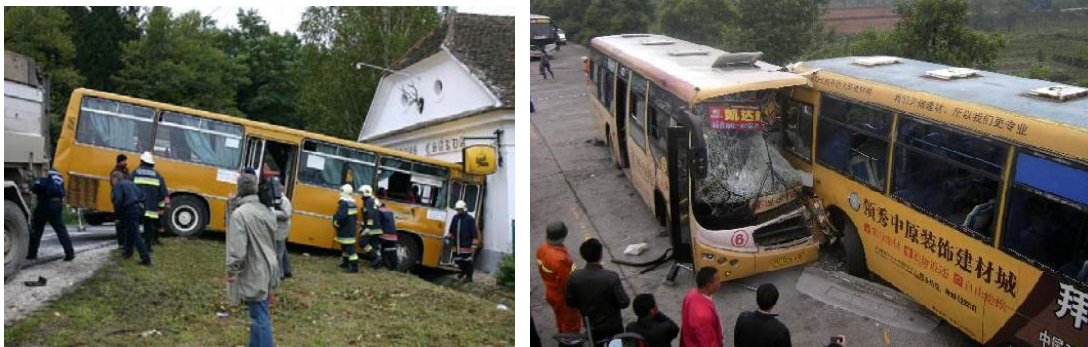
Figure 12. The bus is standing on its wheels

**When the bus is standing on its wheels** (Figure 12.): usable emergency exits are two service doors and one emergency door (One door is more than enough to evacuate the bus). There is no need for emergency side windows!

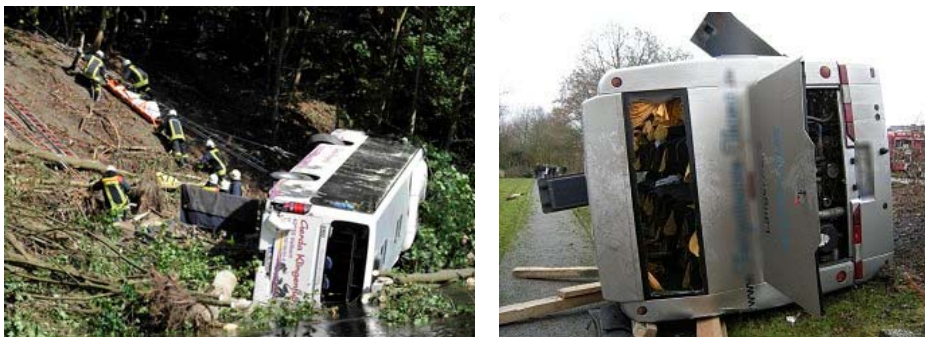
Figure 13. The bus lying on its side

**When the bus is lying on its side** (Figure 13.): usable emergency exits are the escape hatches and the rear window, or possibly the windscreen. Side windows on one side are blocked by the ground, on the other side it is impossible to break the windows above the head and climb up through the window. There is no need for emergency windows!

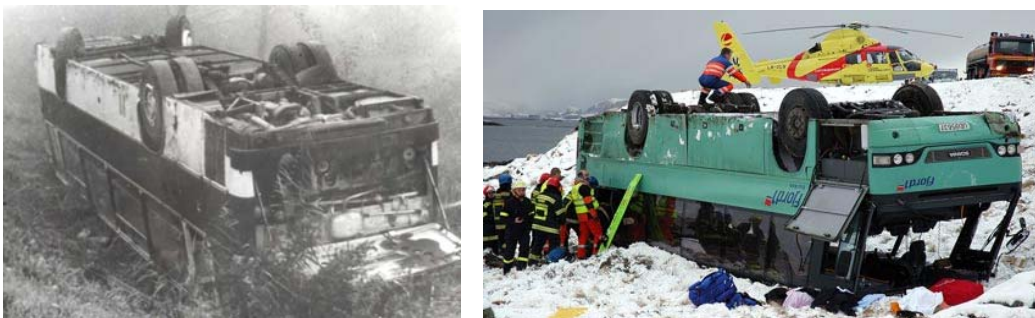
Figure 14. The bus standing of its roof

**The bus is standing on its roof** (Figure 14). The doors (both service and emergency doors) can be used also the rear window and windscreen. There is no need for emergency side windows!

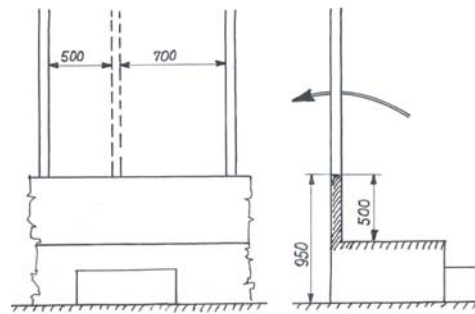
Figure 15. The use of breakable side emergency window

Interesting test was carried out in UK [14], when the UN-ECE Regulation 36. (General safety provisions of large buses) was discussed. 100 voluntary elderly people (average of 73 years) were asked to simulate an emergency evacuation of a bus through side window. The test arrangement is shown on Figure 15. The participants knew the task, they knew what to do, there was no glass in the window frame (nothing to break) and 44% refused to pass the test, they were unable to exit through the window simulation. It has to be pointed out that it was a very “lightened” test: in real bus constructions the inside height of the side wall is 700-800 mm (instead of 500 mm), and the outside height is 1600-1800 mm (instead of 950 mm)

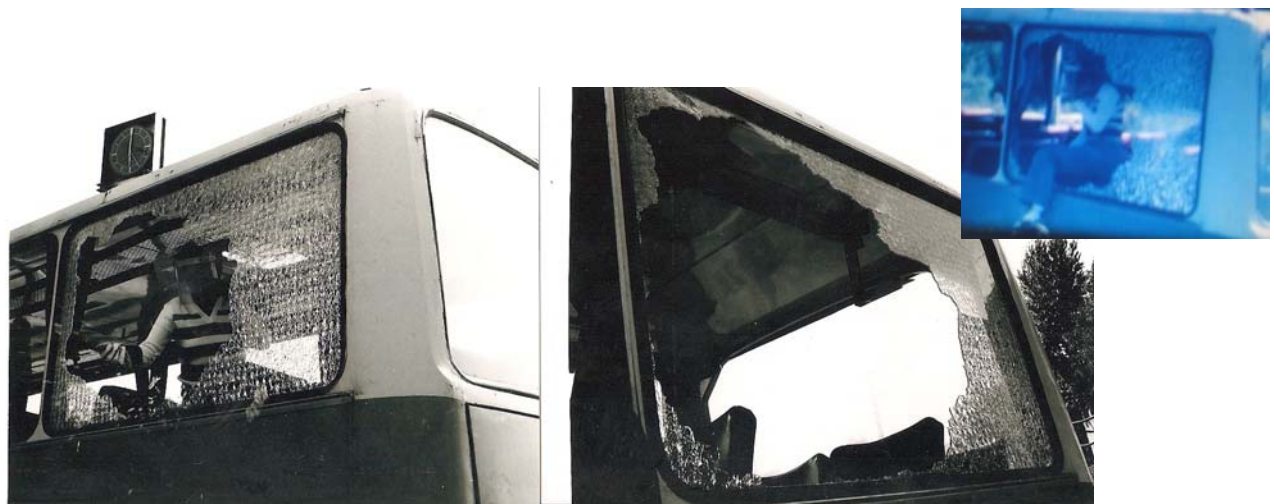
Figure 16. Arrangement of evacuation test through side window

We also made evacuation test with breakable side window [13]. 30 years old woman – using protection gloves and face protective mask – was asked to leave the bus through a breakable side window. The measured time was:

The massive outside help meant that two men lifted her out, she could not grasp the window pillar, she could not touch the window rail (waist rail) because of the sharp glass fragments (see Figure 16).
