Informal document GRSP-49-23
(49th GRSP, 16-20 May 2011,
agenda items 4(a))

Update on Pedestrian Leg Testing

**National Highway Traffic Safety
Administration**

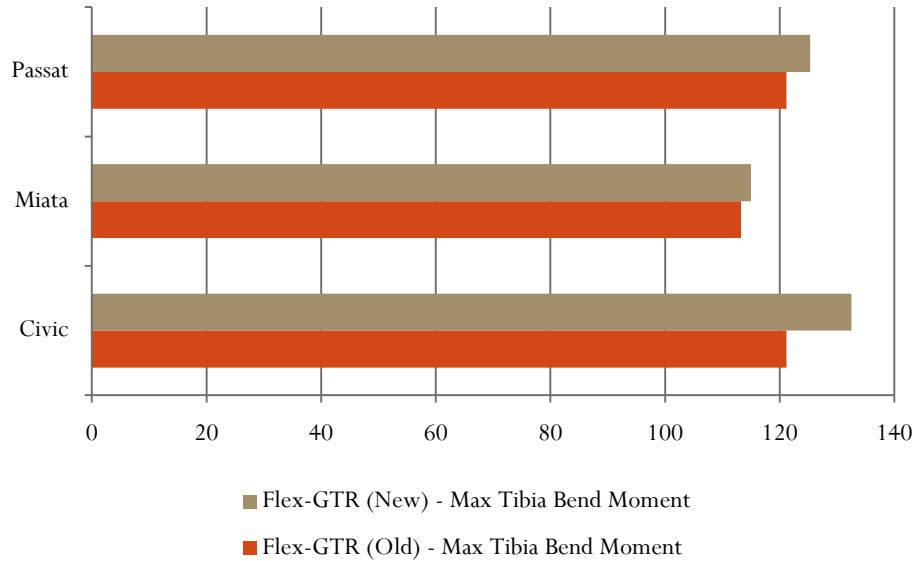
Fracture Measures

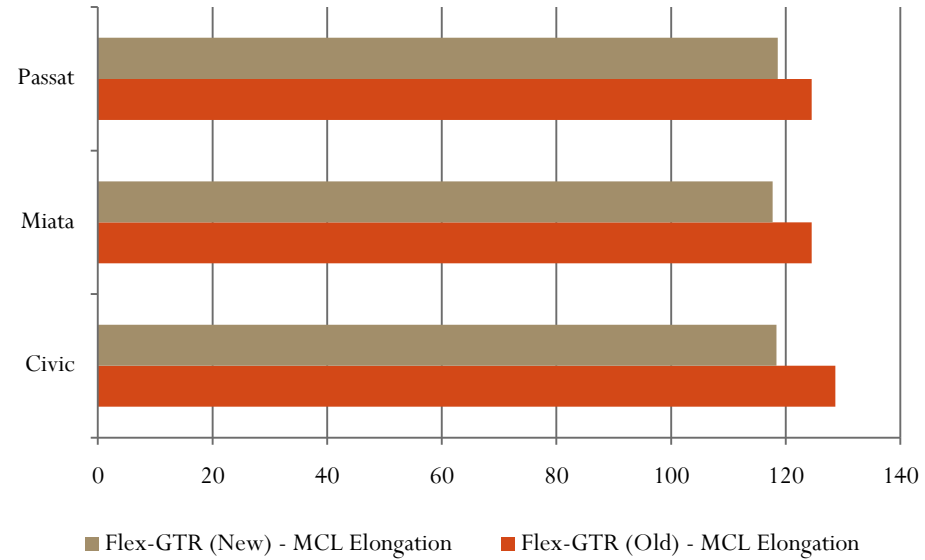
Bending Injury Measures

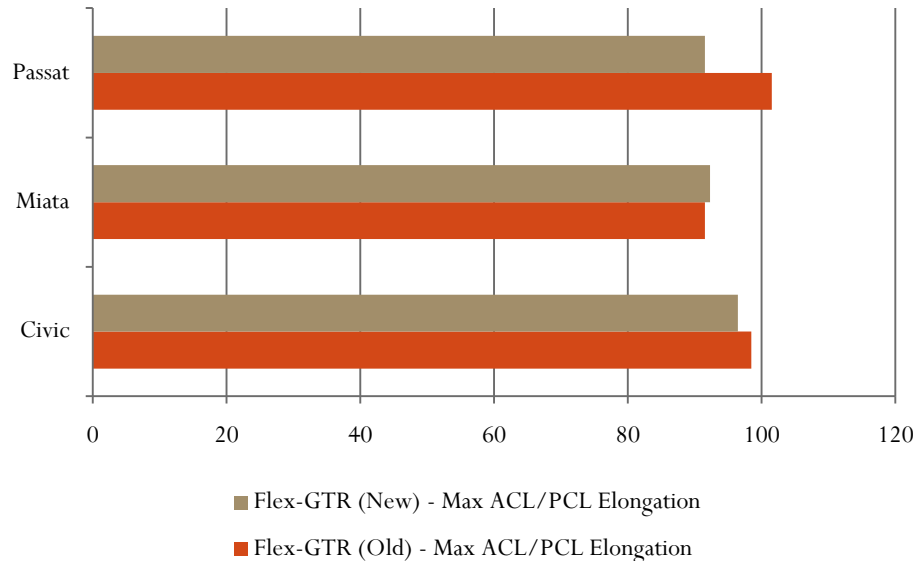
Shear Injury Measures

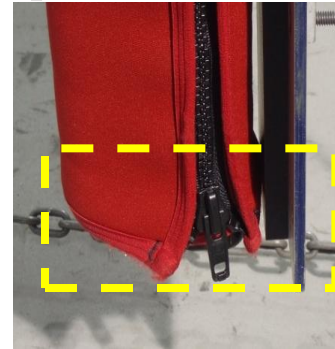
- Needed to modify the legform in order for its flight to be within GTR tolerances for forward pitch (specific to the VRTC launch system)
 - Removed black protective end caps

- Konosu-san (JARI) informed us that they cut out notches at the top and bottom of the launch plate to accommodate for the end caps
- Femur strain gauge #2 (middle gauge)
 - Broken gauge/wire
 - Still being investigated
