Transboundary safety aspects: Experience from the Czech Republic, Serbia and the Komi Republic

Petr Mothejl, Jakub Kanta, Marie Komárková

1. Gasoline Pipeline Accident **The Massive Spill of Gasoline near** **Polepy, Czech Republic**

2. Remediation of soil and groundwater in Bogutovac (Serbia and Montenegro)

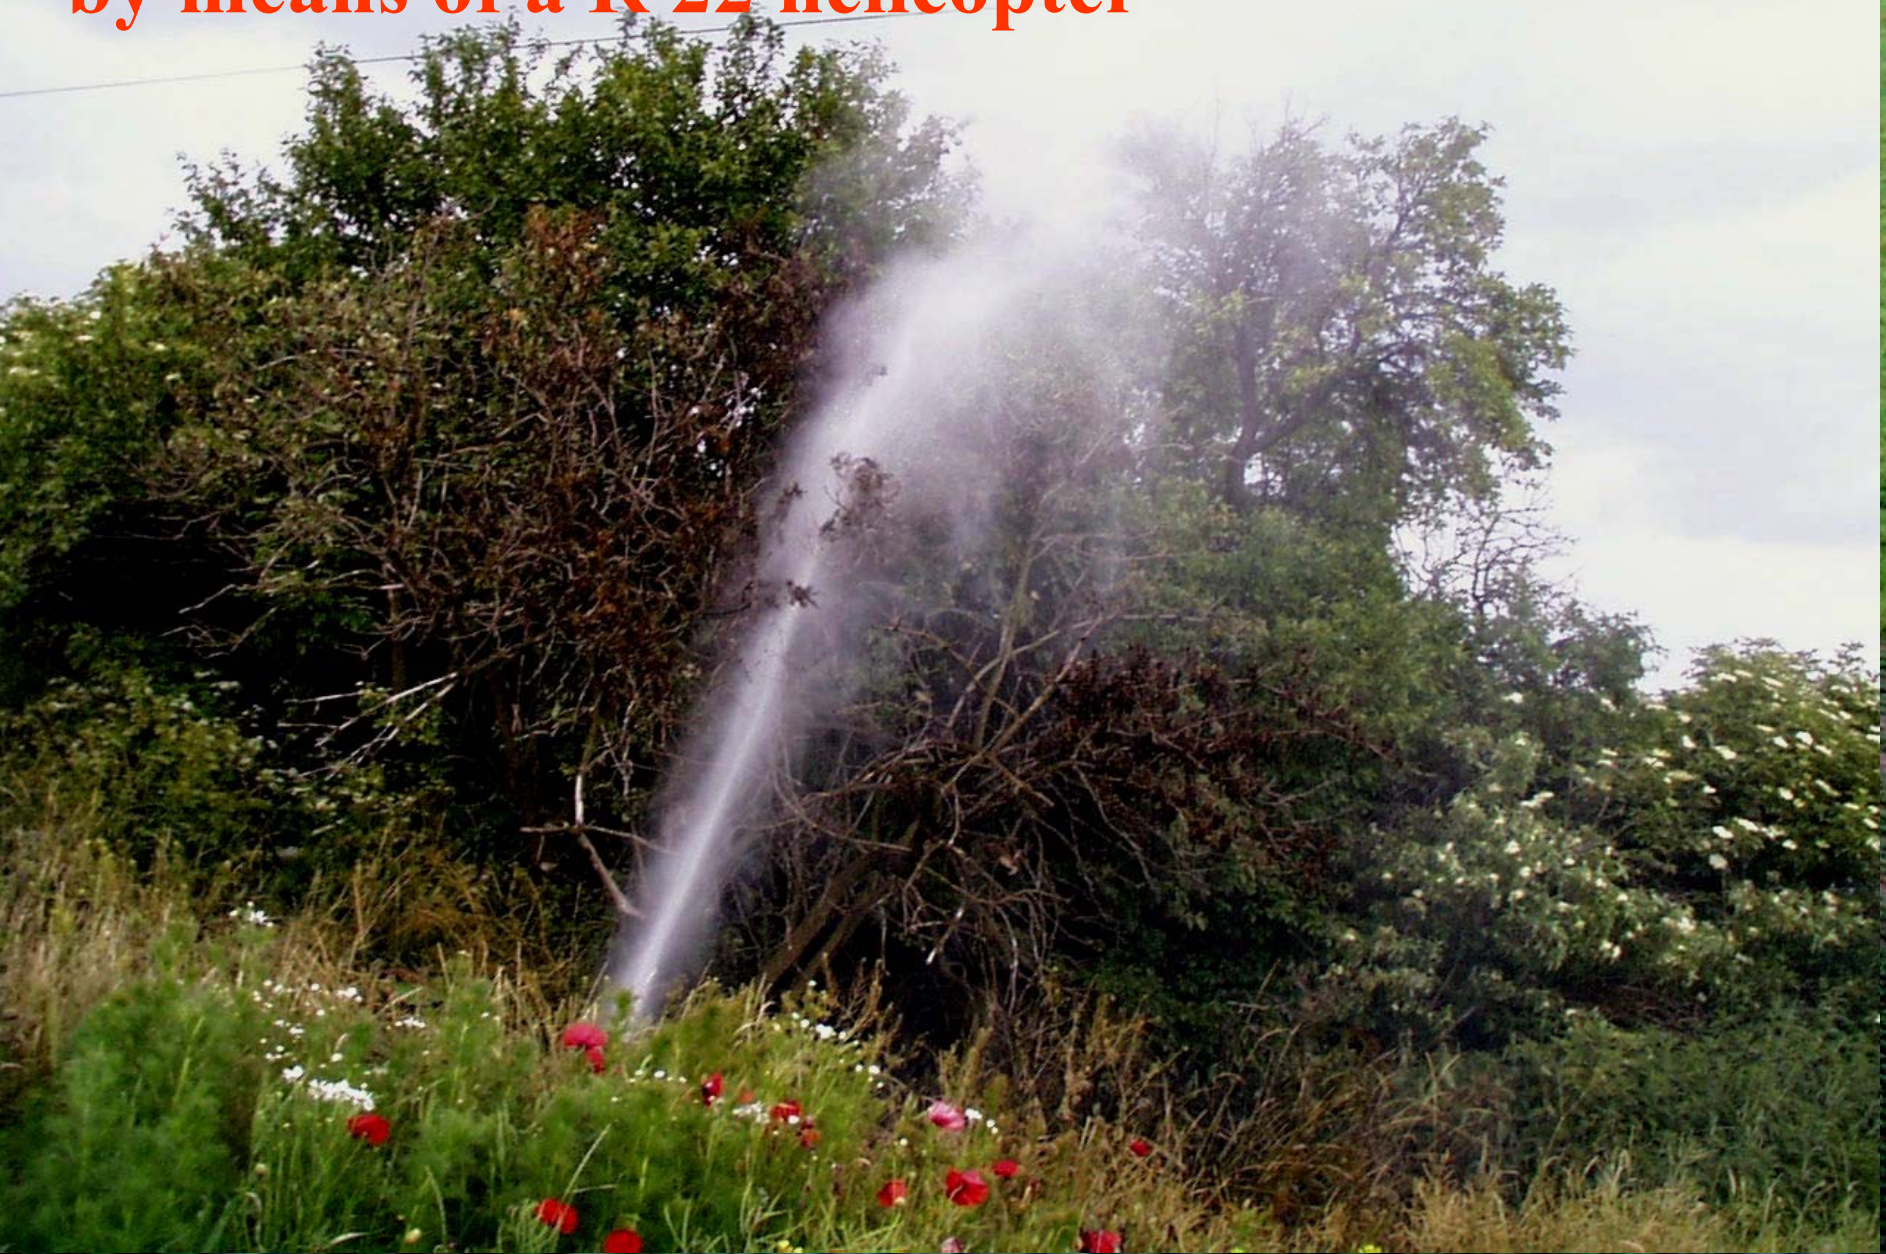
The aerial investigation - by means of a R 22 helicopter

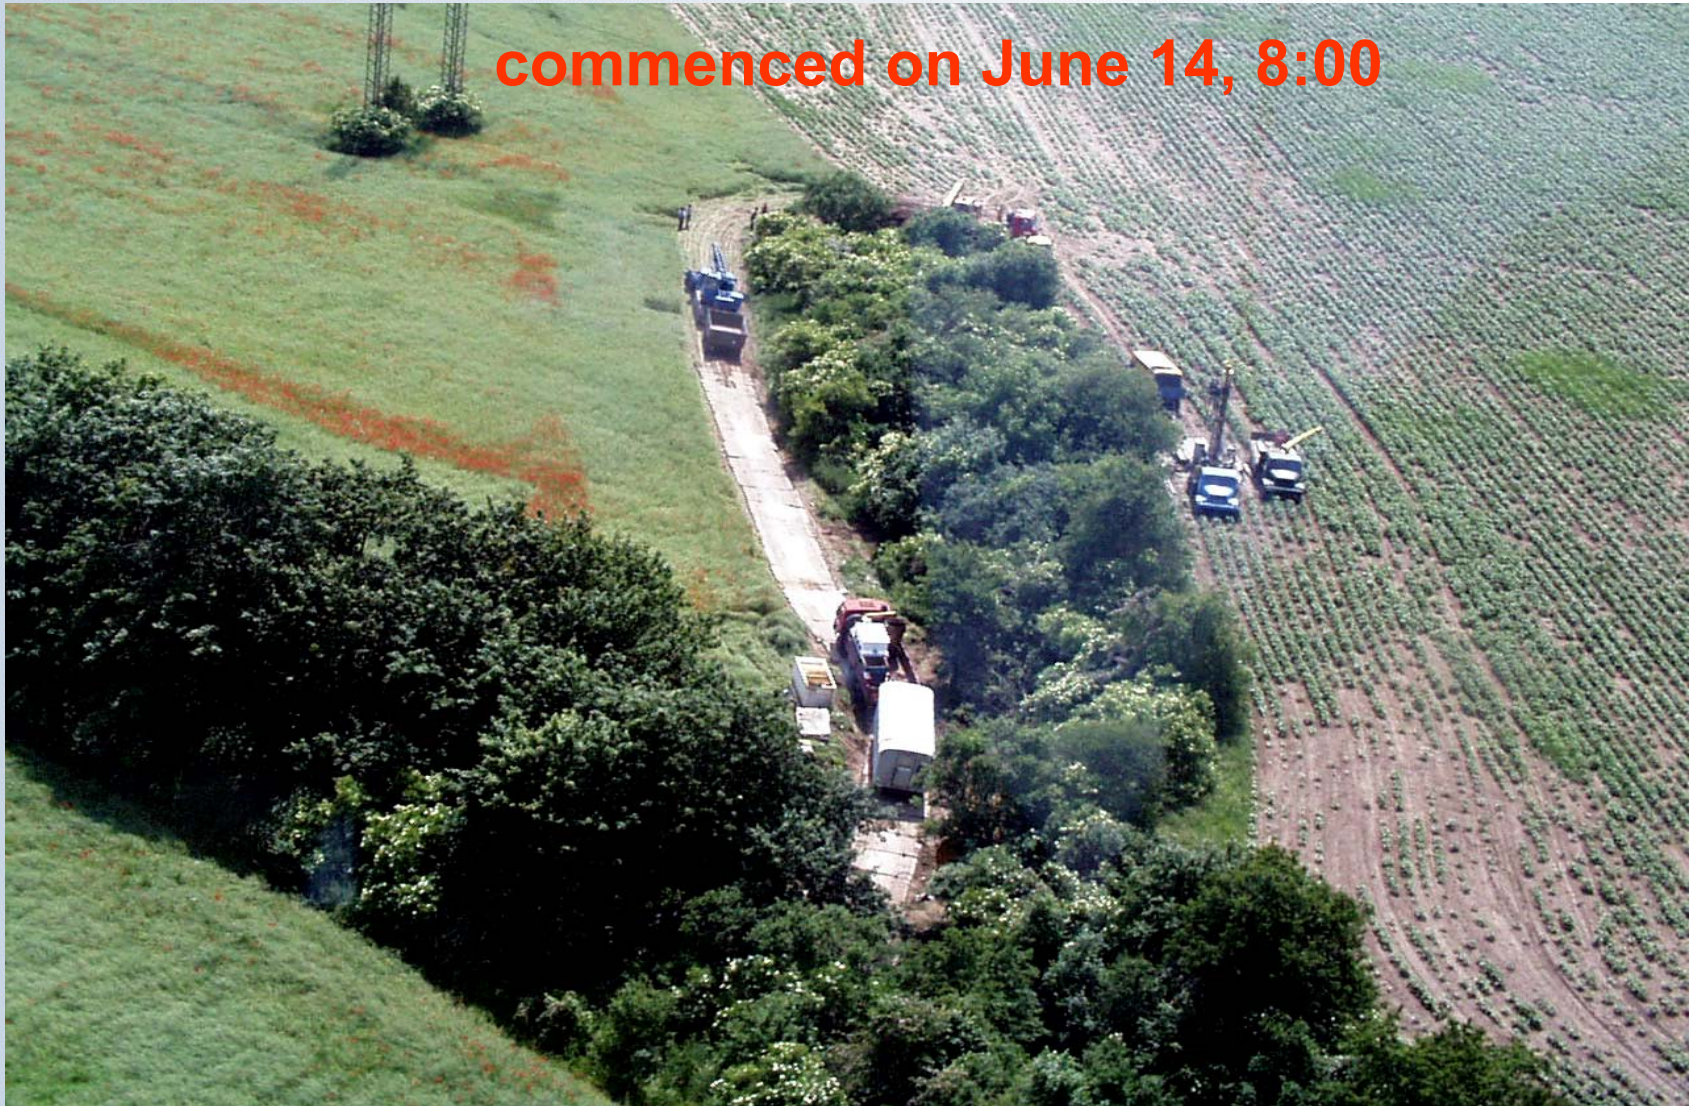
Primary investigation, soil excavation, risk assessment

commenced on June 14, 8:00

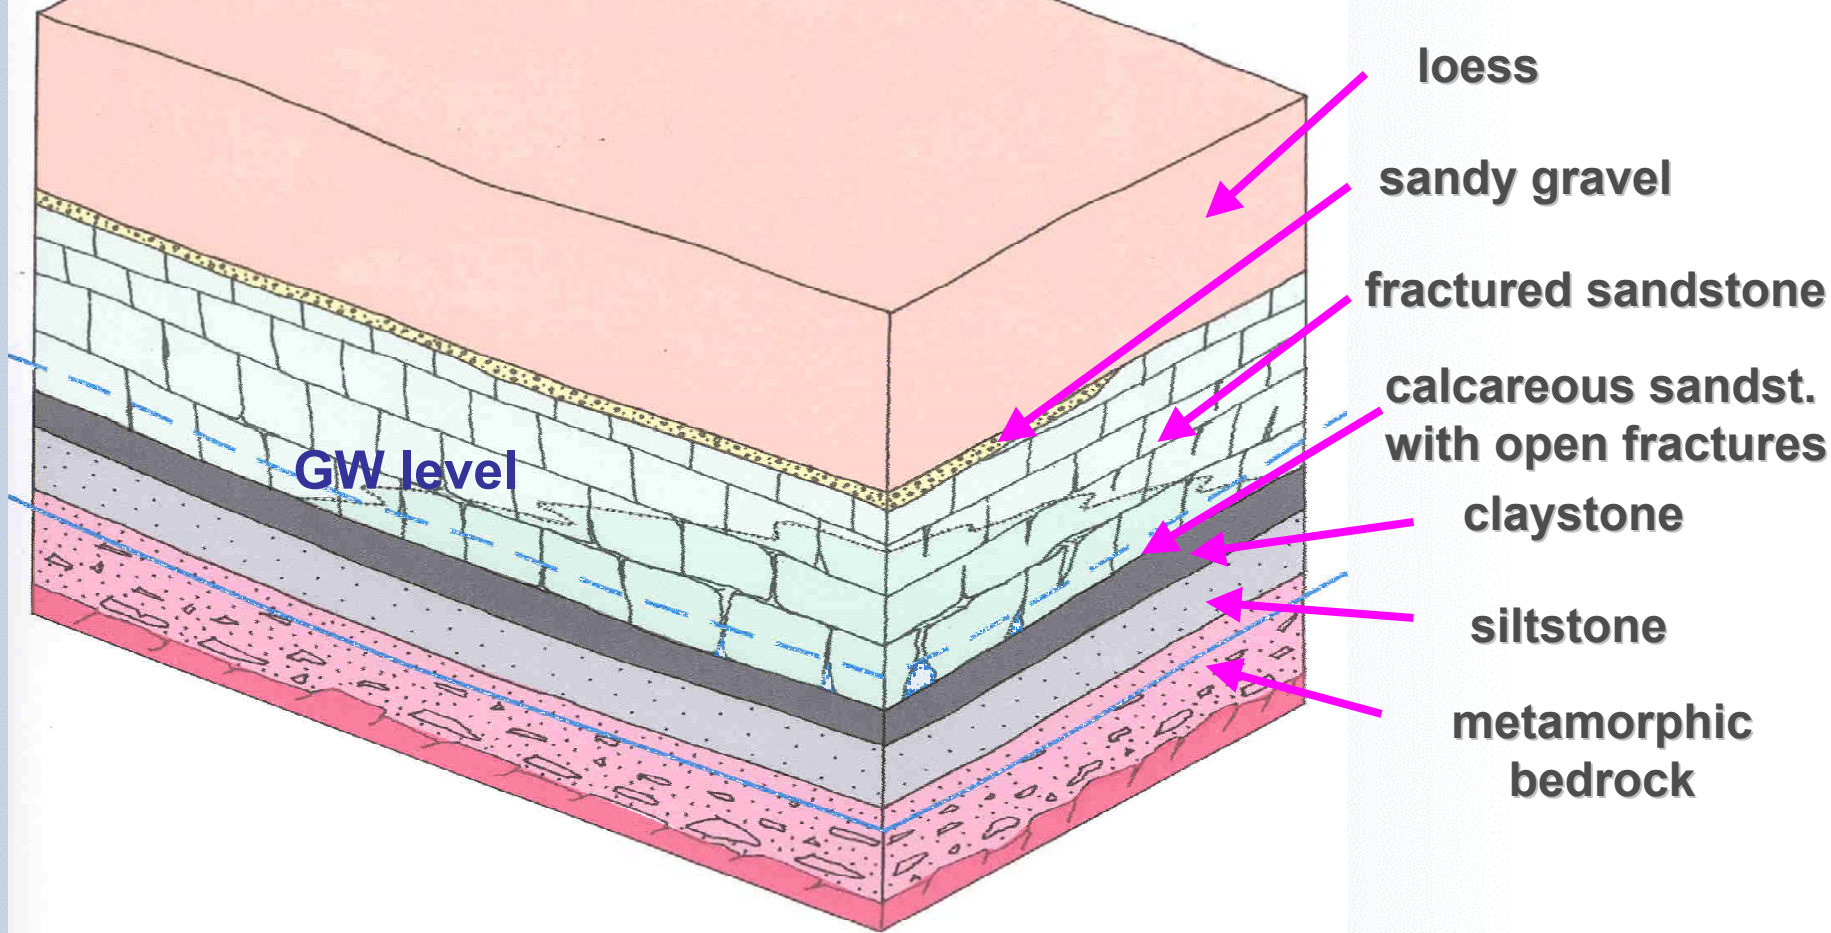
The impact of local geologic conditions

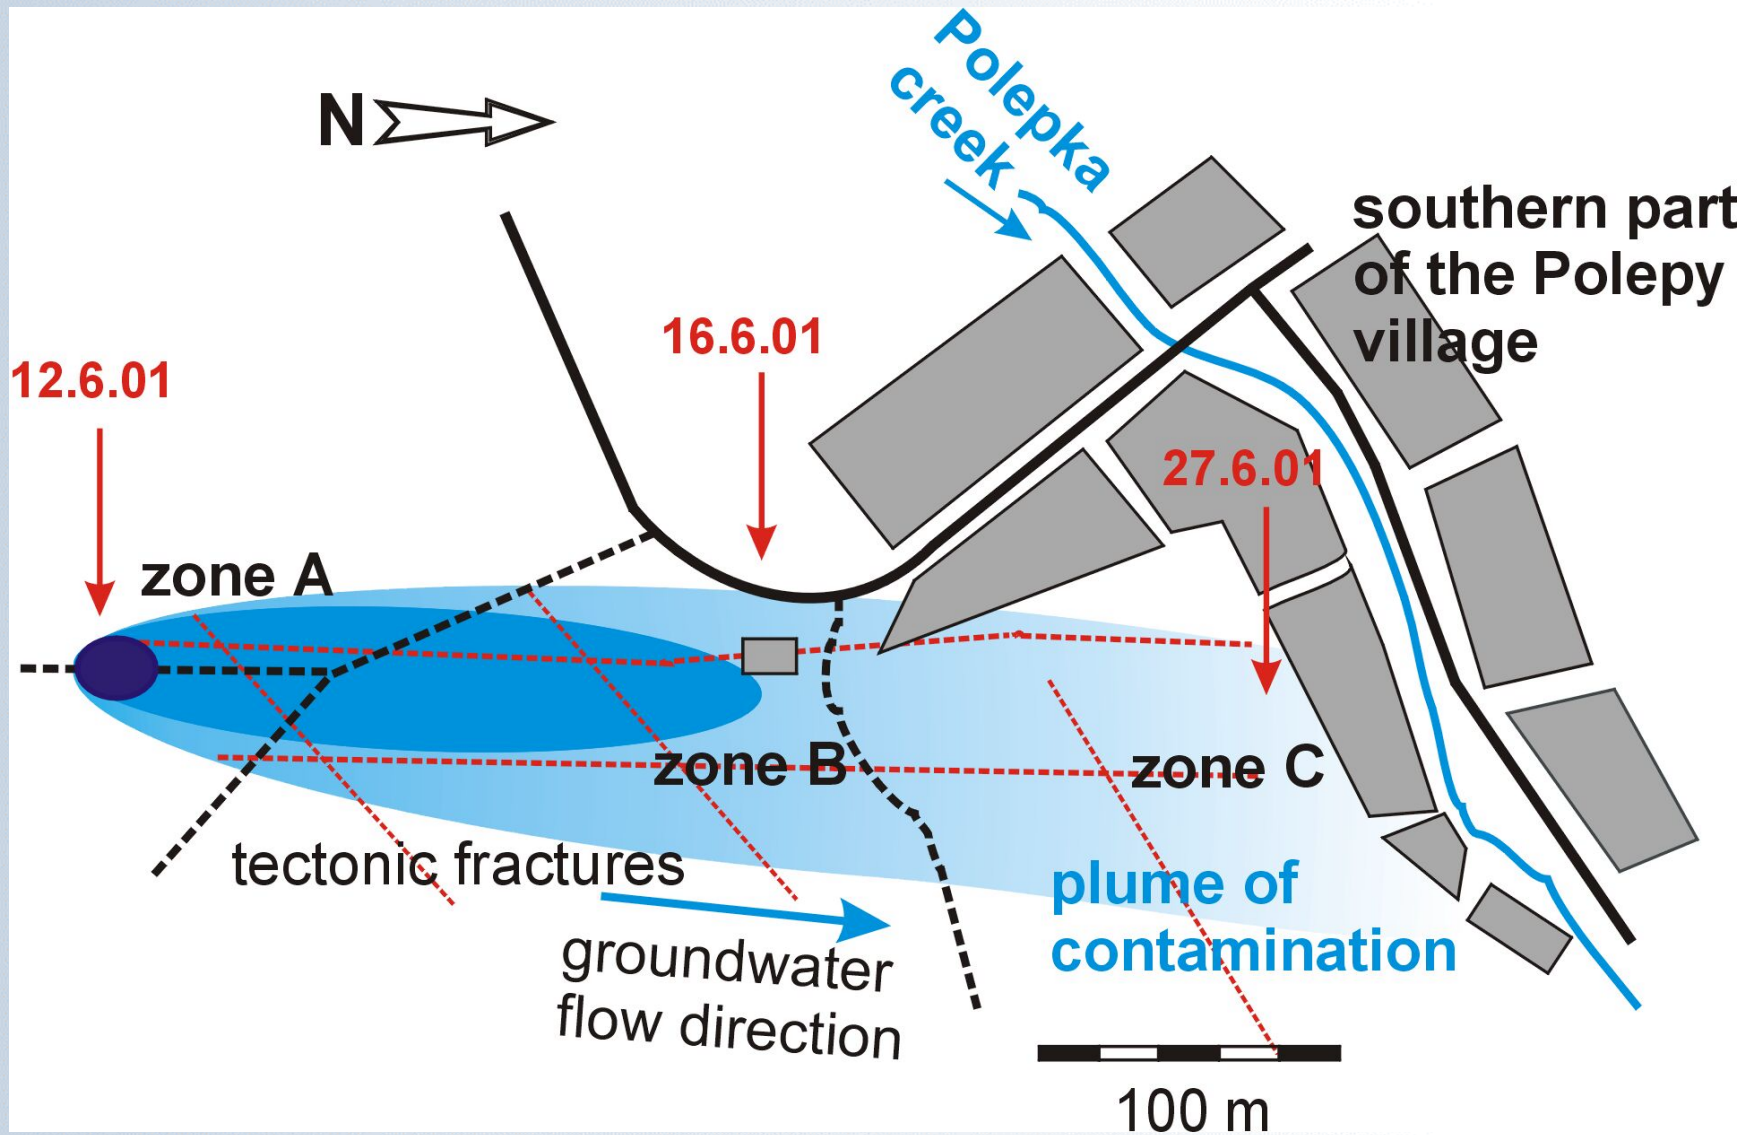
Forms of contaminant migration

- 1) As a **LNAPL** - at shallow groundwater level
- 2) As a **gasoline vapor** (soon recognized as the **most dangerous factor**)
- 3) Dissolved in the groundwater (particularly methyl tertiary butyl ether MTBE appeared to be very mobile component due to its high solubility)

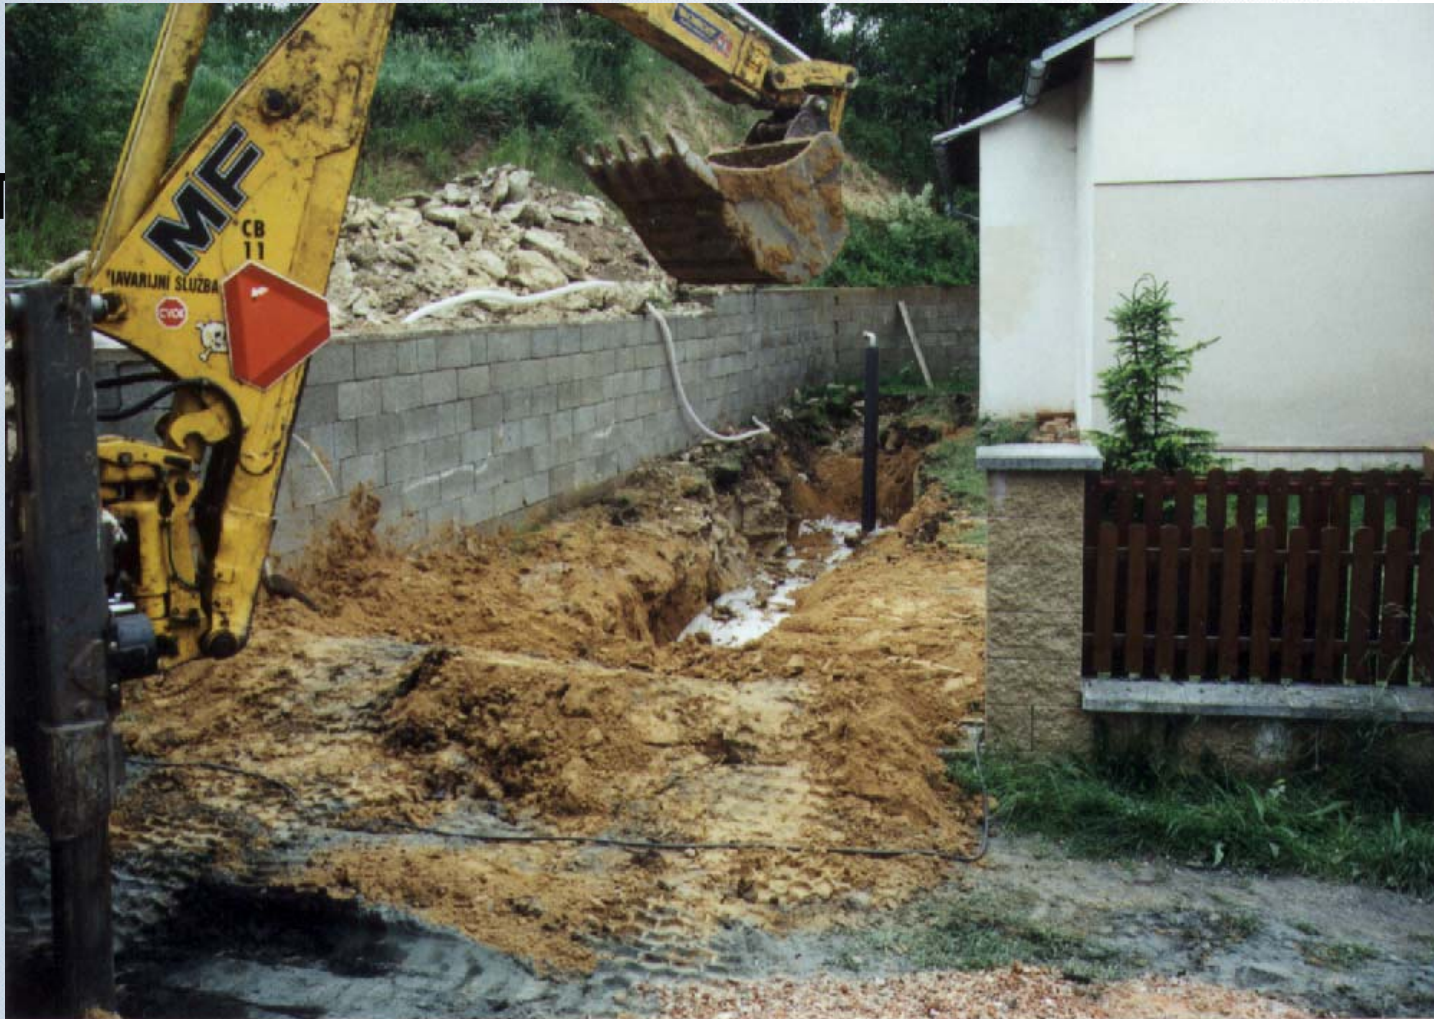
Buildings affected by gasoline vapor (4 days after)

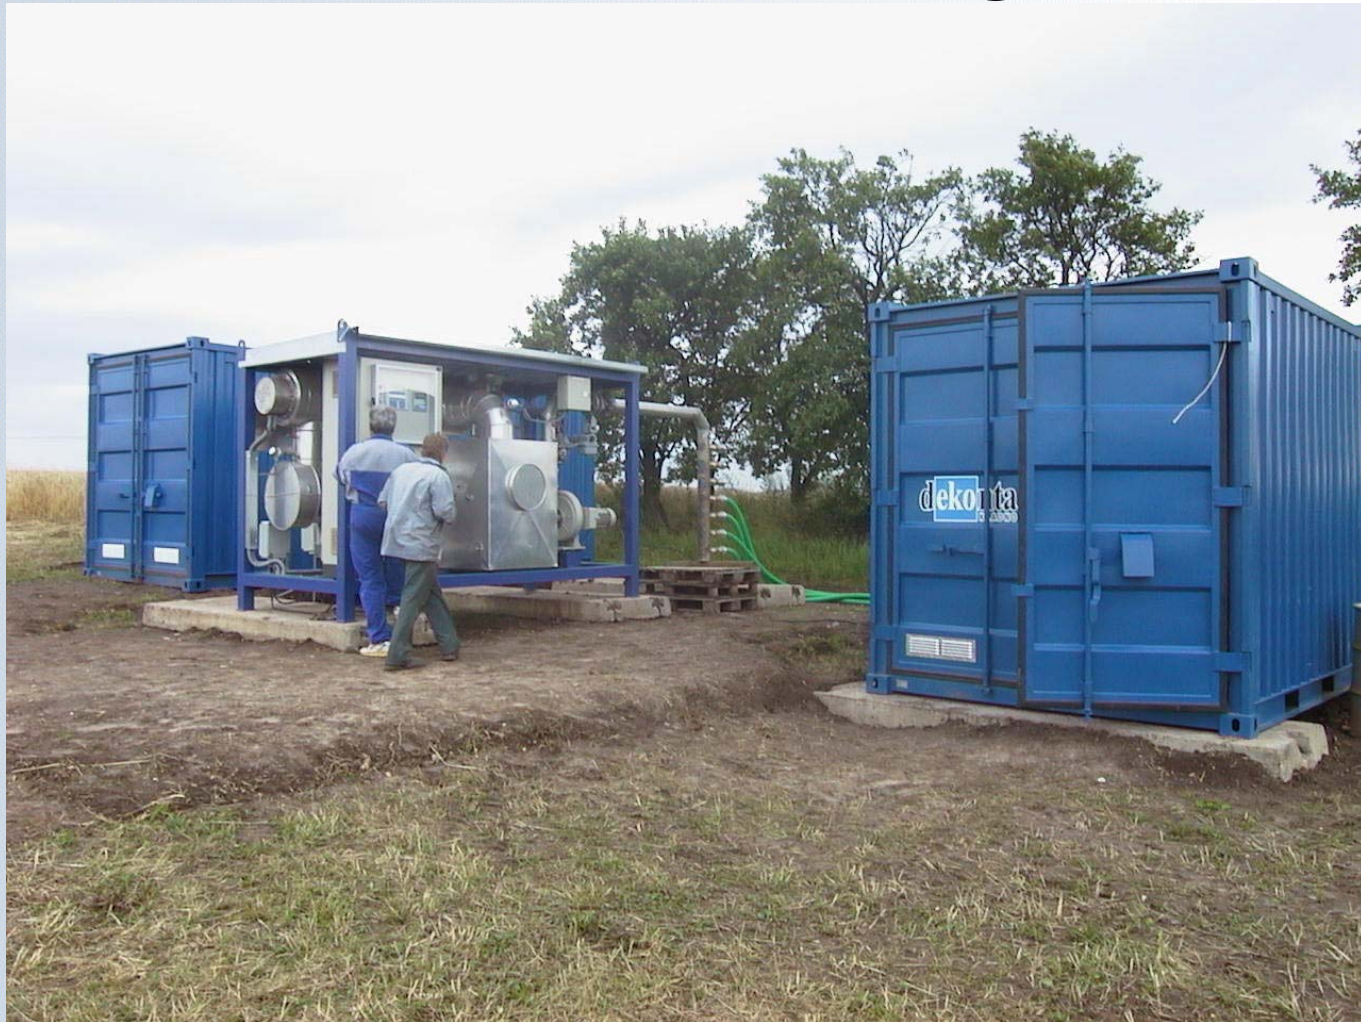
Catalytic incinerators for the remediation of soil gas

- Ex situ - contaminated soil excavation and treatment by means of biodegradation
- In situ - soil vapor extraction, using 59 venting boreholes and 2 catalytic incinerators

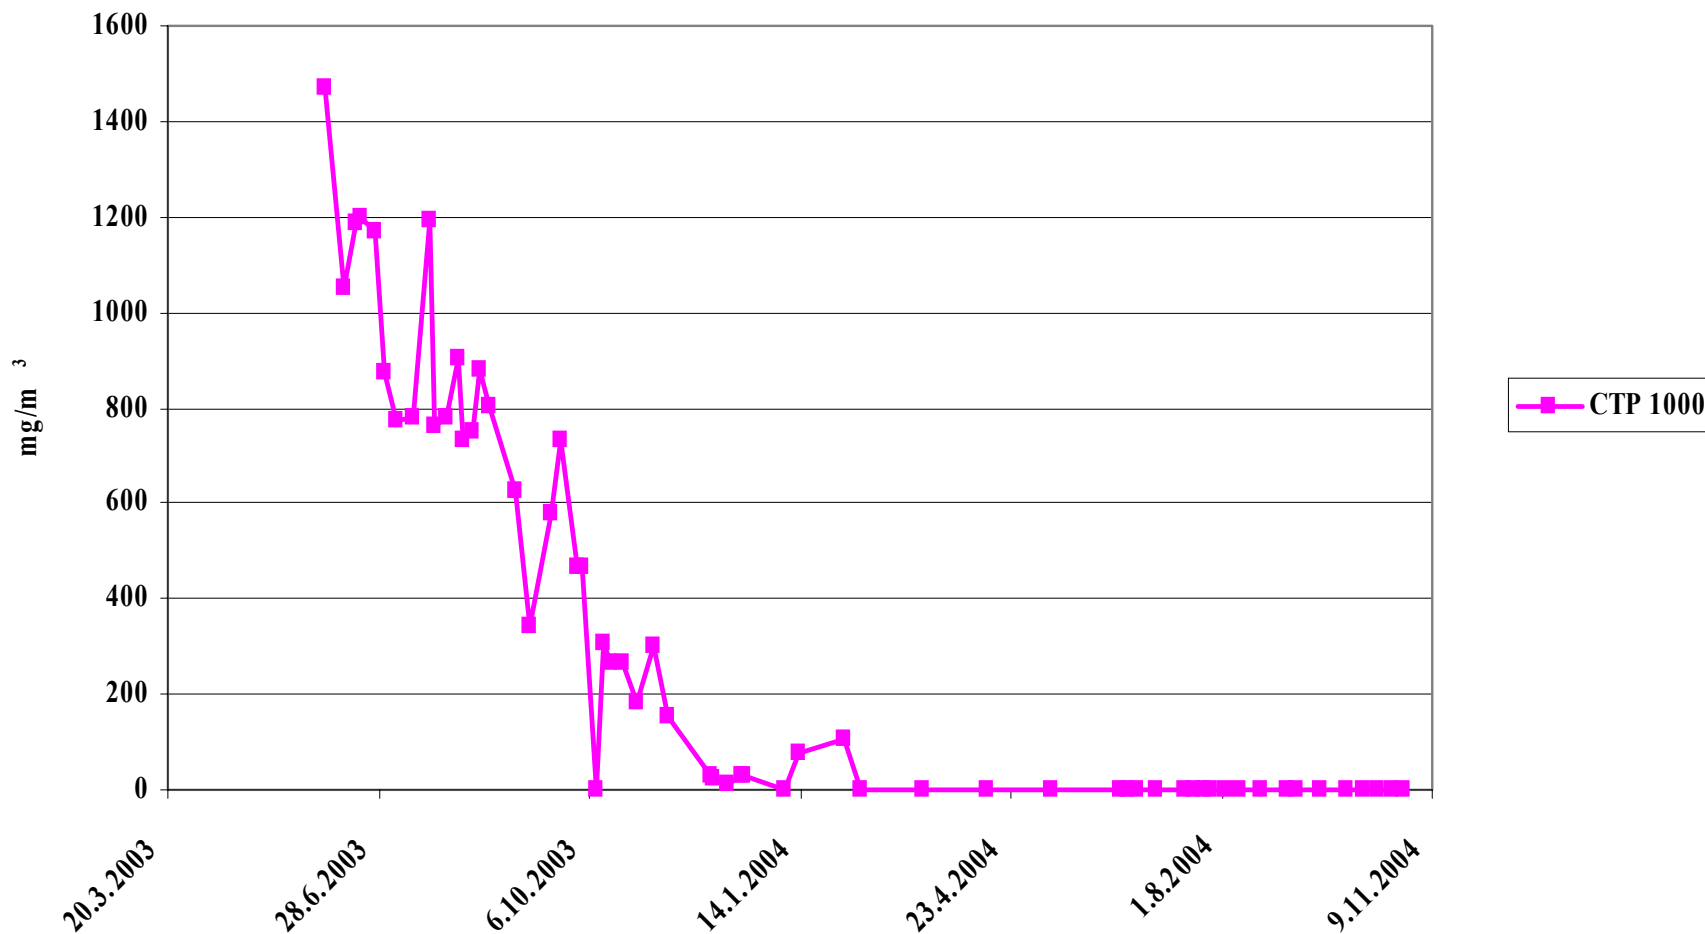
The concentration of petroleum hydrocarbons in the soil gas

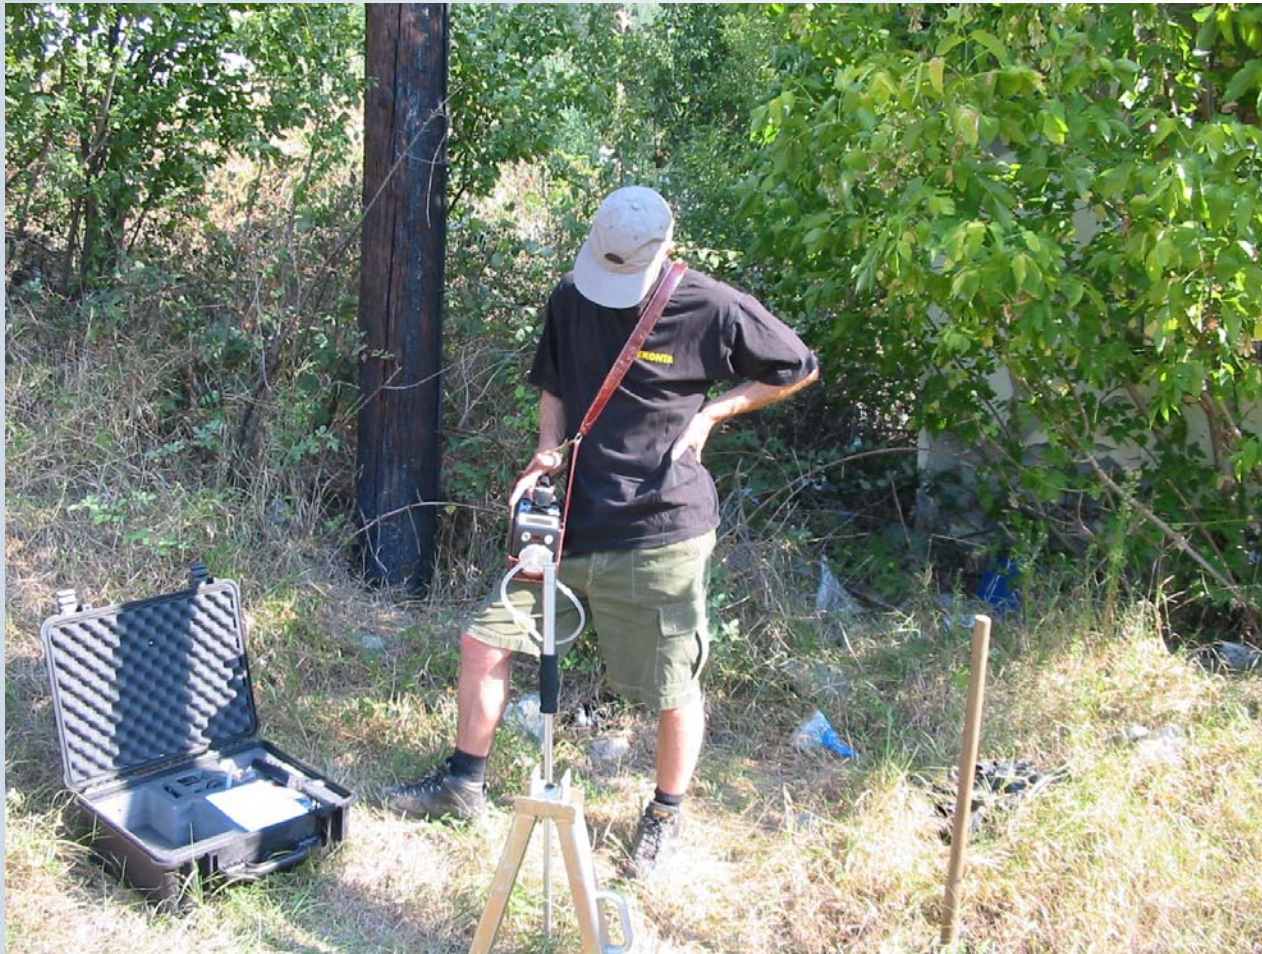
Atmogeoechemical measurements by ECOPROBE 5

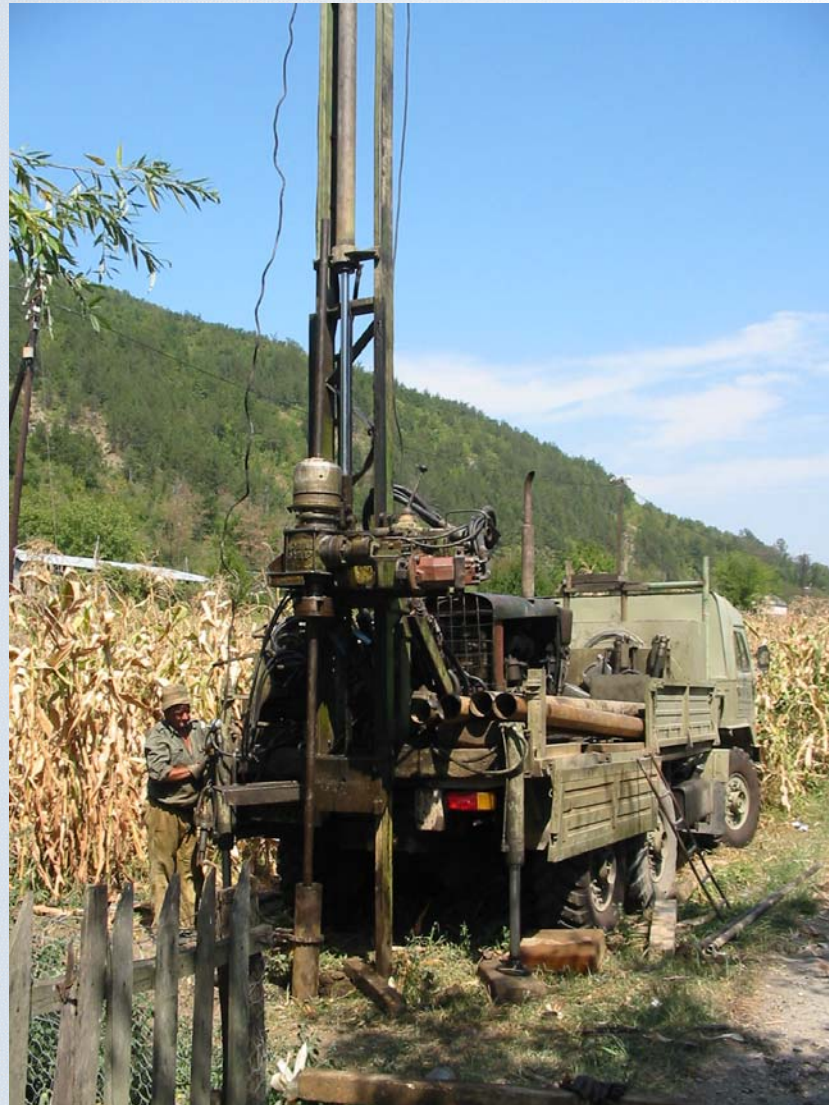
Drilling of monitoring wells

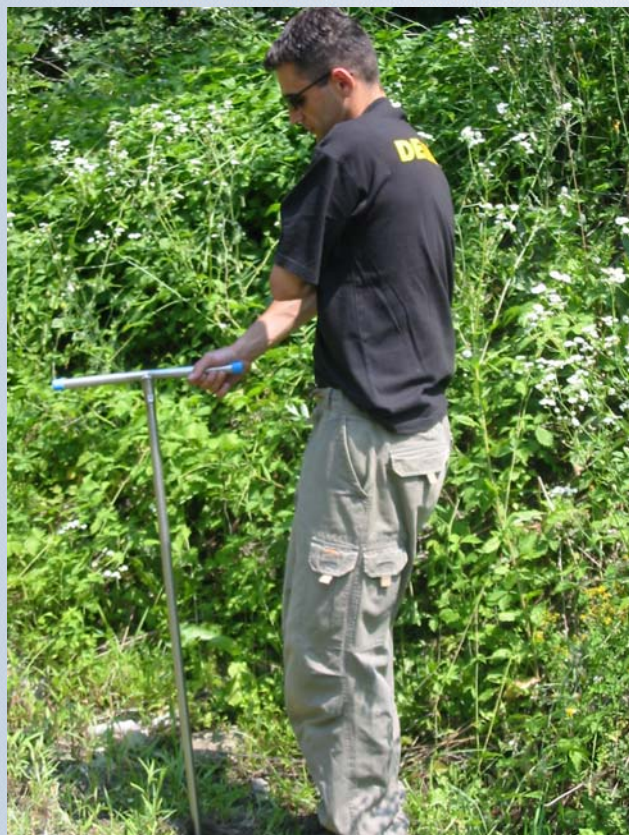
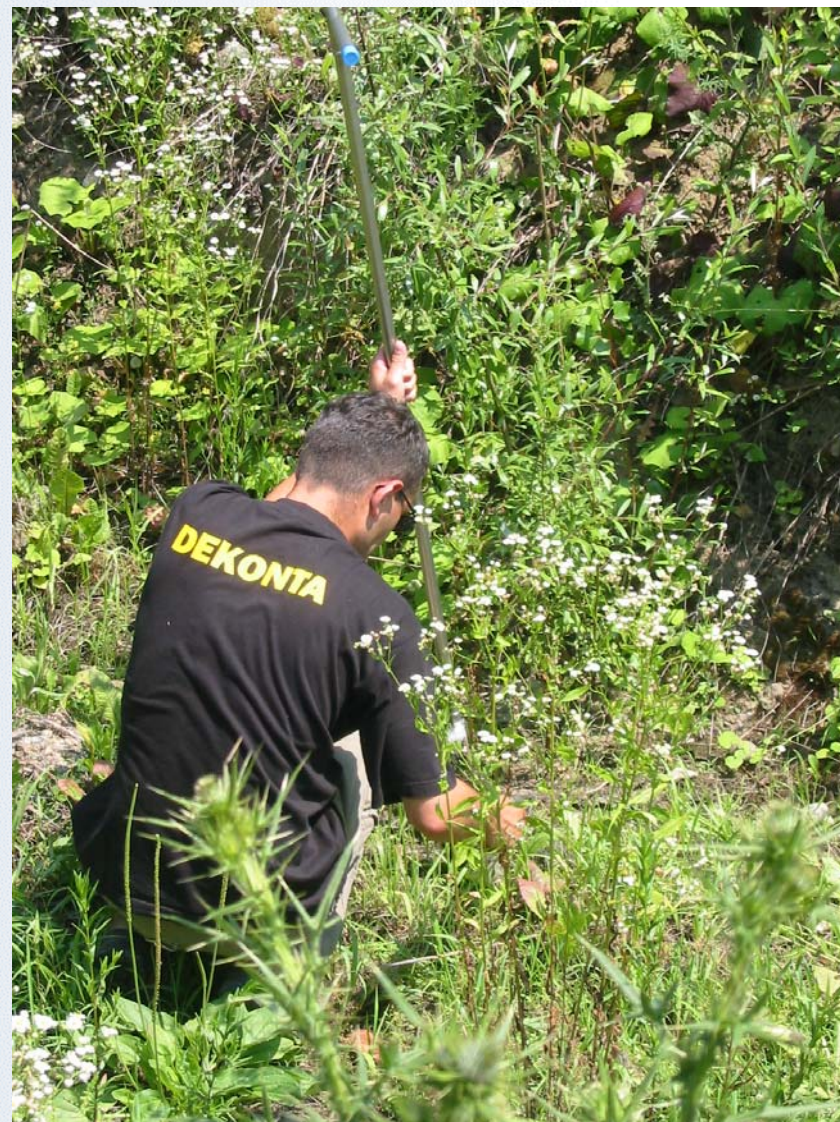
Soil probes

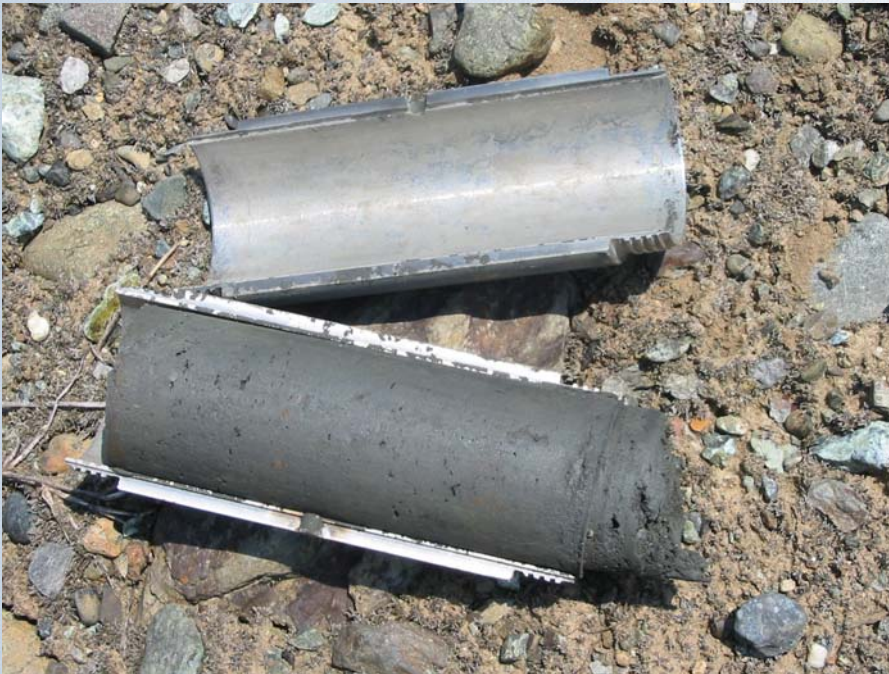
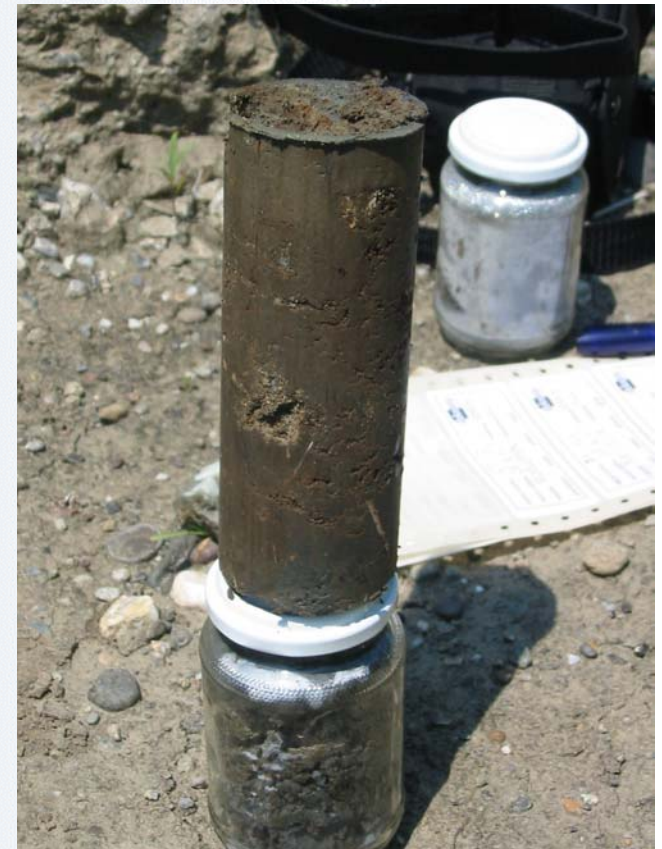
Results of the site investigation

- Max. concentration of TPH in soil:
 $5\,279,7 \text{ mg.kg}^{-1}$

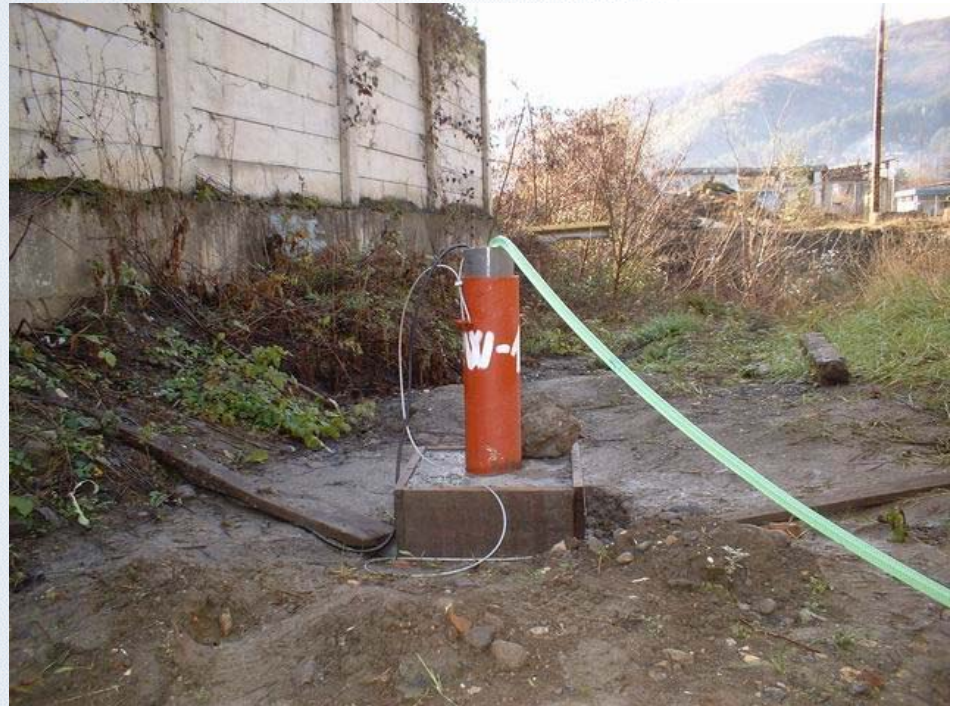
**Presence of free phase
on the groundwater table**

**Concentration of
benzene: 4 mg.L⁻¹**

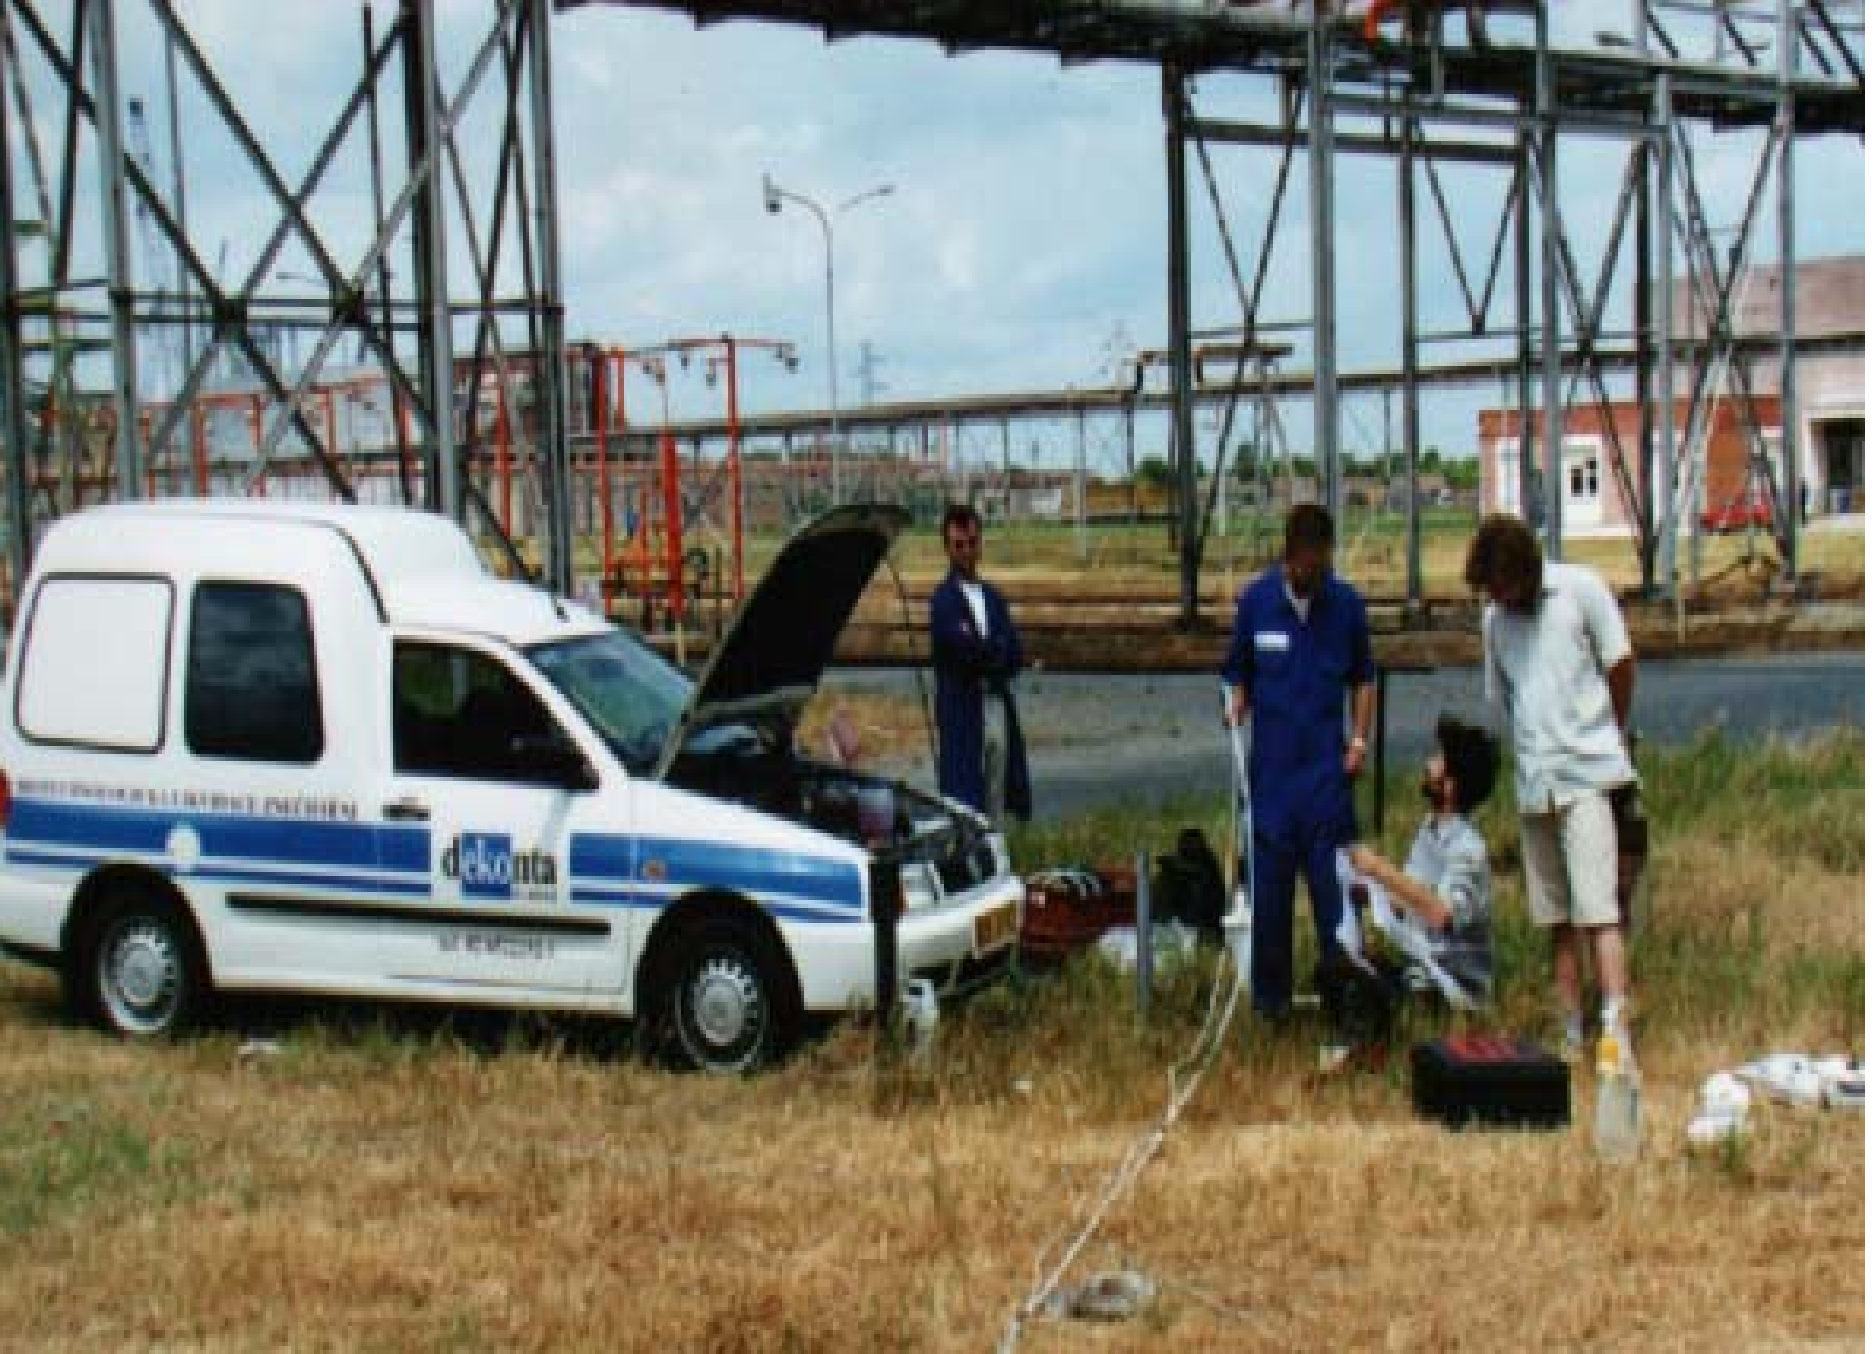
- ***DNAPL – Dense Nonaqueous Phase Liquid***
- **Start-up DNAPL extraction from the saturated zone ASAP (simple, cheap & effective)**
- **Reducing horizontal & vertical migration of DNAPL**
- **Maximising the total DCE extraction rate**
- **Step-by-step optimisation and expansion of the installed system**

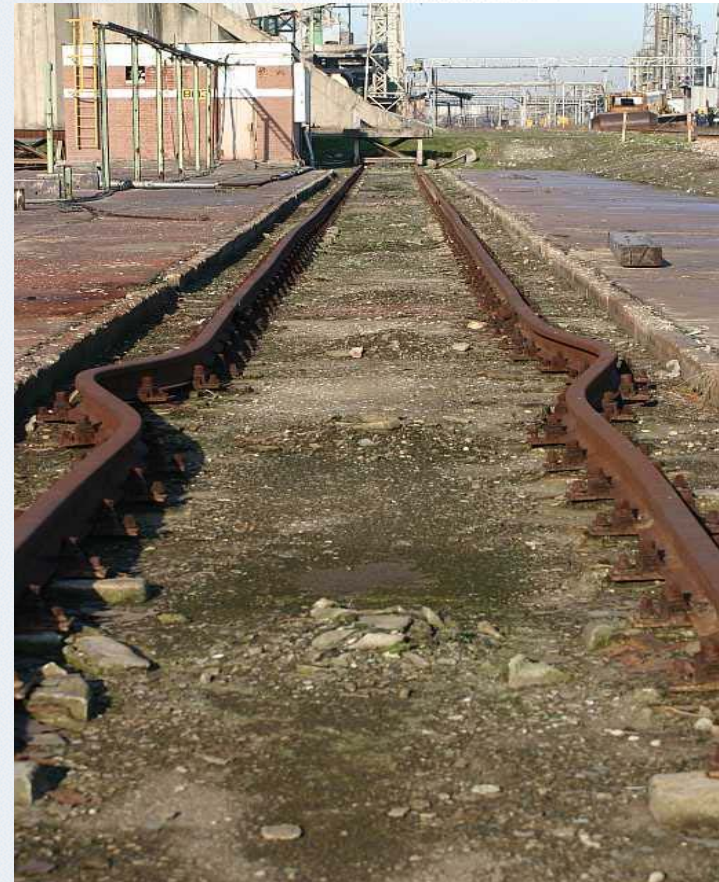
**421.7 t of DCE extracted from saturated zone
out of which:**

- **81.0 t as DNAPL**
- **340.7 t dissolved**

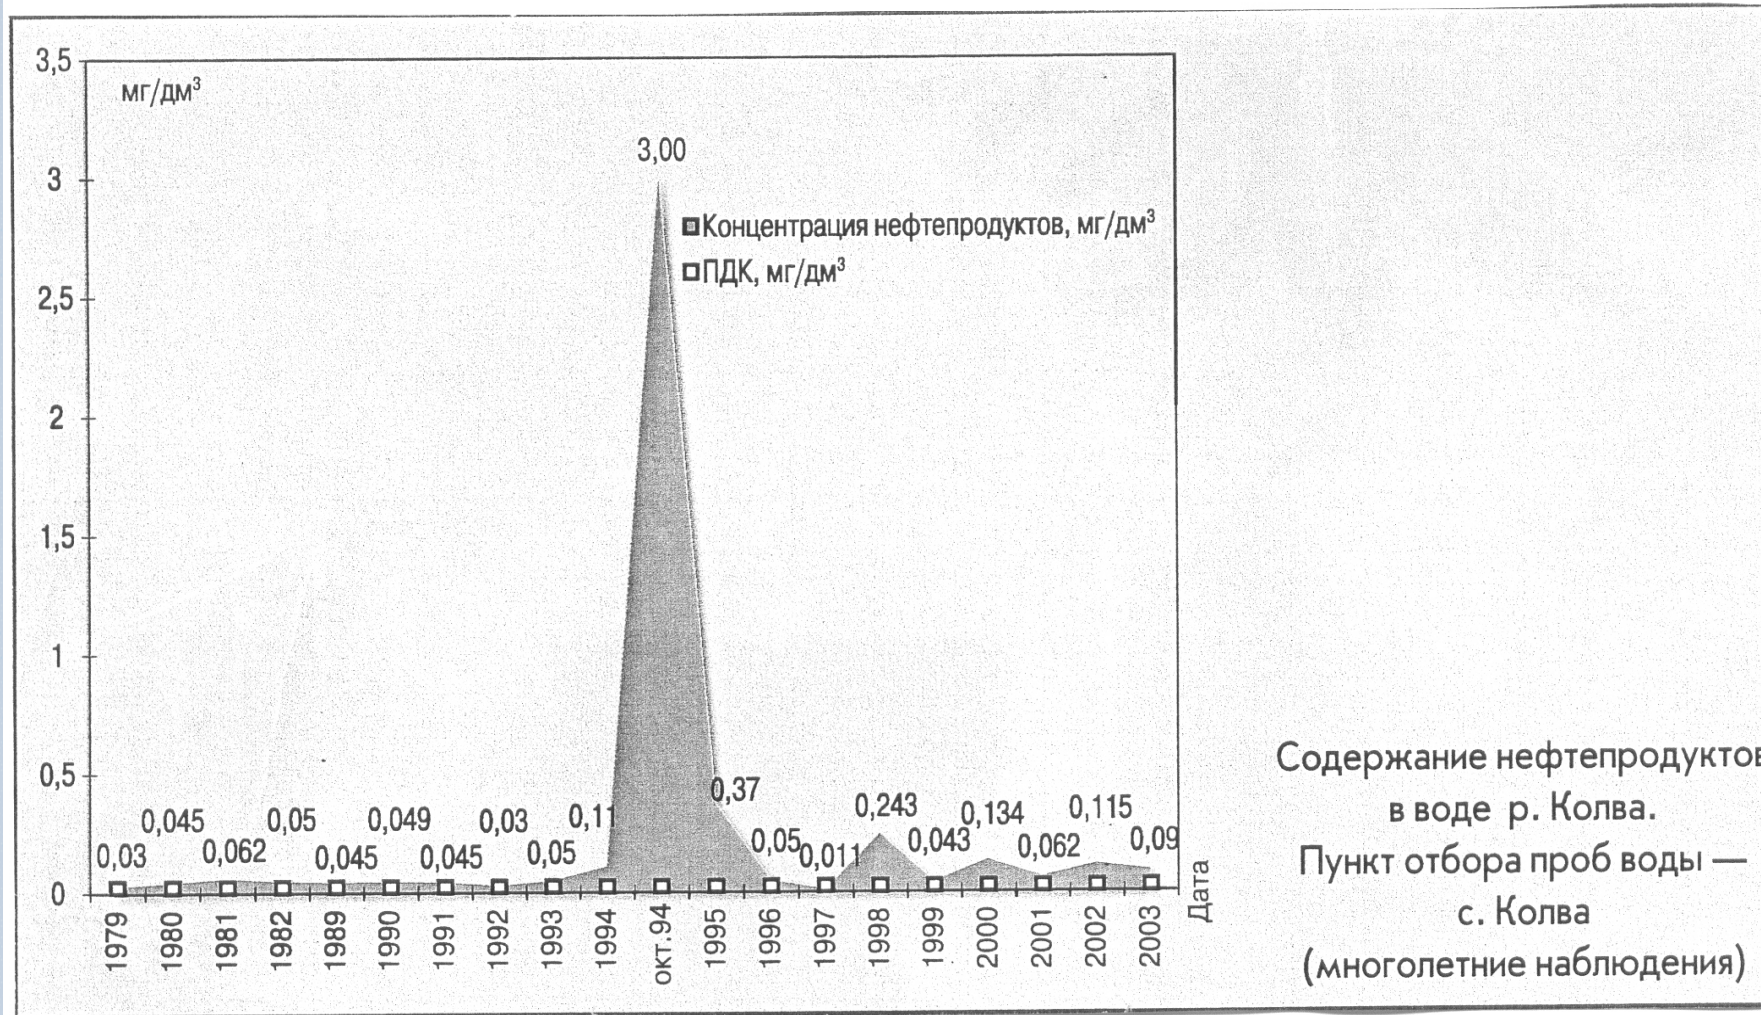
Contamination in 1994
