Presentation of main findings in report from:
**Norwegian Safety Investigation Authority (NSIA) related
to a high-speed frontal road-collision (GRSP-69-02)**

UNECE/GRSP-69/May 2021

*REPORT ON A HEAD-ON COLLISION
BETWEEN A PASSENGER CAR AND A
VAN ON THE E39 AT AUSTEFJORDEN,
VOLD, MØRE OG ROMSDAL ON
20 OCTOBER 2019*

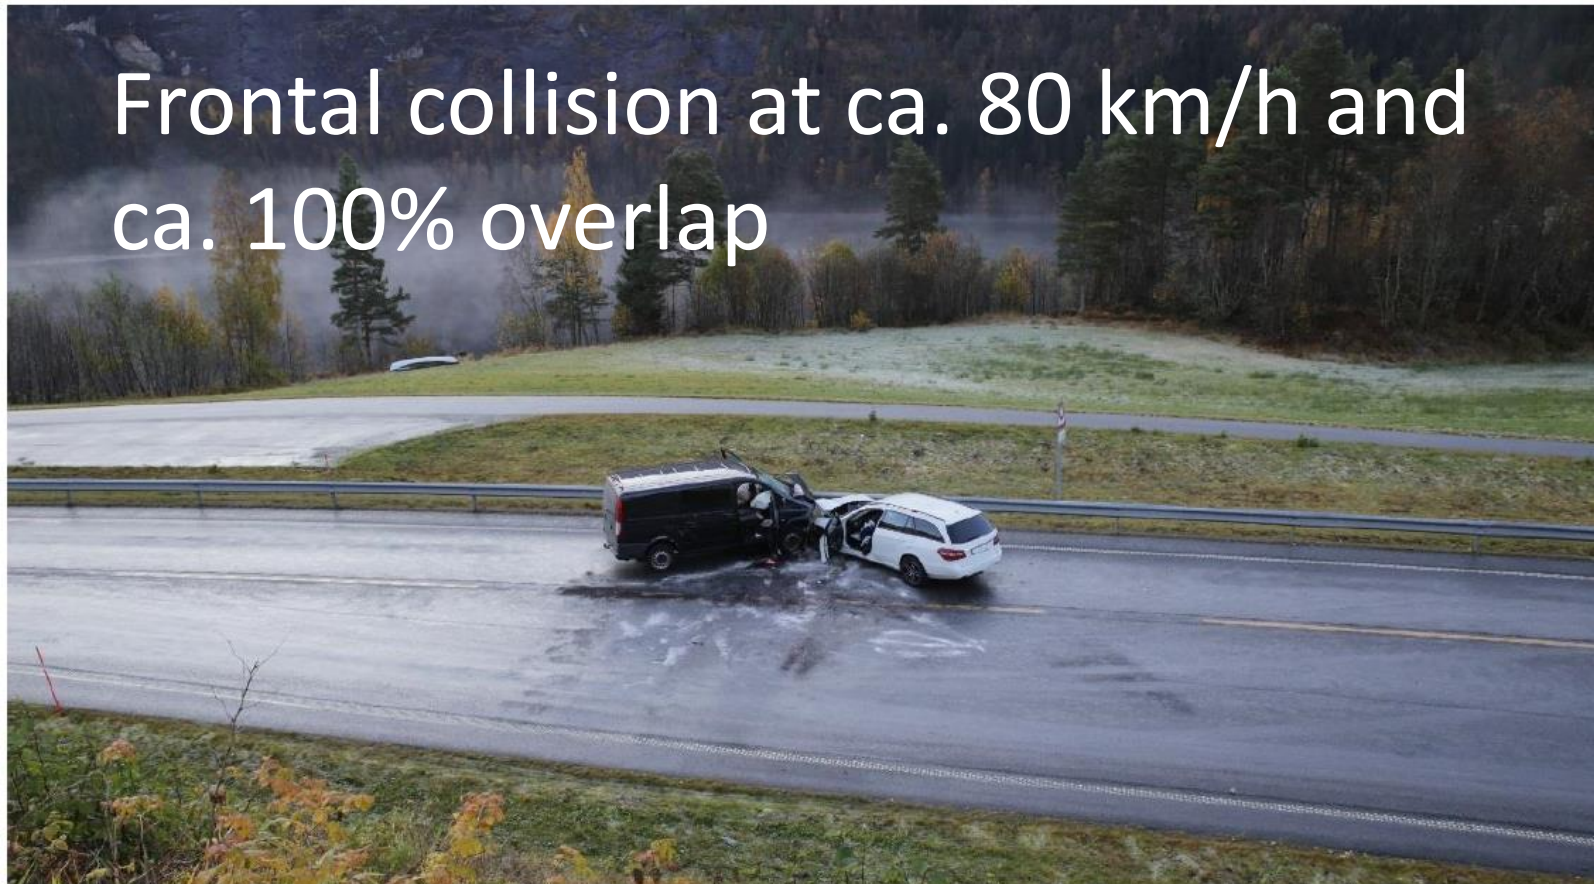
*Figure 2: Final positions - northbound van and southbound passenger car photographed at 11:48.
Photo: The police*

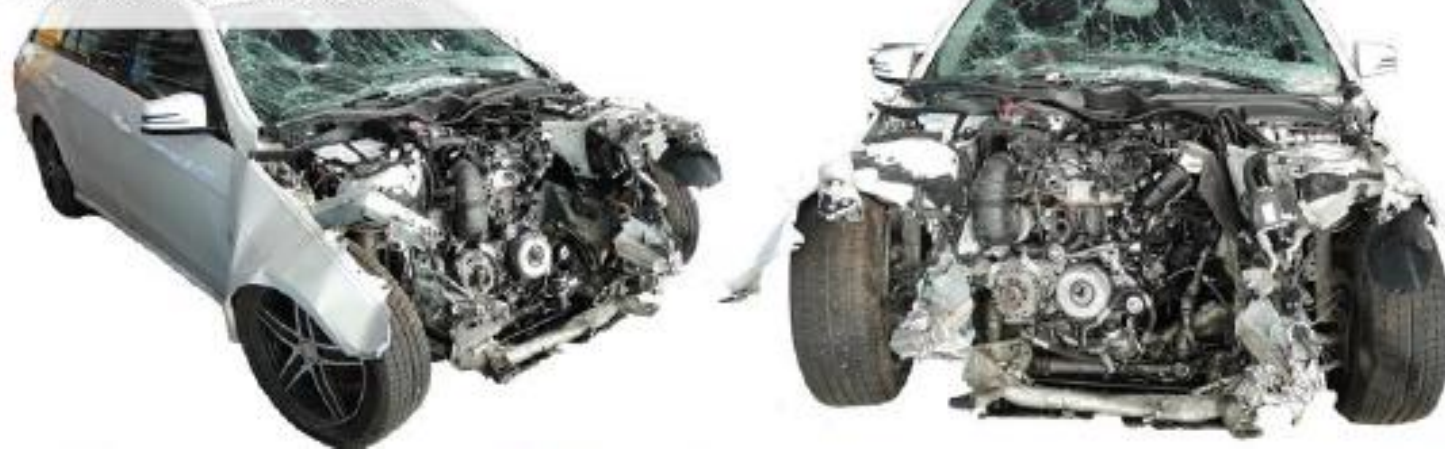
External deformations

Passenger car

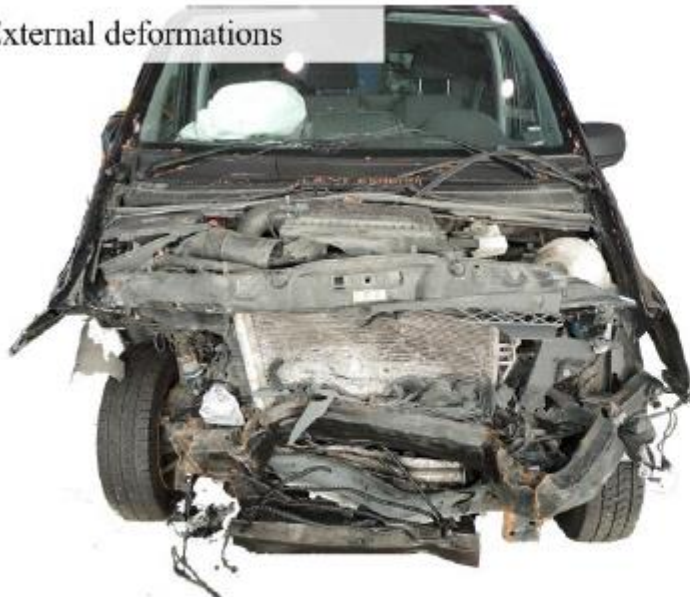
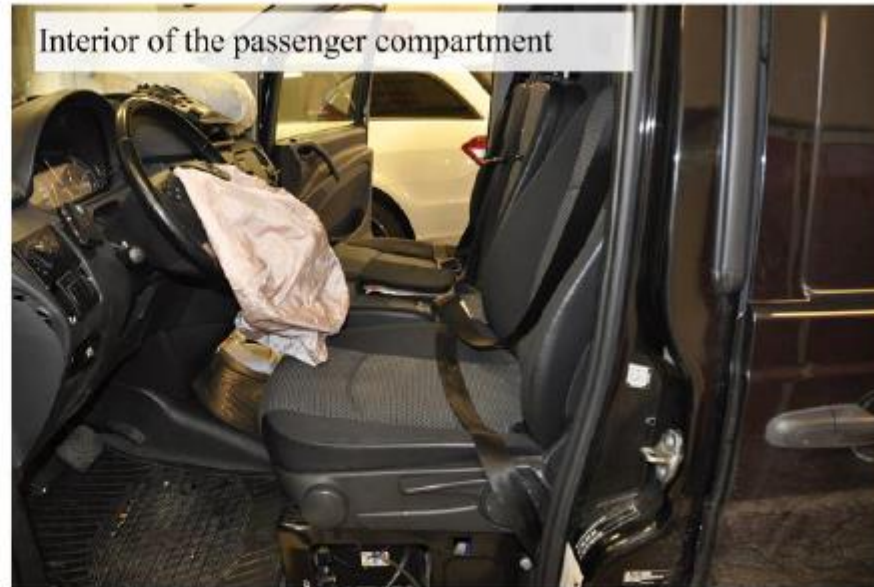
External deformations

Van

Interior of the passenger compartment

*Figure 5: External deformations on the van and the interior of the passenger compartment.
Illustration/photo: NSIA*

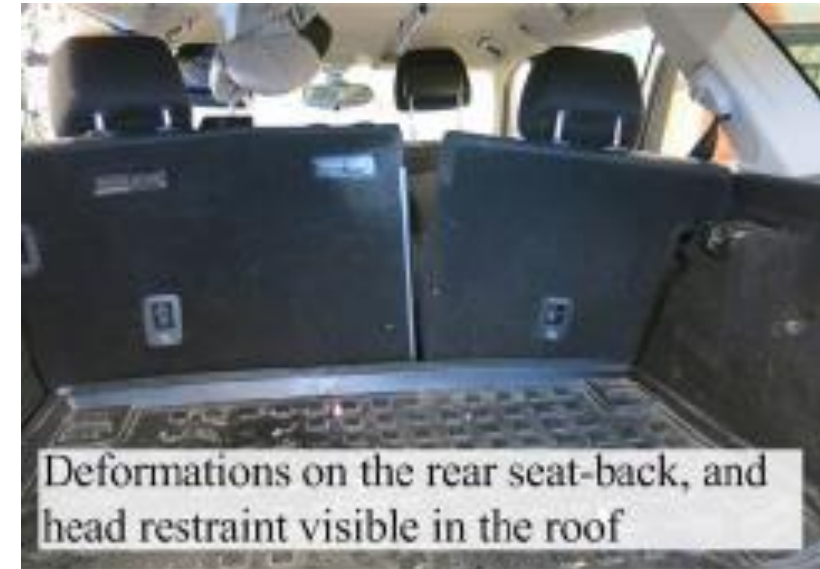
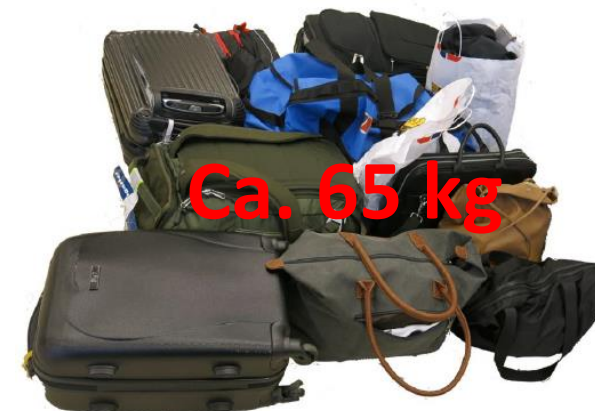
Focus on rear seat back with integrated belt-system

Figure 8: Luggage that was placed in the estate car's boot. Photo: NSIA

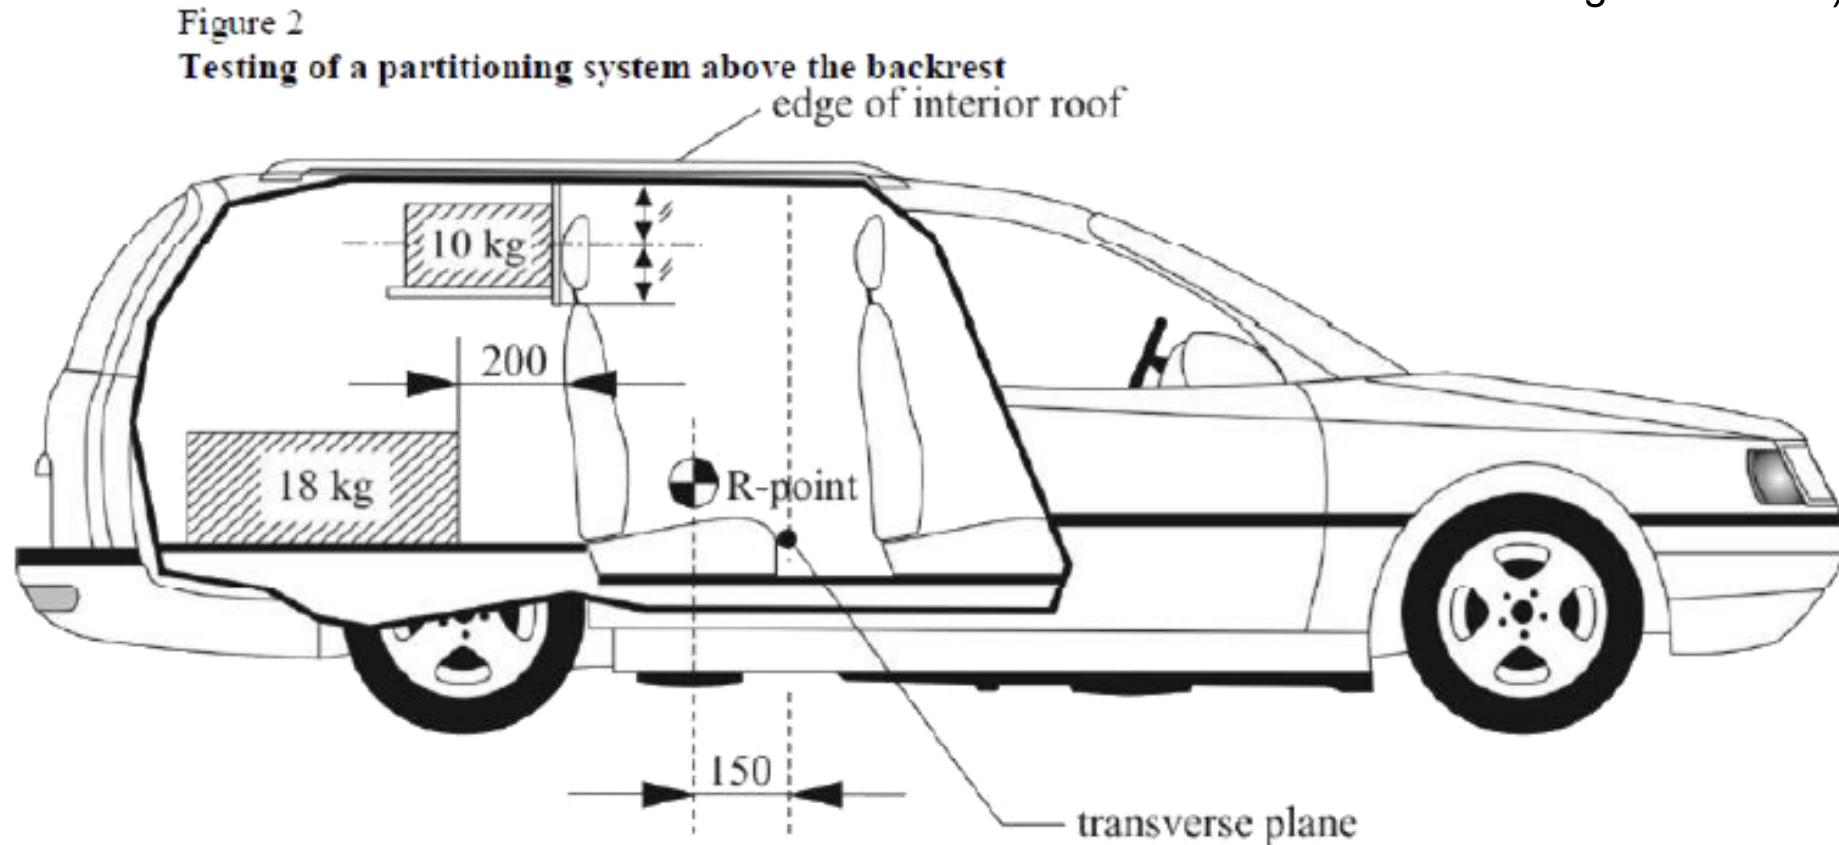
Figure 19: Test of seat-back with 2 x 18 kg luggage and 10 kg against the head restraint in a sled test at 50 km/h. The minimum requirement for forward deformation of the seat-back is described below. Source: UN-ECE R17

- Increase the test-mass (90 kg luggage proposed in 2003 by ANEC)
- Reduce allowed post-test deformation (100 mm/150mm)
- Add crash-test dummy(ies) in the seat during dynamic-test (without measurement)

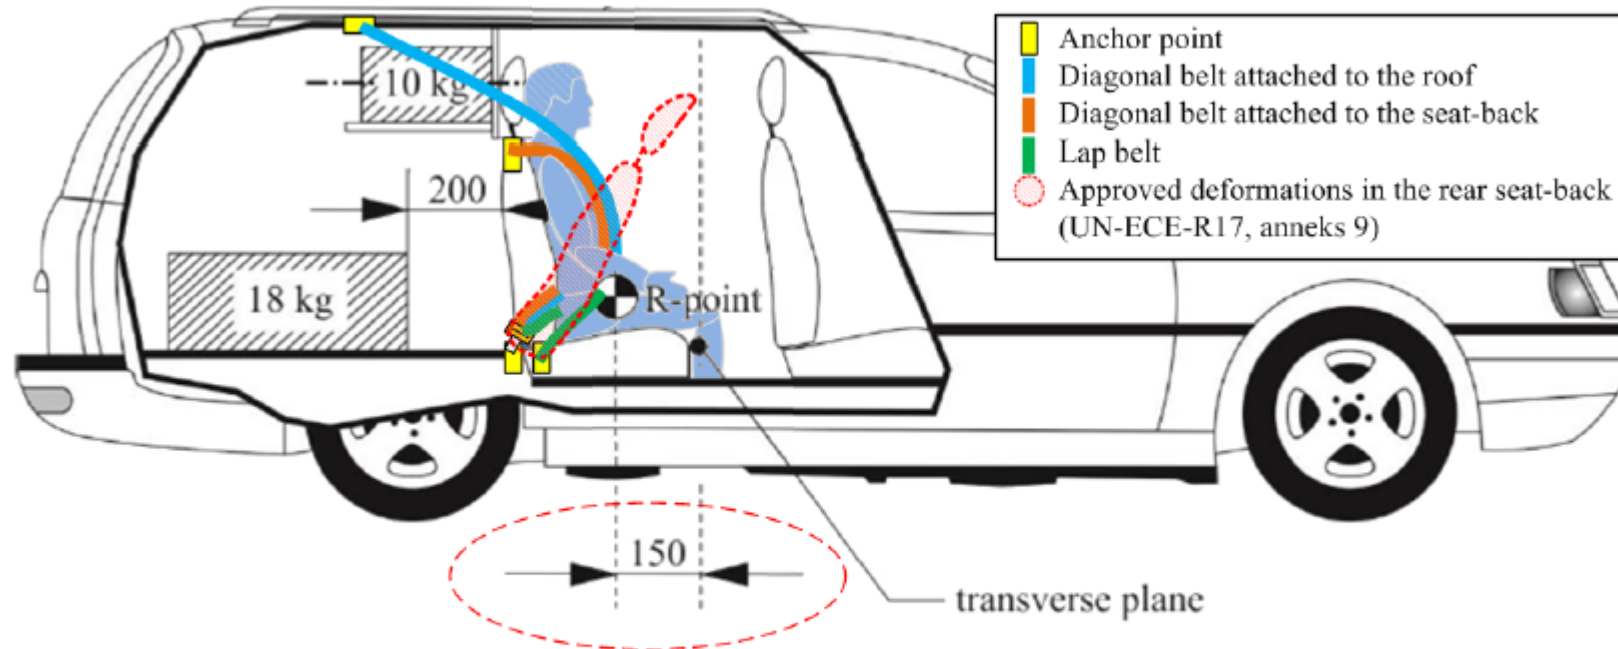
Figure 25: Strength requirements for rear seat-backs - showing middle rear passenger and seat belts with alternative shoulder belt anchorages. (Note: R-point is determined by the car manufacturer and will vary). Illustration: NSIA
