Lessons learnt from the tailings dam failure at Kolontar,
Hungary, in 2010

Péter Kovács

Ministry of Interior of Hungary

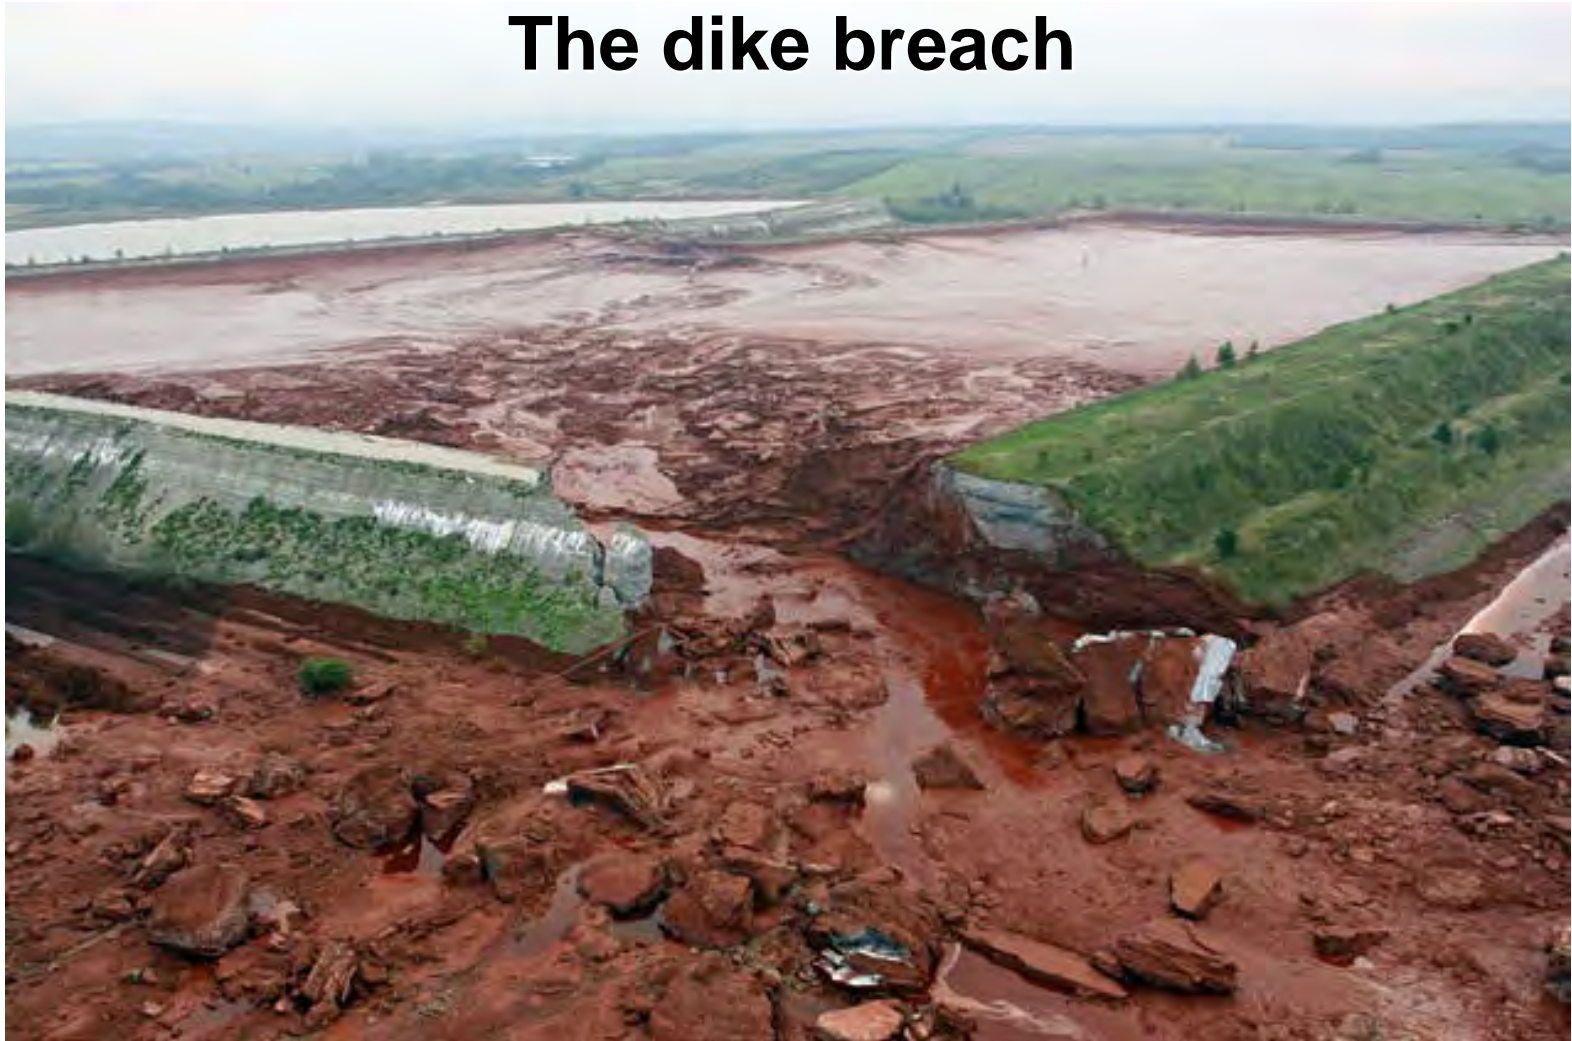
The dike breach

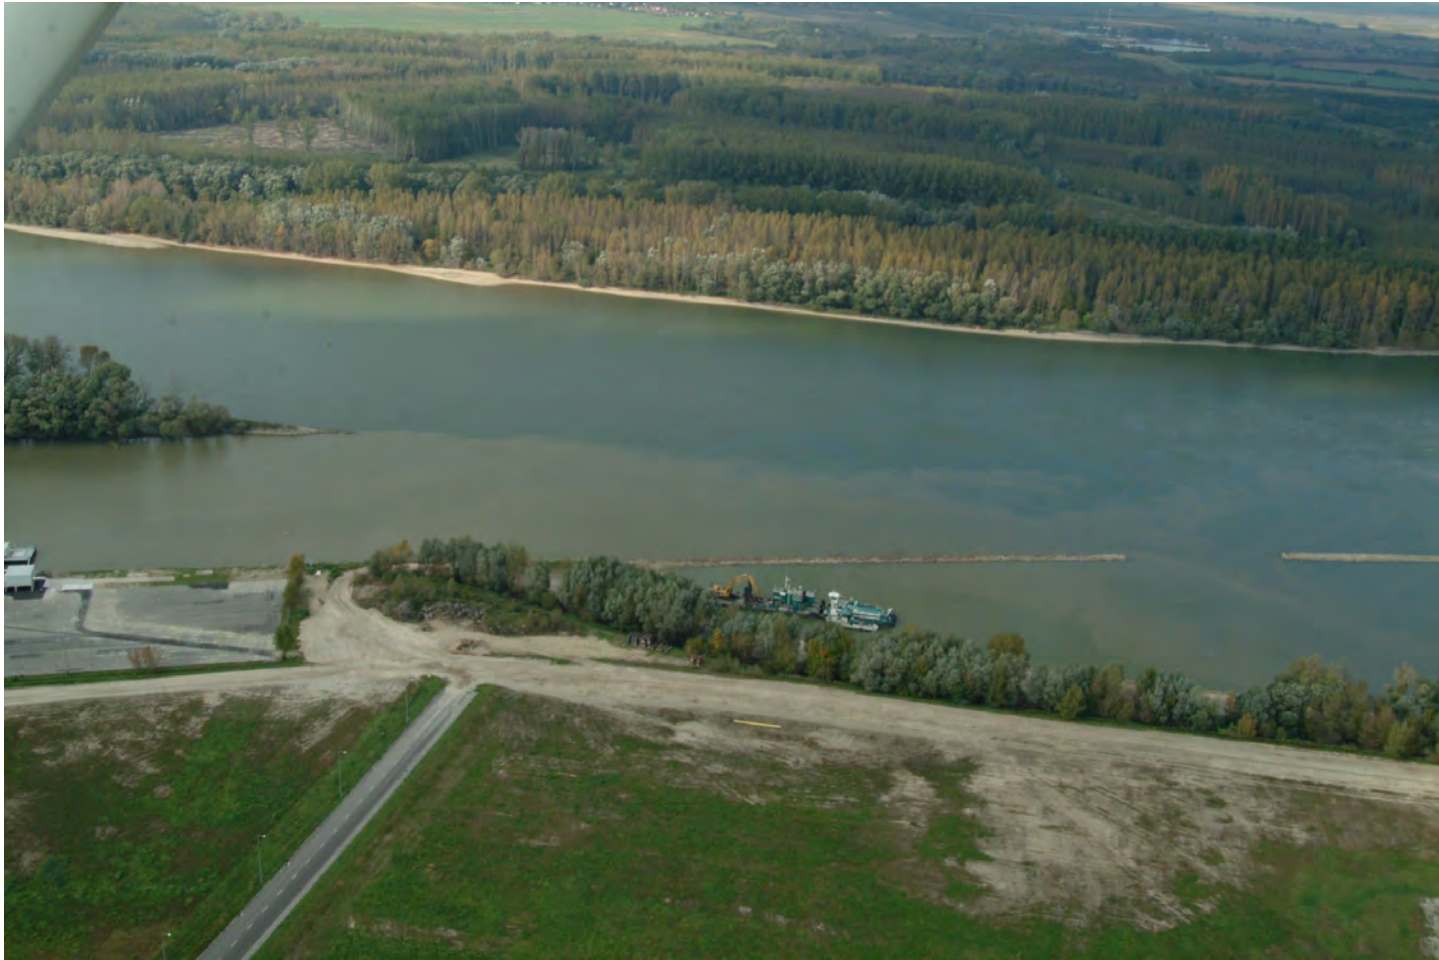
Danube confluence 2010. 10. 08.

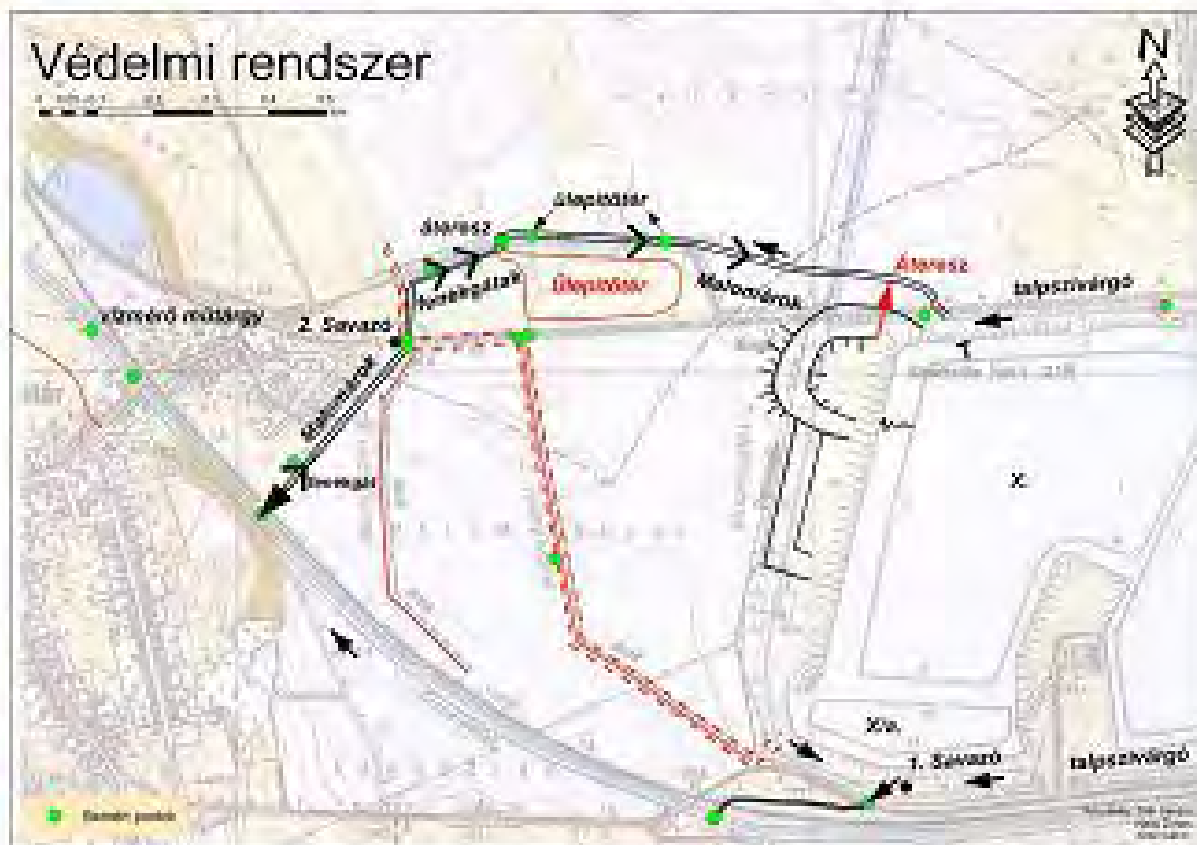
New protection system

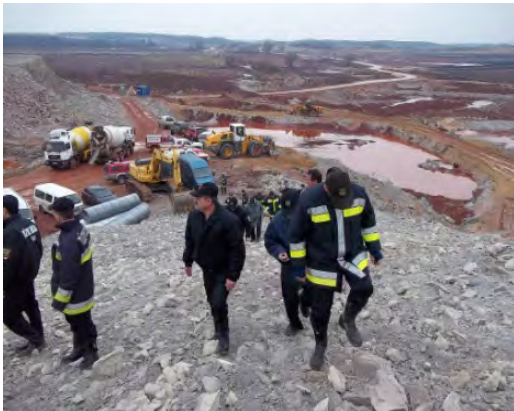
Soil contamination: in the 5-20 cm layer

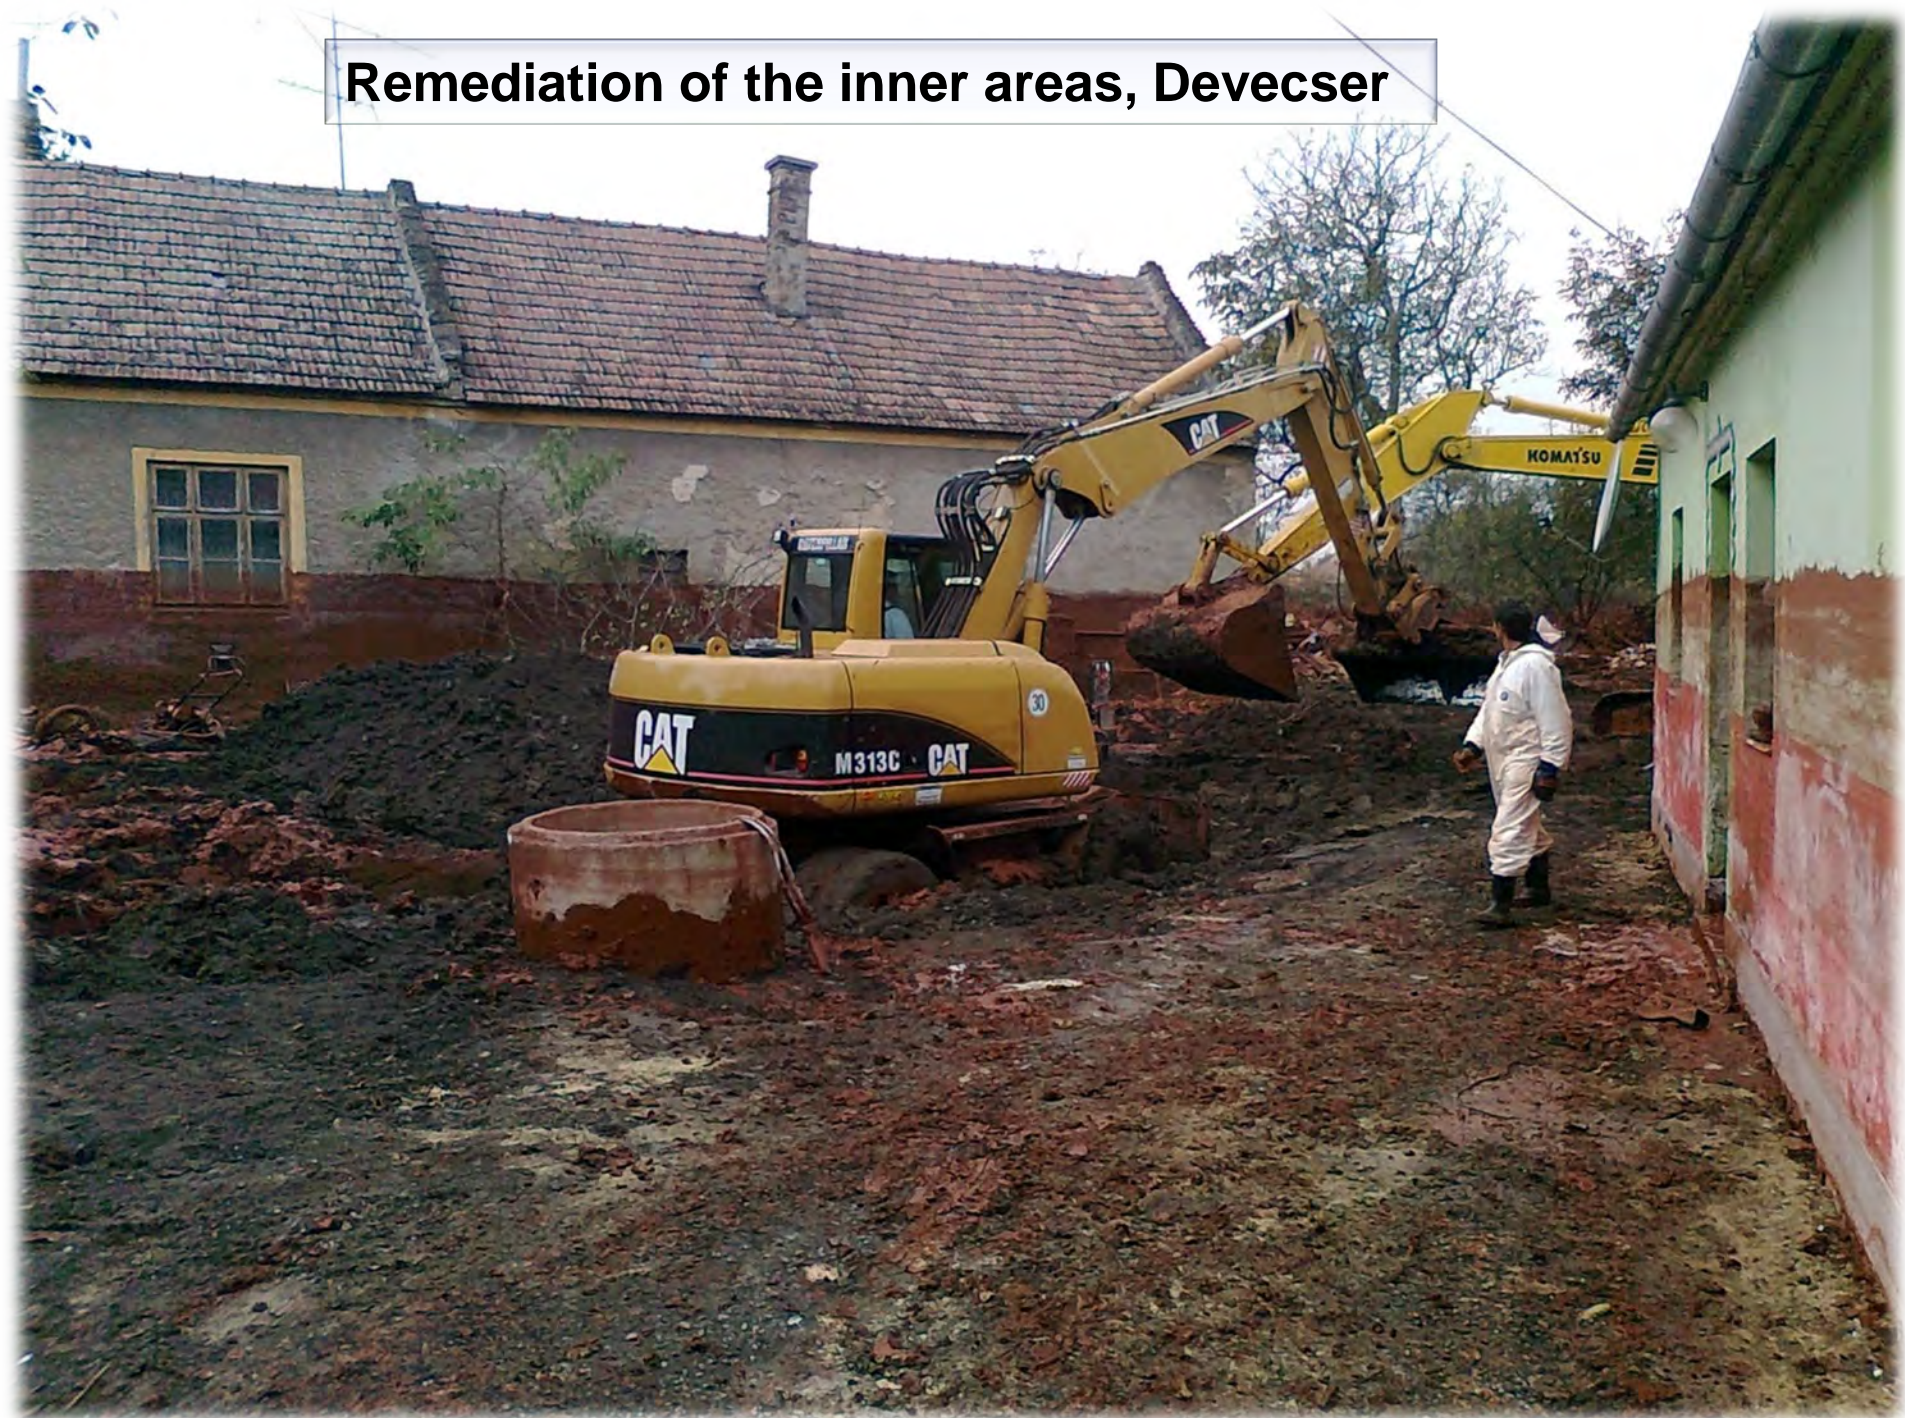
Remediation of the inner areas, Devecser

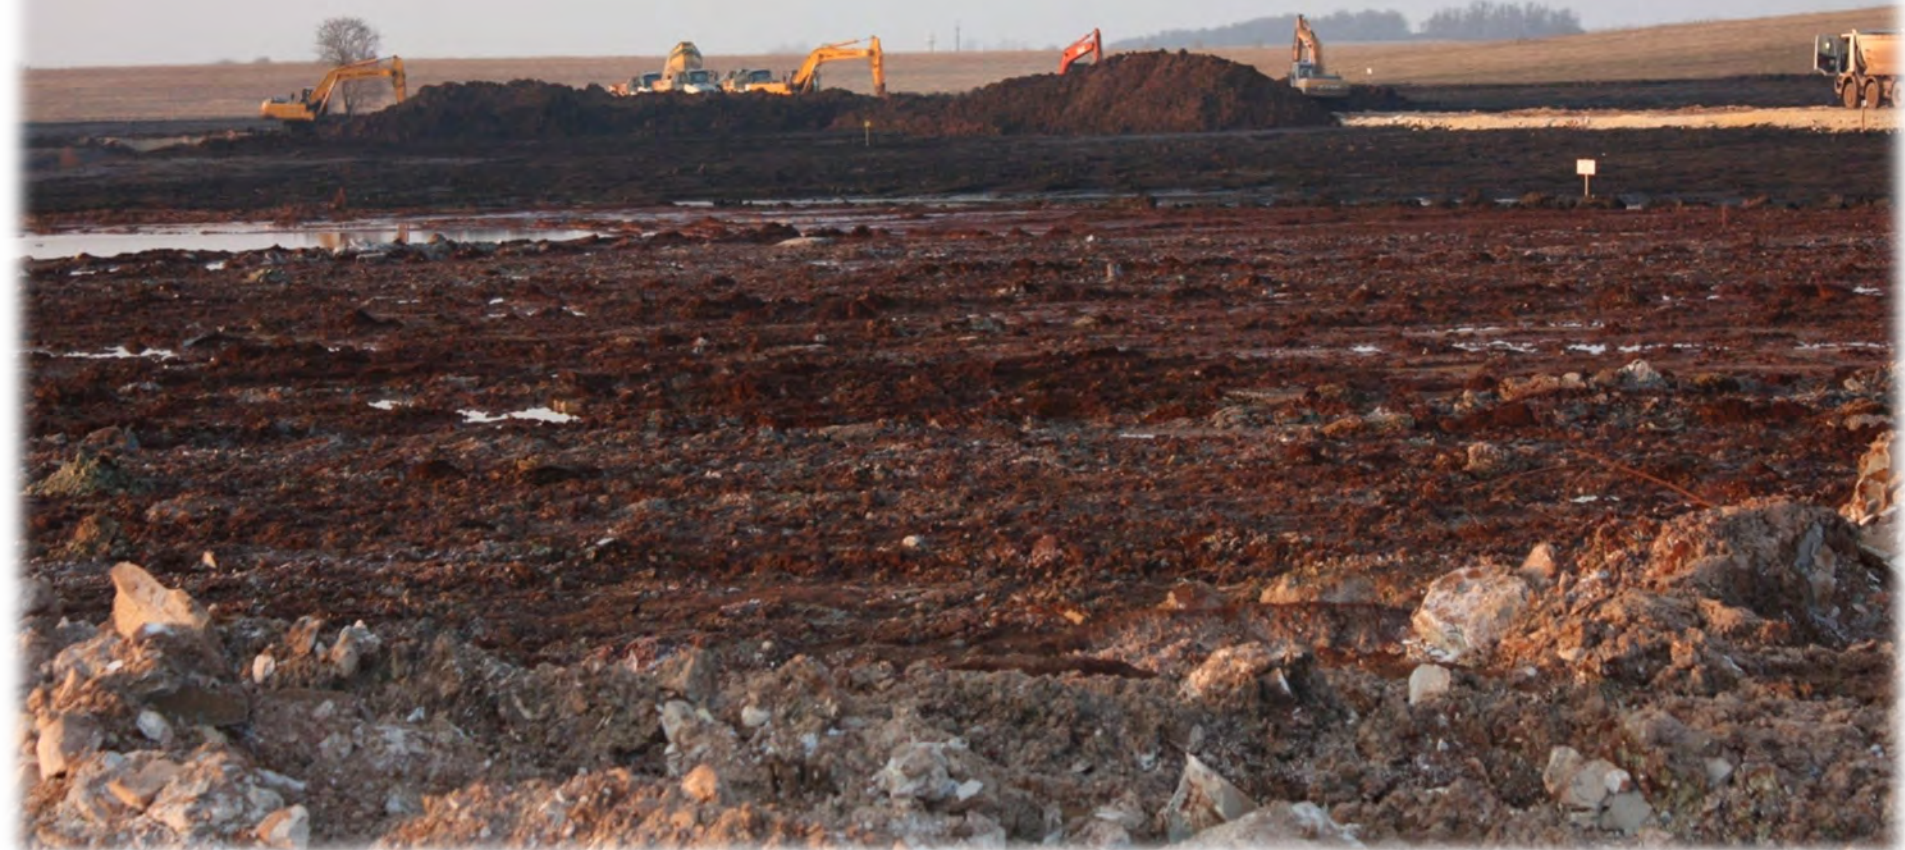
Remediation of agricultural areas (Kolontár)
