LESSONS LEARNT FROM THE TAILINGS DAM FAILURES AT BAIA MARE AND BAIA BORSA, ROMANIA, IN 2000

ZOLTÁN TÖRÖK, ASSOC. PROF. PHD;

*RESEARCH INSTITUTE FOR SUSTAINABILITY AND DISASTER MANAGEMENT,
BABES-BOLYAI UNIVERSITY, ROMANIA;*

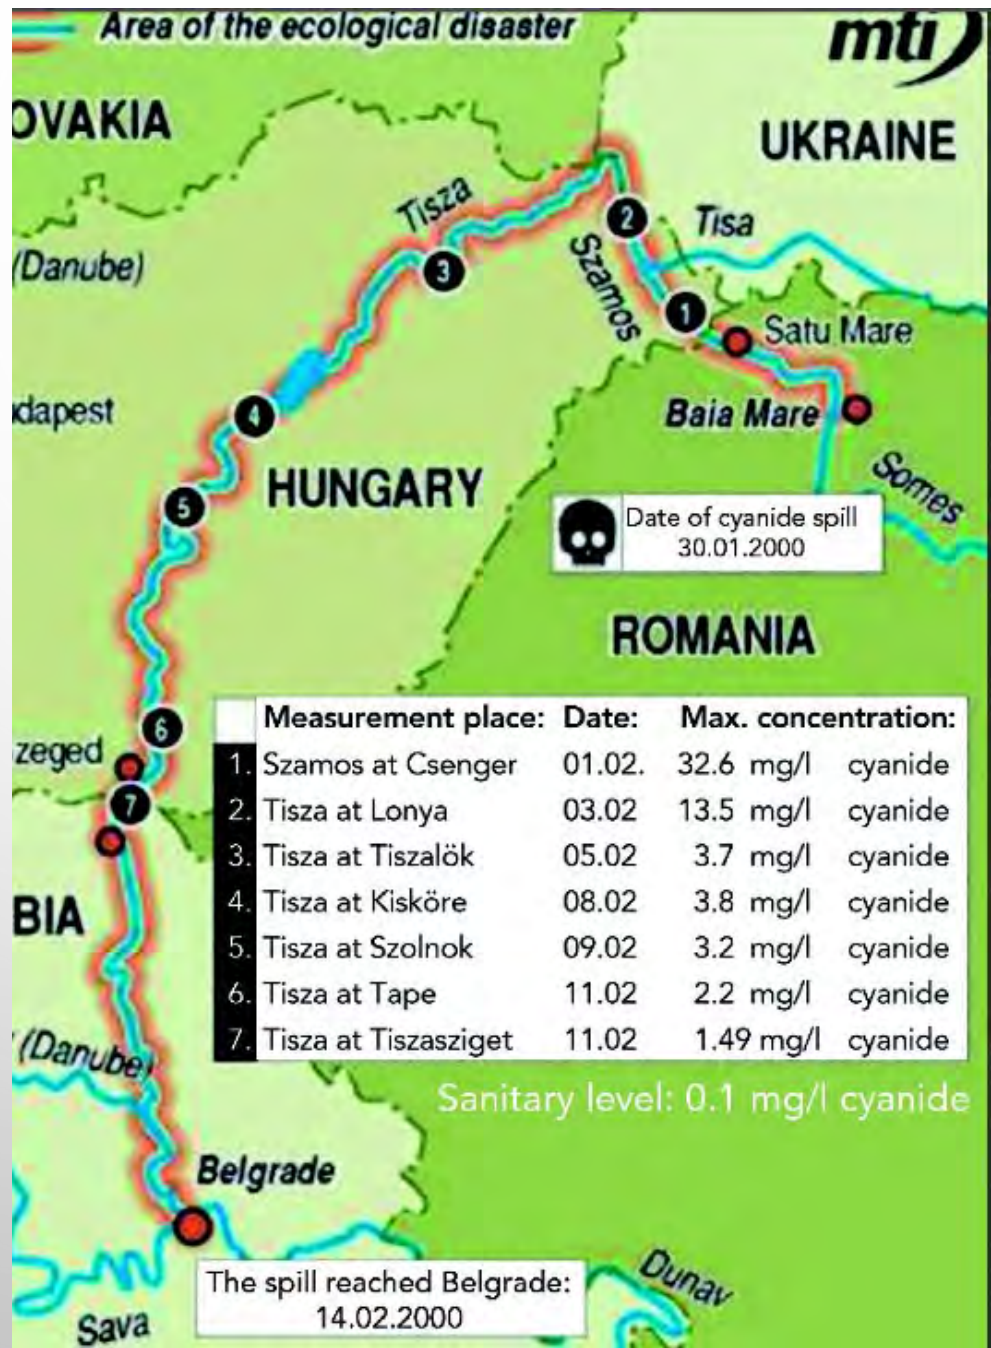
- TRANS-BOUNDARY EFFECTS: EXTENSIVE CONTAMINATION OF A MAJOR RIVER SYSTEM, FROM THE SZAMOS STREAMS AND THE TISZA RIVER, TO THE DANUBE RIVER
- CONTAMINATION AND INTERRUPTION OF THE DRINKING WATER IN 24 TOWNS AND OF 2.5 MILLION PEOPLE;
- MASSIVE FISH-KILL AND DESTRUCTION OF AQUATIC SPECIES IN THE RIVER SYSTEMS.

Figure 7. Event timeline and measurements in Szamos and Tisza Rivers, Hungary

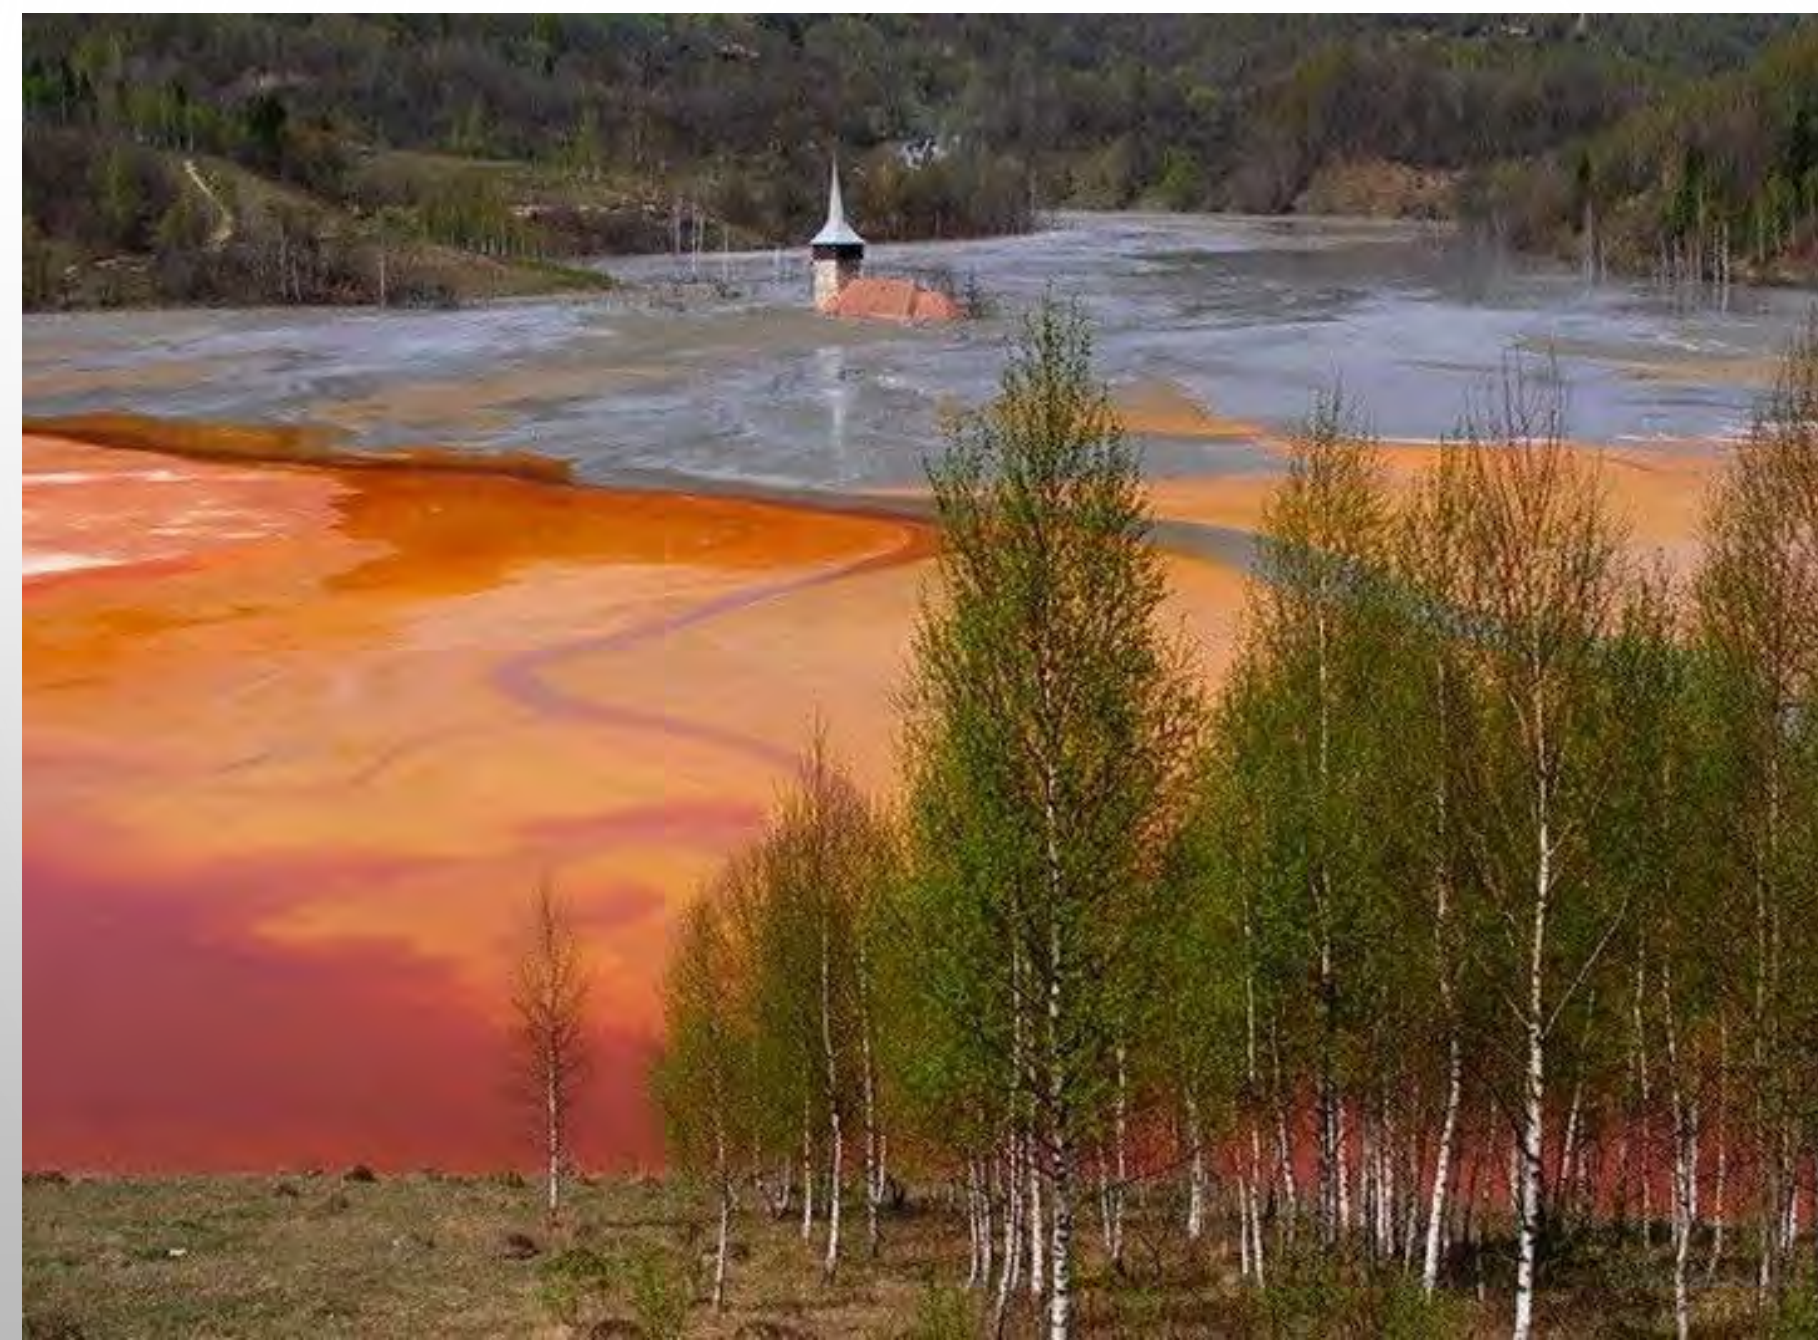
Figure 11. Valea Sesei TMF – 3rd highest TRI in Romania
