**CUSTOMS CONVENTION ON THE INTERNATIONAL TRANSPORT
OF GOODS UNDER COVER OF TIR CARNETS (TIR CONVENTION 1975) ^{*/}**

Amendment proposals relating to technical provisions

New Comment to Annexes 2 and 7

Draft comment to Annex 2, Article 2, paragraph 1 (b)

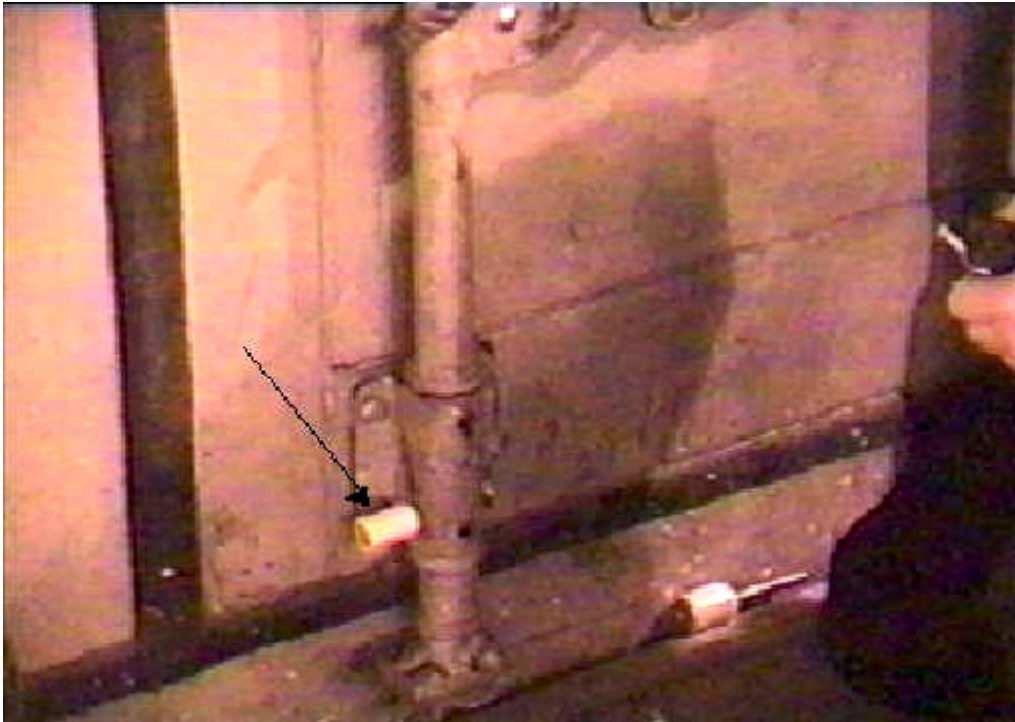
Photo A

- (a) A ½ in. (1.27 cm) hole should be drilled through the vertical bar on the right-hand door of the container and through the lower plate fastening that bar to the door of the container. A mechanical or electronic seal should then be affixed through this hole, covering the rivet heads on the plate to prevent tampering. The placement of a seal in this manner will prevent opening of the container, despite any tampering with the handle area. (See photo A)*

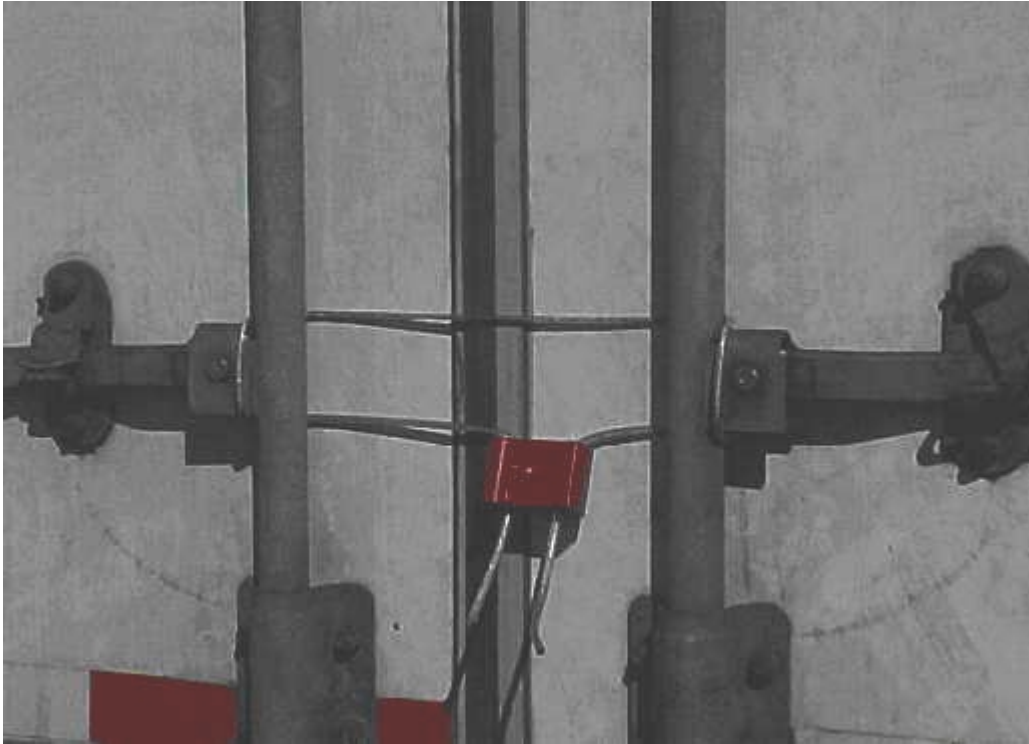
Photo B

(b) Cable seals should be attached as per the manufacturer's instructions. In addition, when affixed, cable seals should be tight, with all excess cable looped, twisted or otherwise secured to prevent them from moving easily. (See photos B and C)

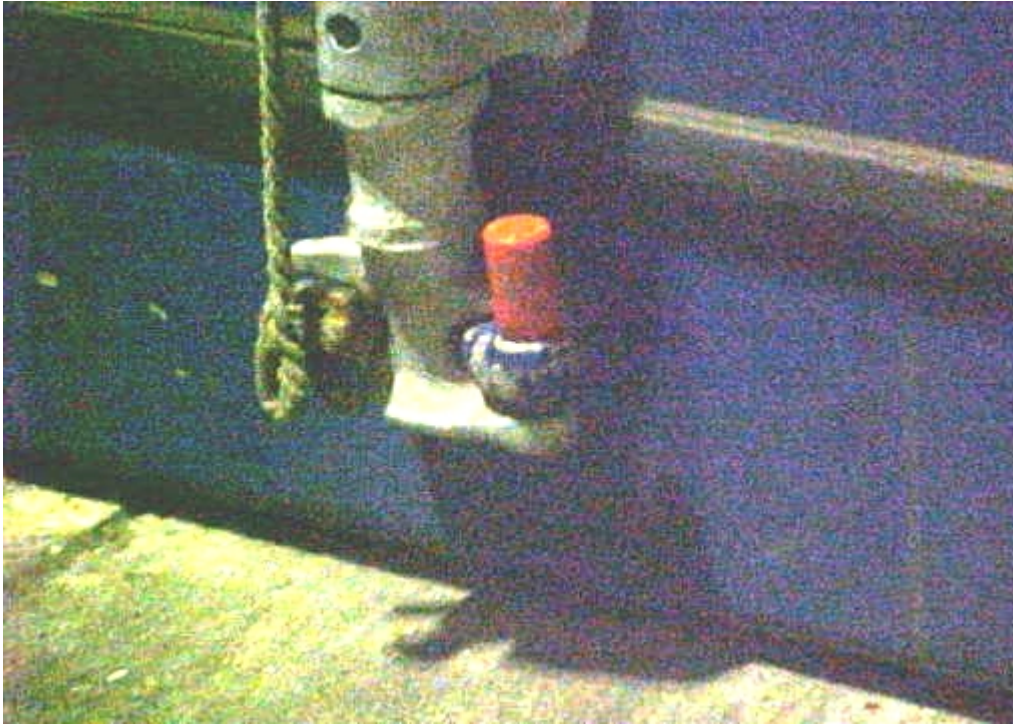
(c) Security is also enhanced by having an additional sealing point near the bottom of the door. When a seal is affixed in this location, the door cannot be opened regardless of attempts to tamper with the handle hub area.

Photo D Maersk/Sealand Containers

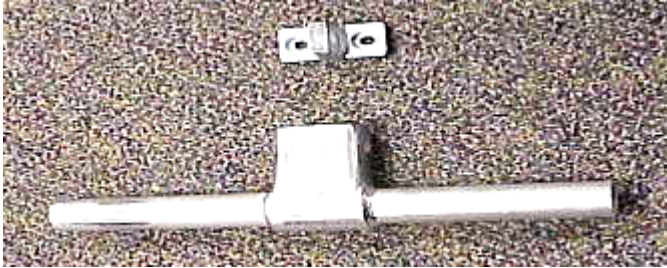
(d) Locking Rod Seal Retainers

Locking rod seal retainers represent another location for placement of mechanical seals.

(See photo E)

Photo E P&O Nedlloyd Containers
