SATELLITE BASED RISK ASSESSMENTS AND MONITORING

SOUTH AFRICA , JAGERSFONTEIN , DIAMOND MINE TSE

RIDDER-SOKOLNOE TAILINGS STORAGE FACILITY (TSF), KAZAKHSTAN

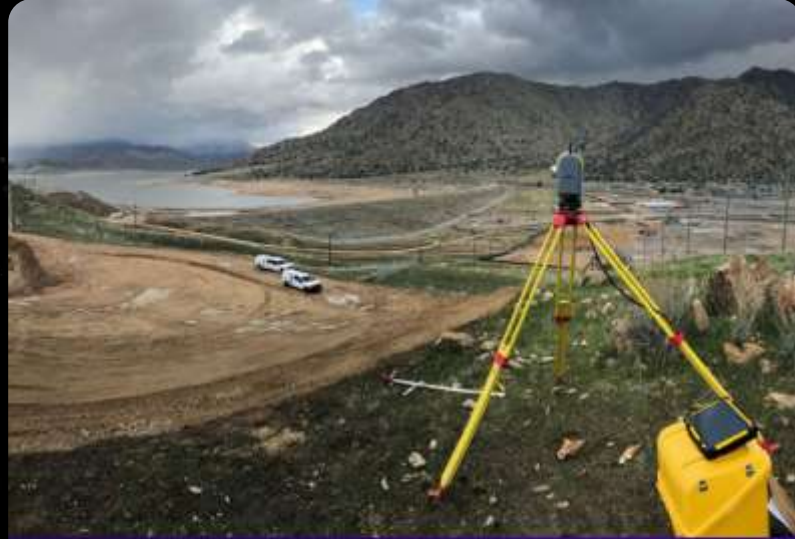
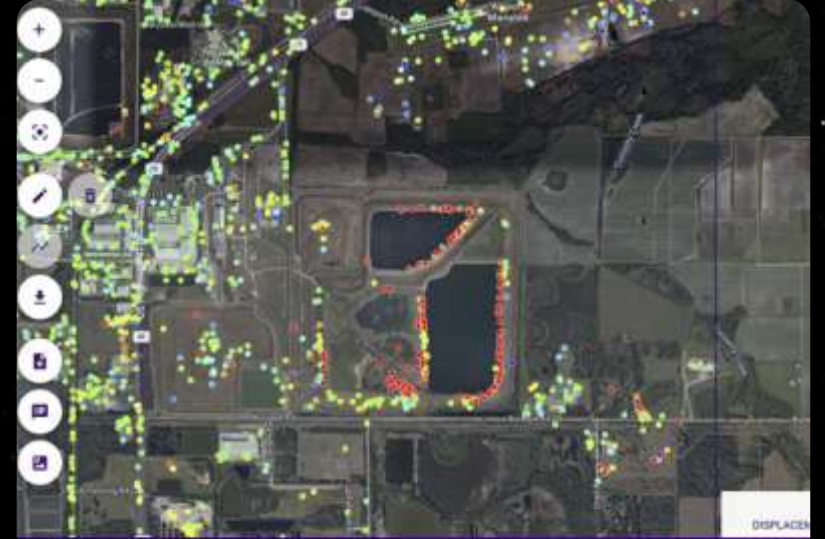
MANUAL WORKLOAD COMPARED TO VALUE.SPACE

Deformation monitoring is largely performed manually today by engineers who must go on-site to a e.g. dam or mine and depending on the size of the structure and area, spend days or weeks, measuring levels of deformation by hand.

This is costly, particularly if the area is large (1km², 10km² or 100km²).

Value.Space provides a digital solution that is **x10 faster**, **100% remote** and up to **x25 more cost efficient** than the manual alternative.

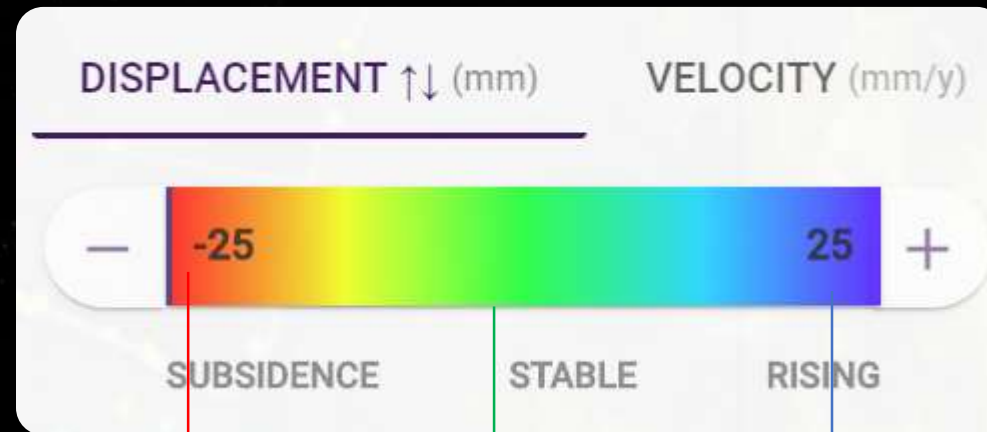
Deformation Gauge

Red = Downward Movement

Green = Stable

Blue = Upward Movement

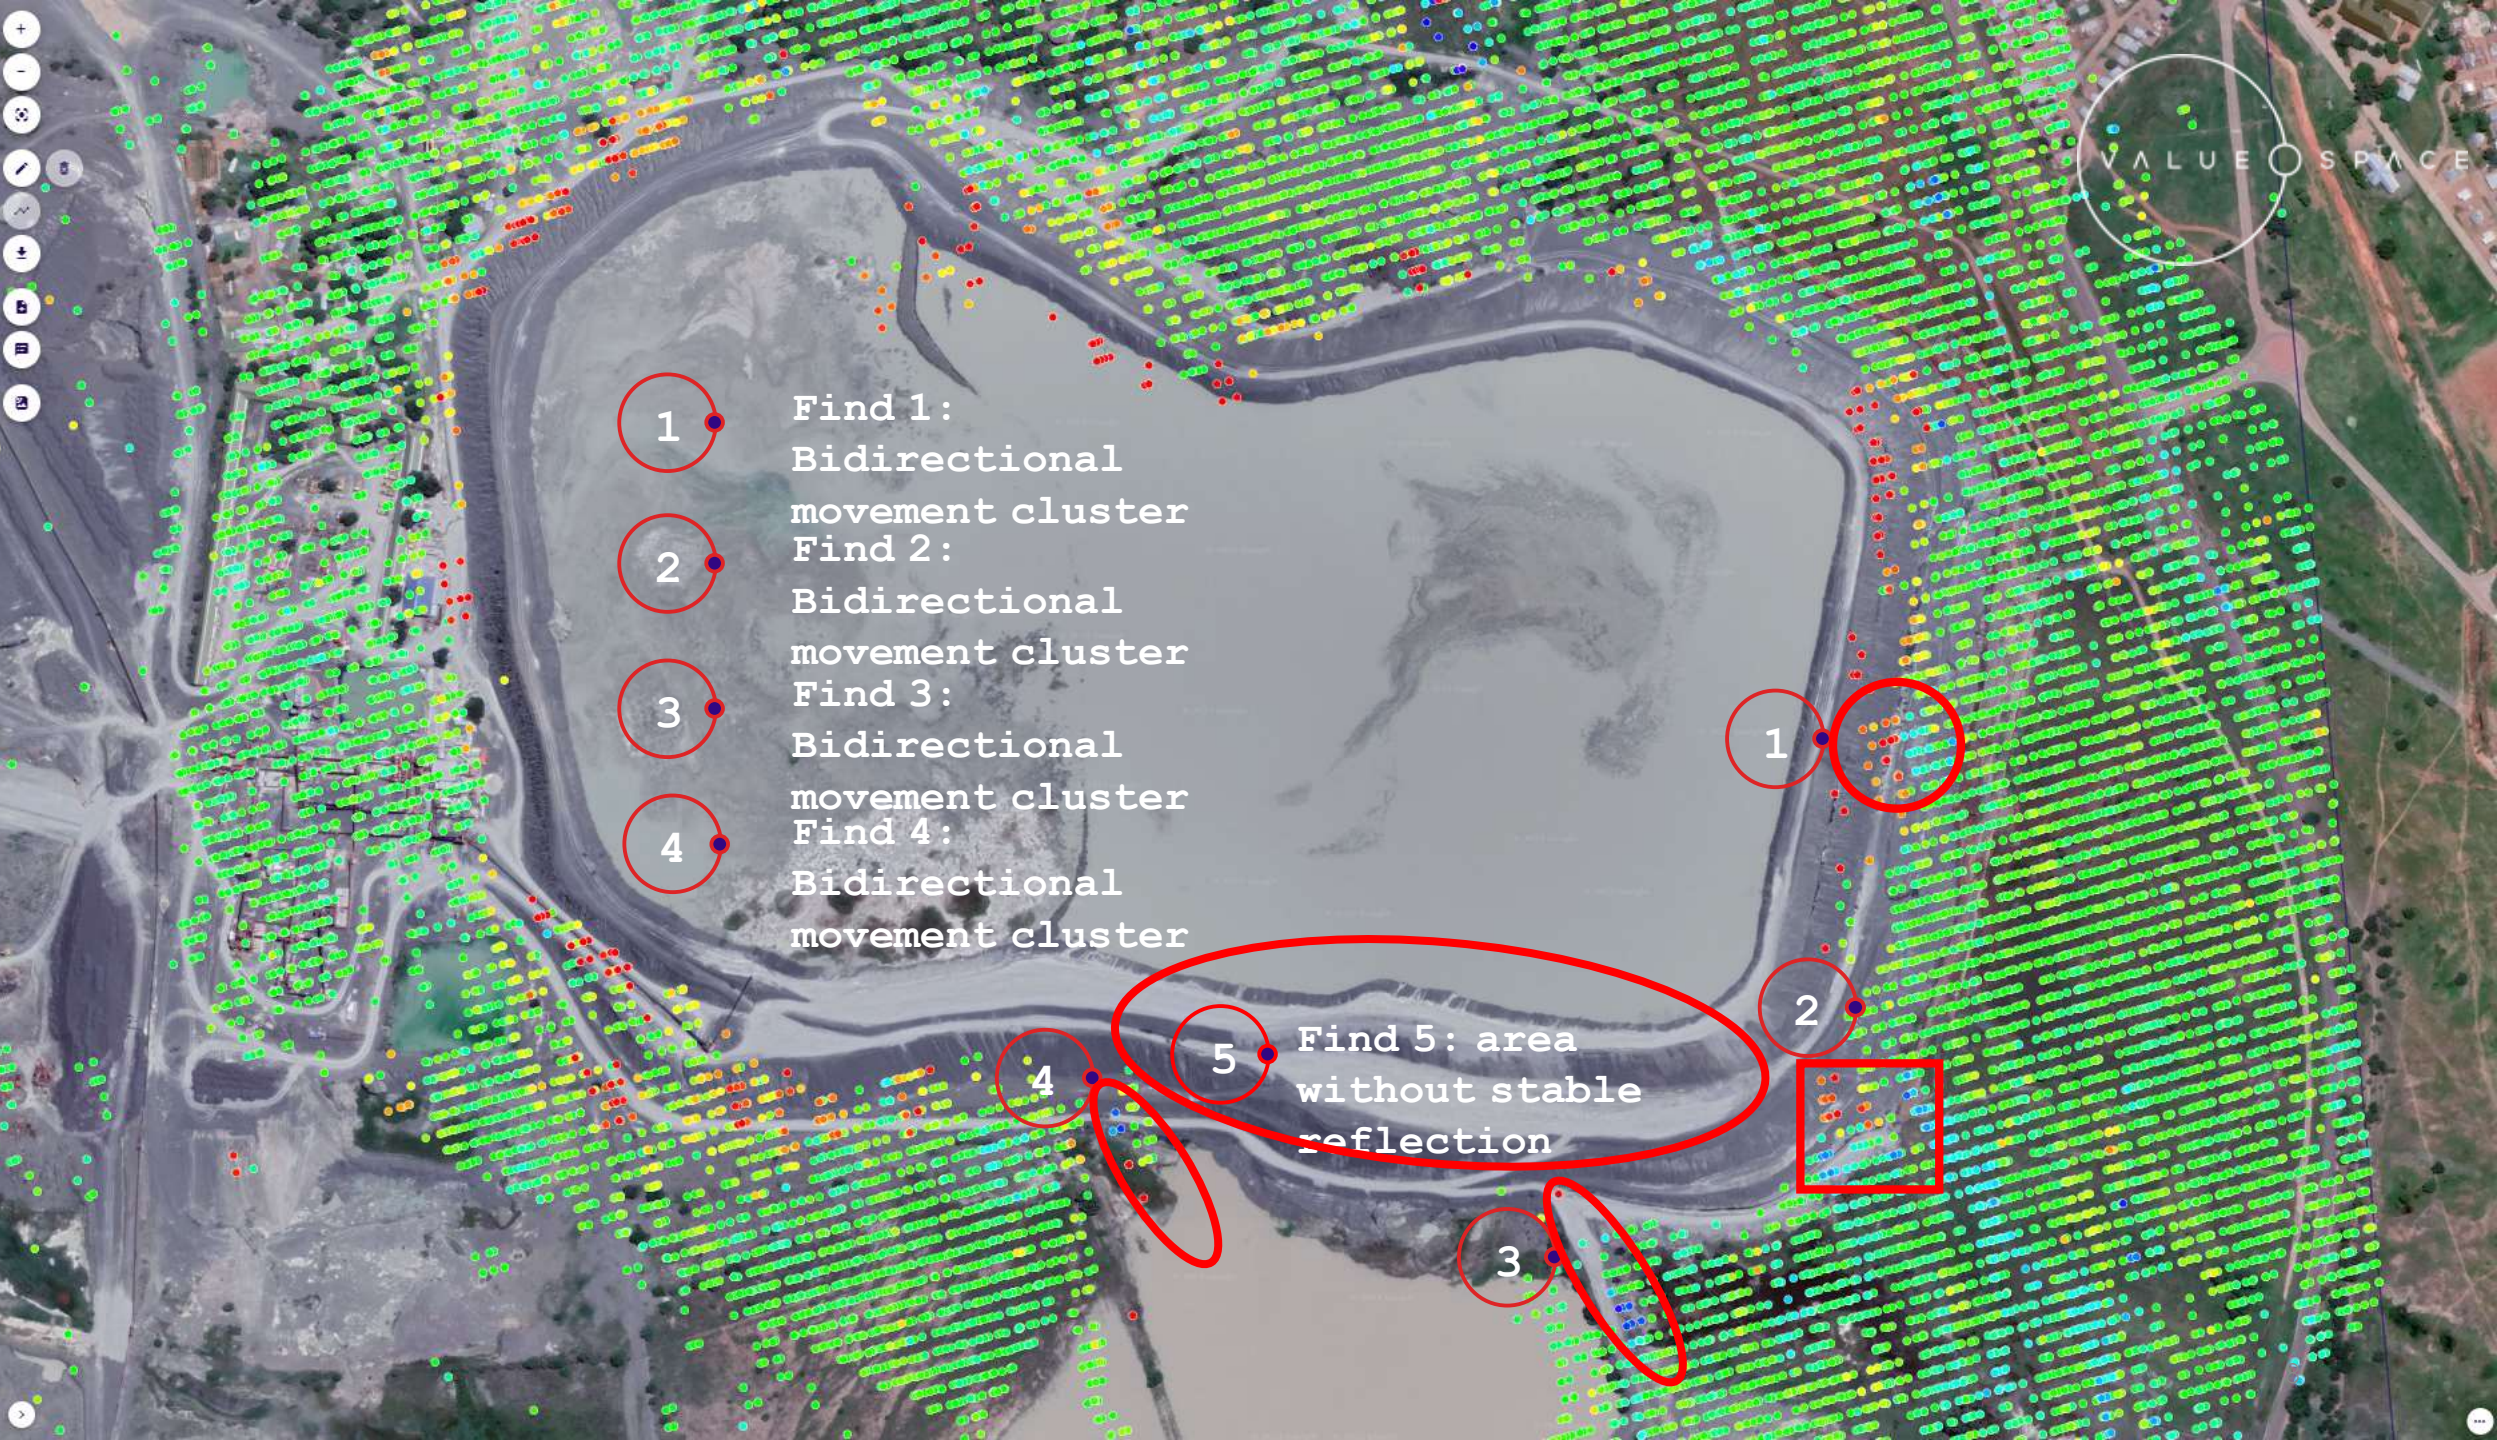
Several risk markers could have been foreseen at least a year and a half before the loss event, likely longer if it would have been monitored regularly.

Loss event occurred 11th September, 2022

- 1 Find 1:
Bidirectional
movement cluster
- 2 Find 2:
Bidirectional
movement cluster
- 3 Find 3:
Bidirectional
movement cluster
- 4 Find 4:
Bidirectional
movement cluster

- 5 Find 5: area
without stable
reflection
- 1
- 2
- 3

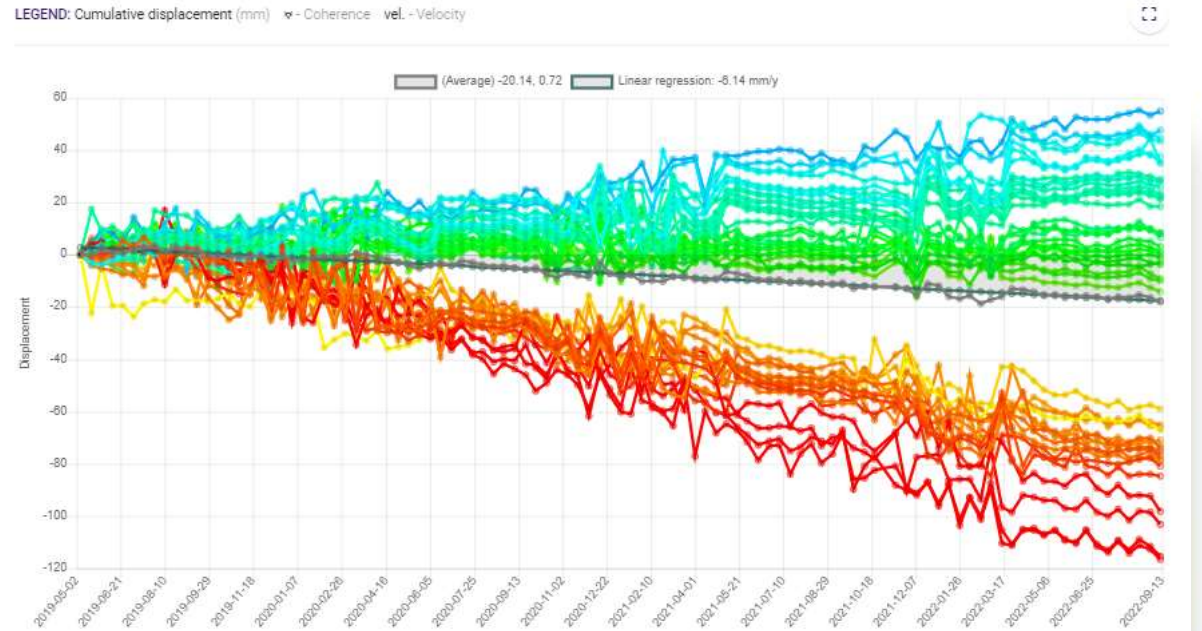
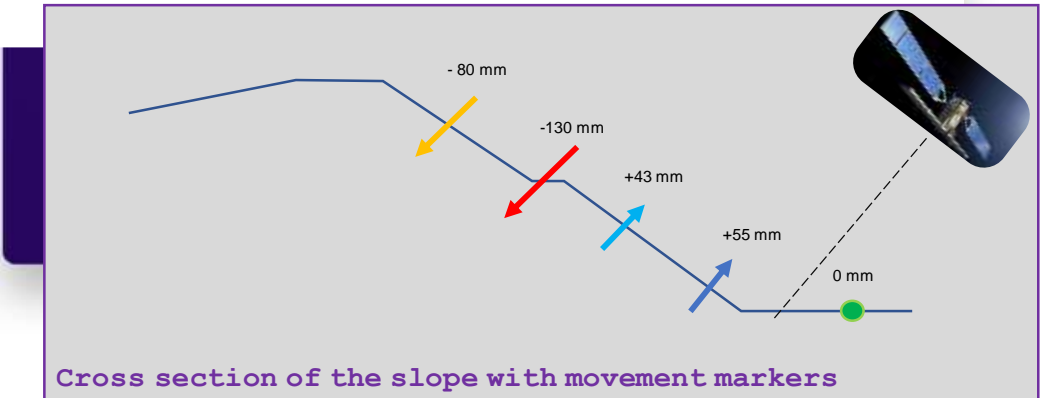
1

Timeline: 05.2019 – 09.2022
 Find 1: Bidirectional movement cluster (differs from usual)

Jagerfontein, TSF: 06.05.2019 - 11.09.2022

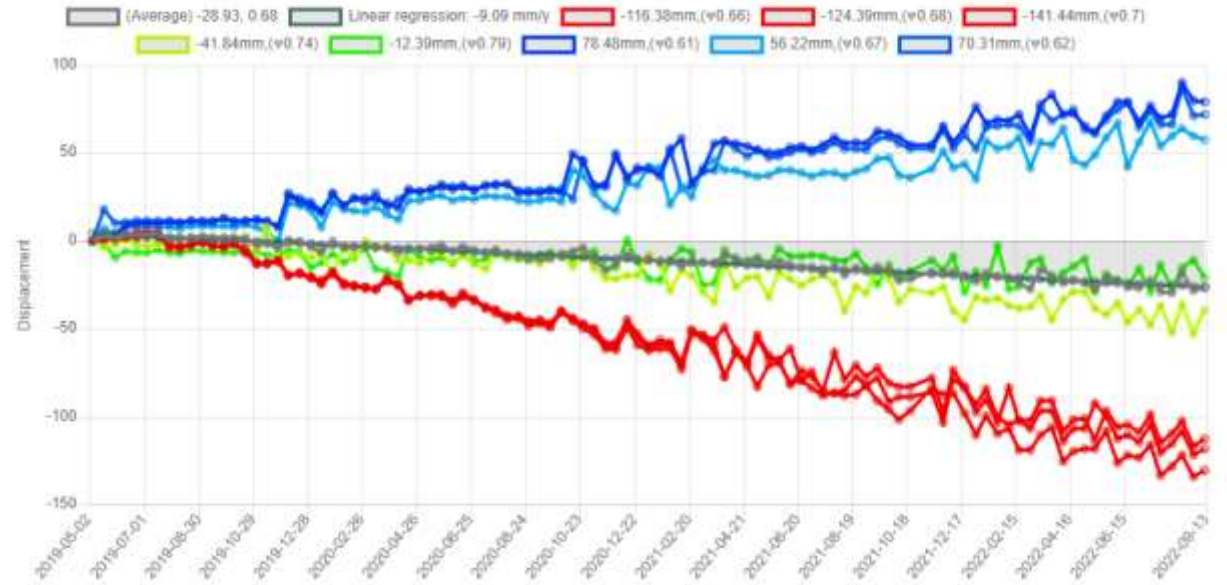
4

Find 4: Bidirectional movement cluster (between relatively

Jagerfontein, TSF: 06.05.2019 - 11.09.2022

LEGEND: Cumulative displacement (mm) ↕ Coherence vel. - Velocity

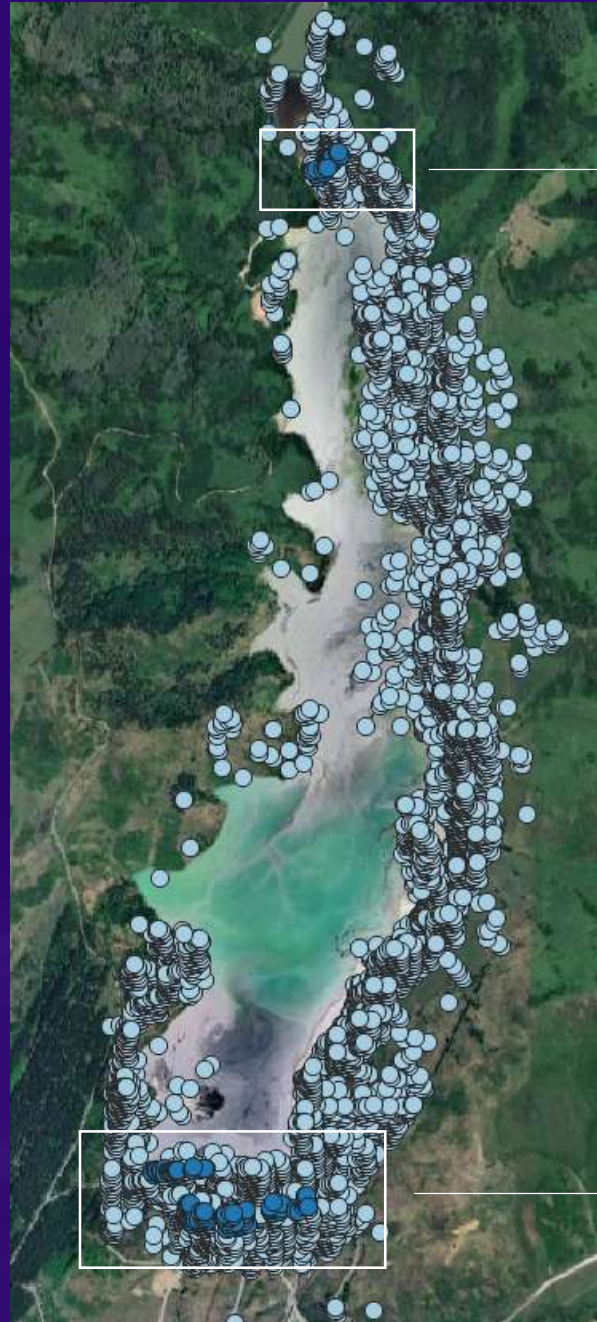
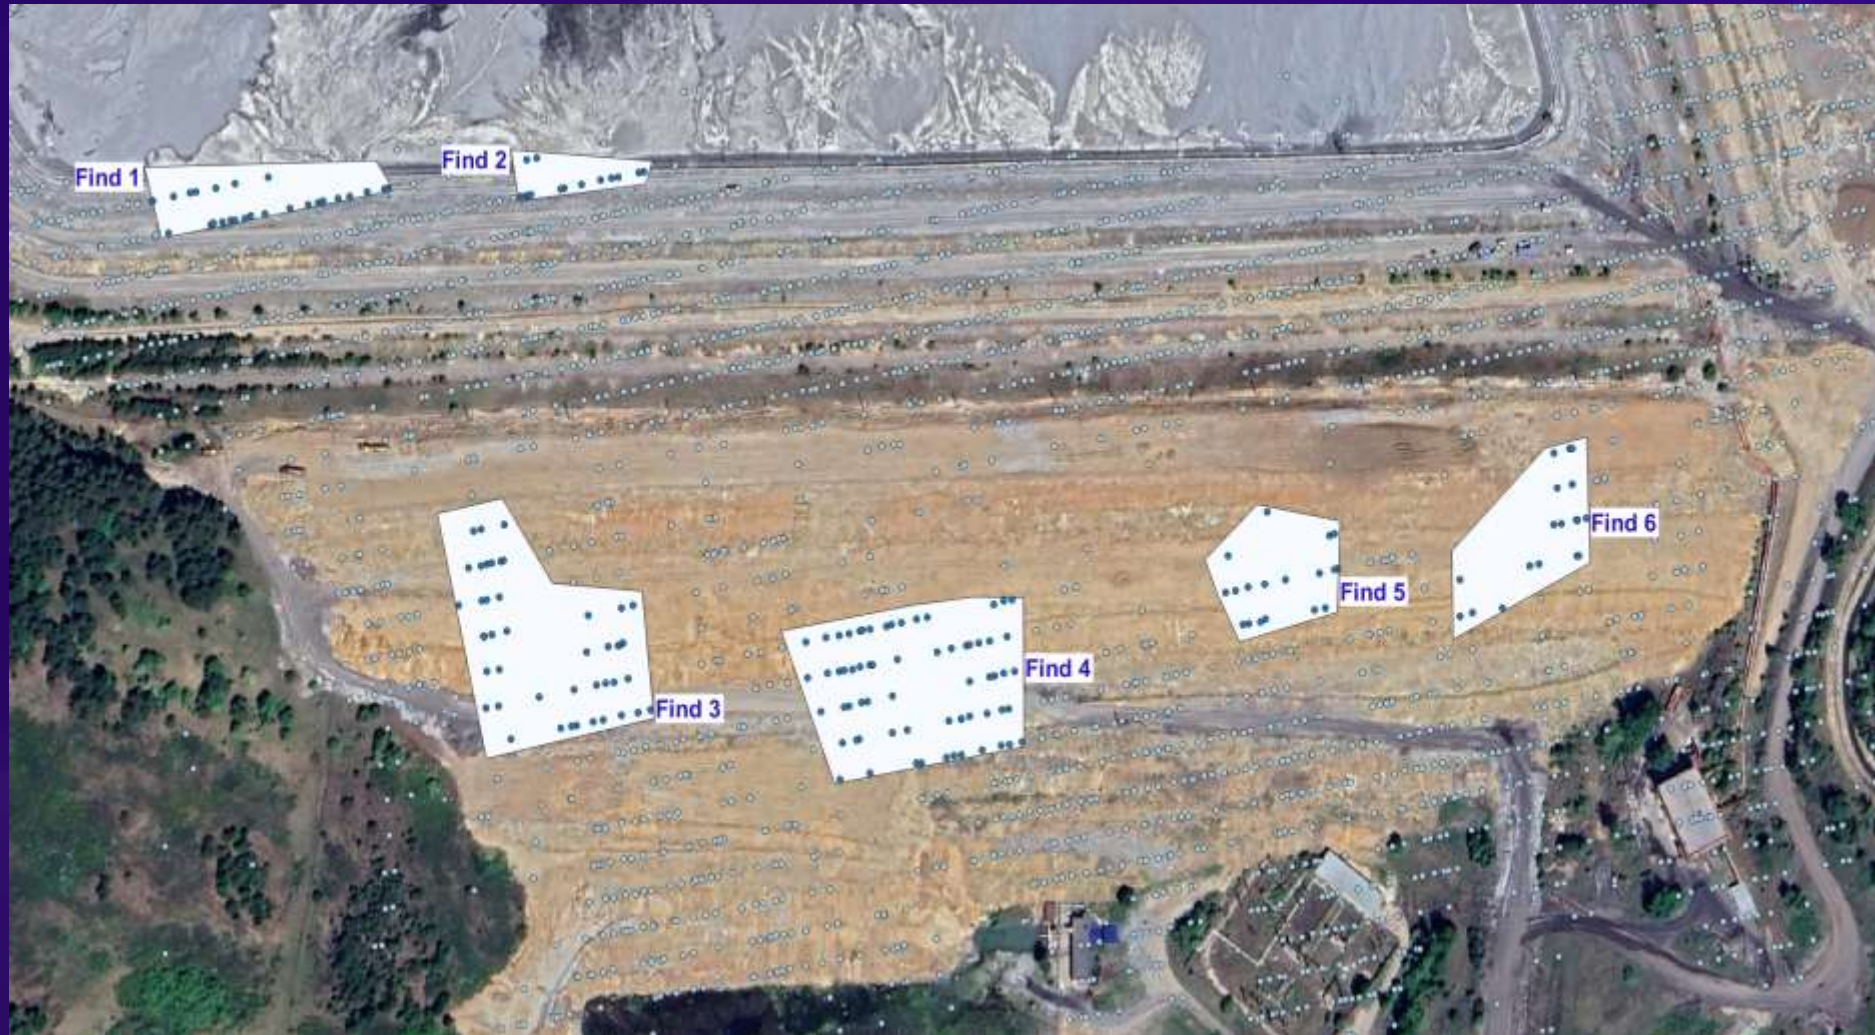
Ridder TSF – Macro
Overview
Site B – North Dam
Find 7

Site A – South Dam
Finds 1, 2, 3, 4, 5, 6

Site A – South Dam Detailed Overview Finds 1 – 6

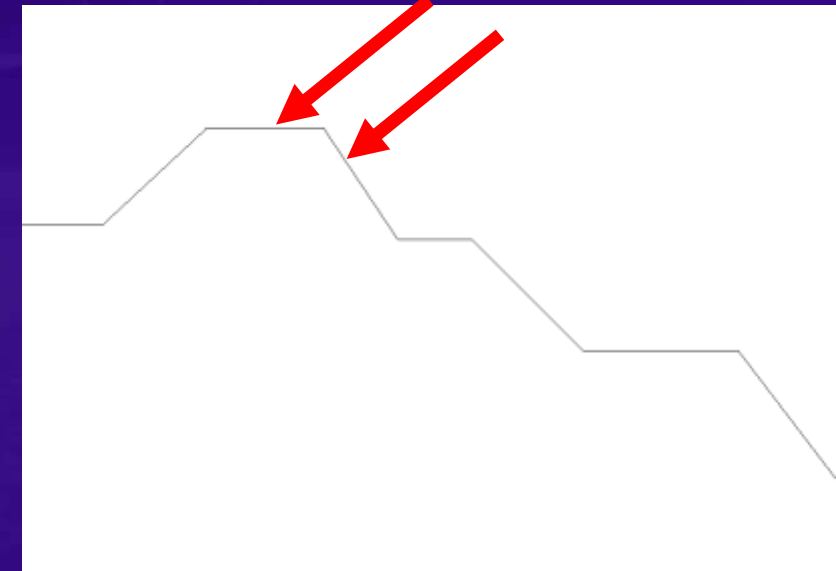
Site A, South Dam - Find 1 in Detail

Section deformation up to 44 mm / year

44 mm/y

*The shape and the angle of the slope are illustrative and may differ from the actual slope profile

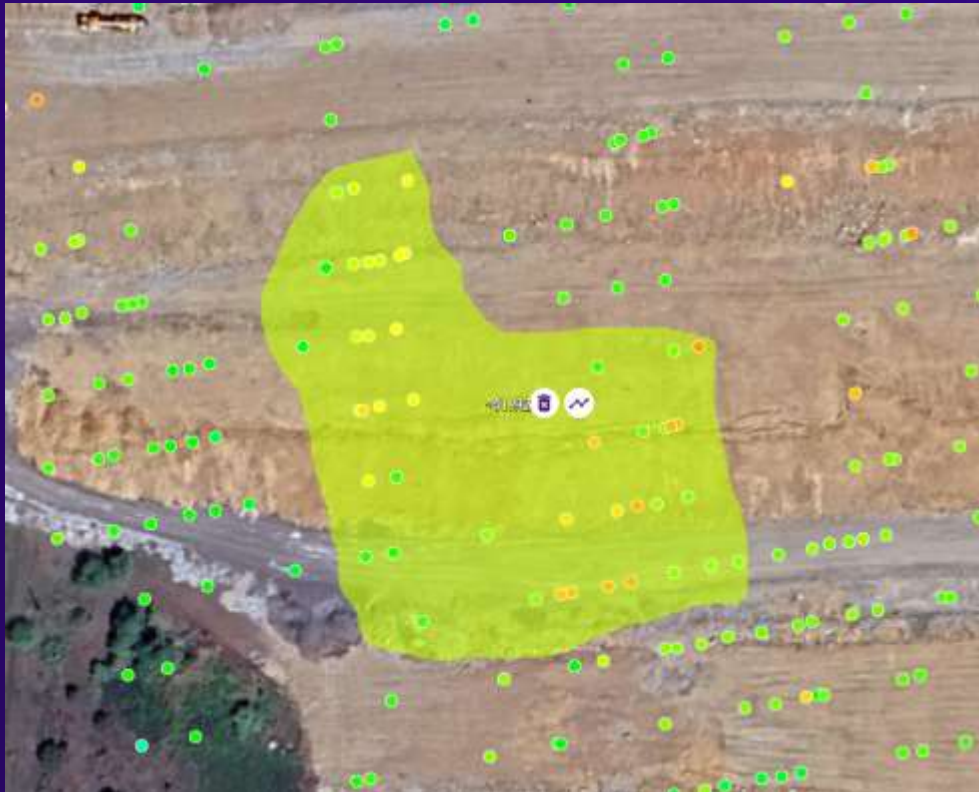
Site A, South Dam - Find 3 in Detail
Section deformation up to 69 mm/year

69 mm/y

*The shape and the angle of the slope are illustrative and may differ from the actual slope profile

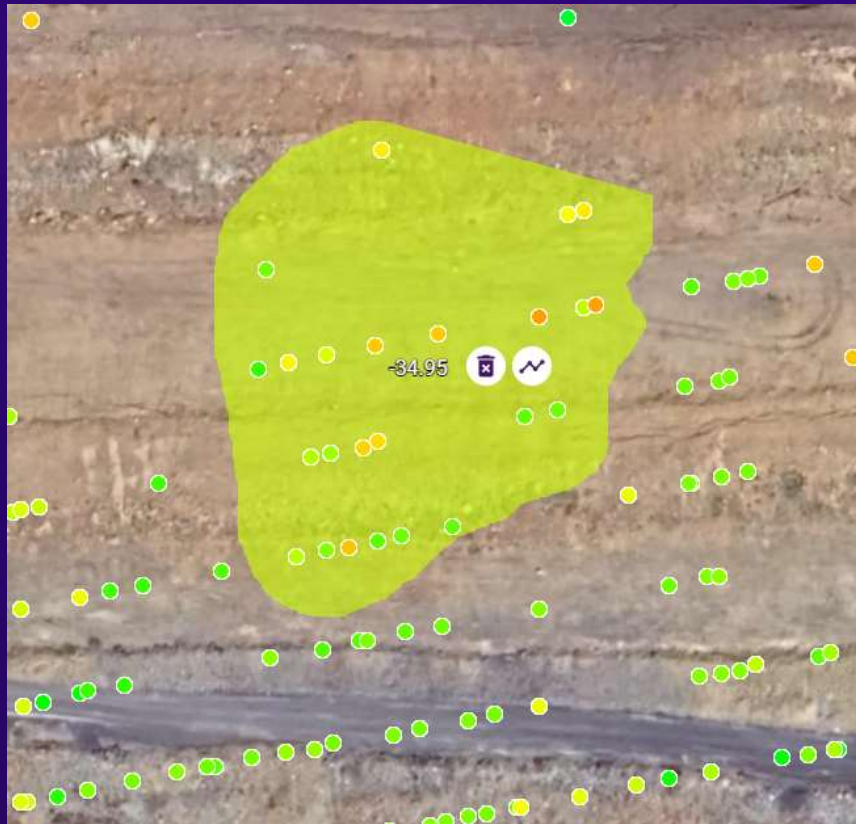
Site A, South Dam - Find 5 in Detail
Section deformation up to 55 mm/year

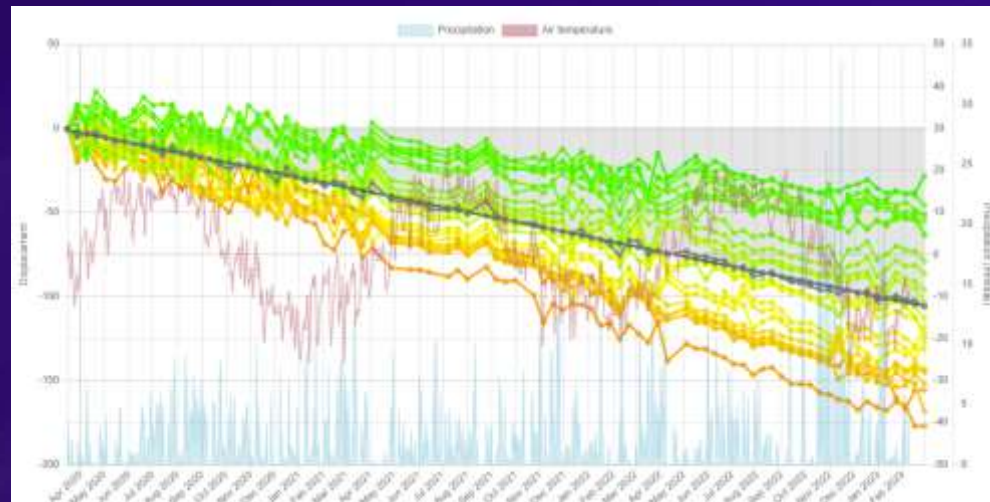
55 mm/y

*The shape and the angle of the slope are illustrative and may differ from the actual slope profile

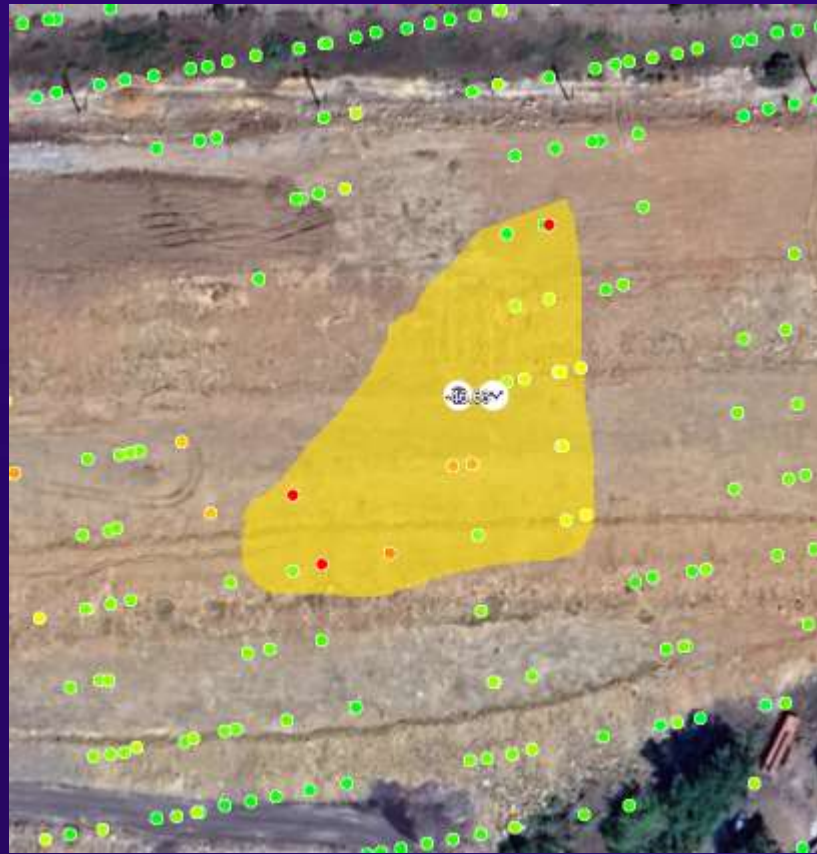
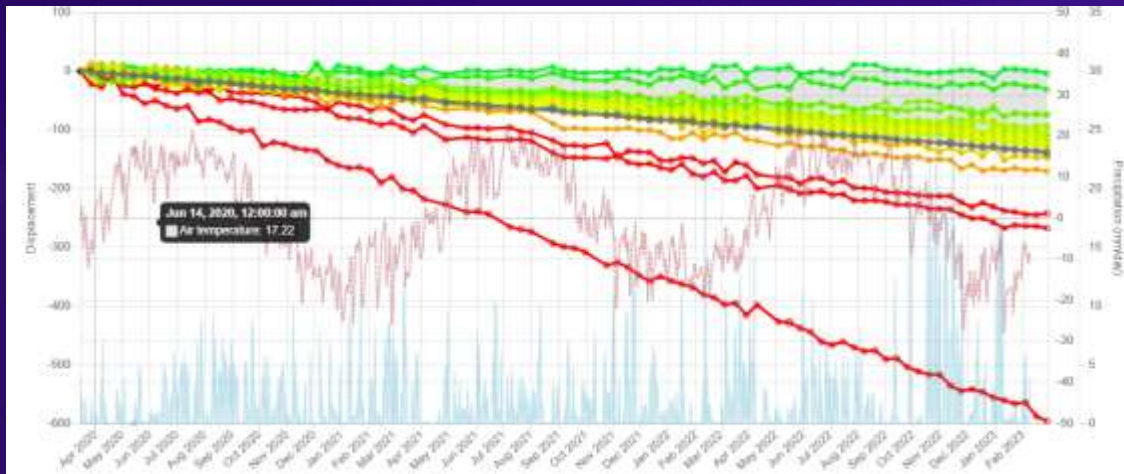
Site A, South Dam - Find 6 in Detail

Section deformation up to 196 mm / year

196 mm/y

*The shape and the angle of the slope are illustrative and may differ from the actual slope profile

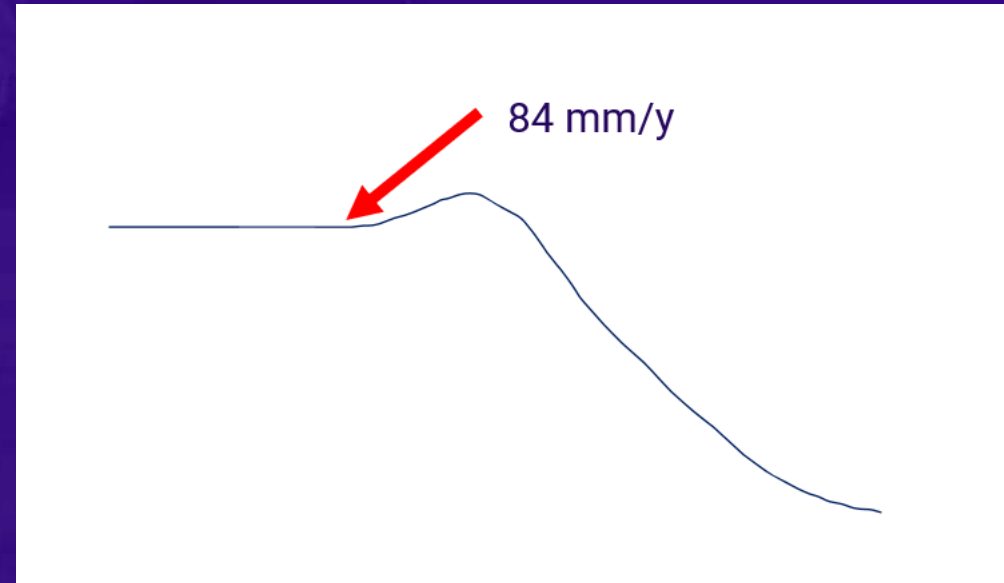
Site B, North Dam Find 7 in Detail: Section deformation up to 84 mm / year

*The shape and the angle of the slope are illustrative and may differ from the actual slope profile
